# Rock Creek Restoration Master Plan

Rebuilding a degraded creek

Prepared for: County of Placer  
Planning Department  
April 27, 2007

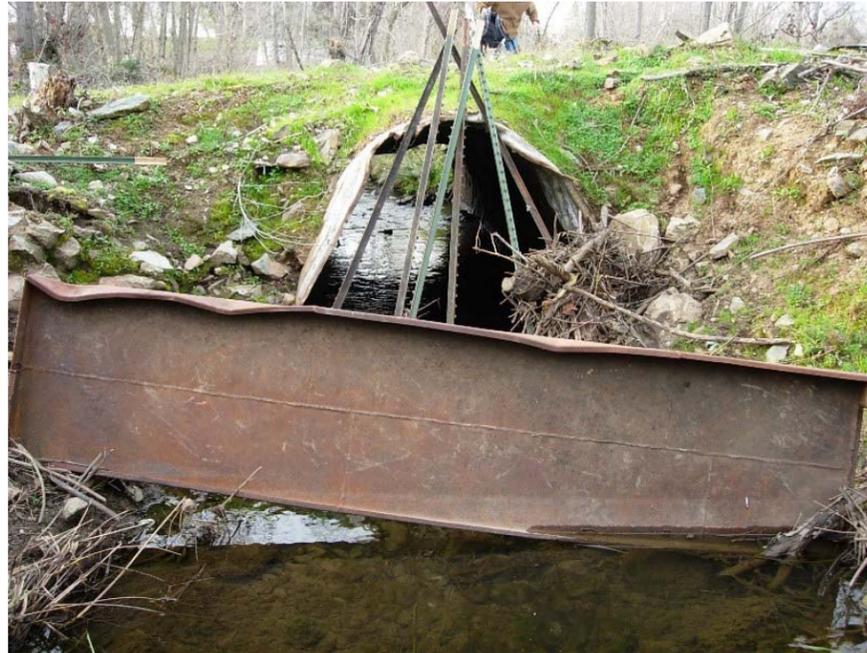
**Figure 7 — In-Stream Structure 1 (INSS1)**

Condition of INSS1 is considered to be poor. Stream flow conveyance is obstructed by a non-standard trash rack, accumulated debris, and a deformed structure shape. The non-standard trash rack is currently constructed of heavy-duty metal t-type fence posts and a thin sheet of metal held in place by cobbles and several more metal fence posts. Debris composed of cobbles and tightly compacted small woody debris has blocked a portion of the trash rack. In addition, it appears as if improper installation of the culvert has deformed the culvert over time. This is most likely caused by the lack of design for traffic surcharges, lack of embedment cover, and use of inadequate fill materials. This structure requires replacement.

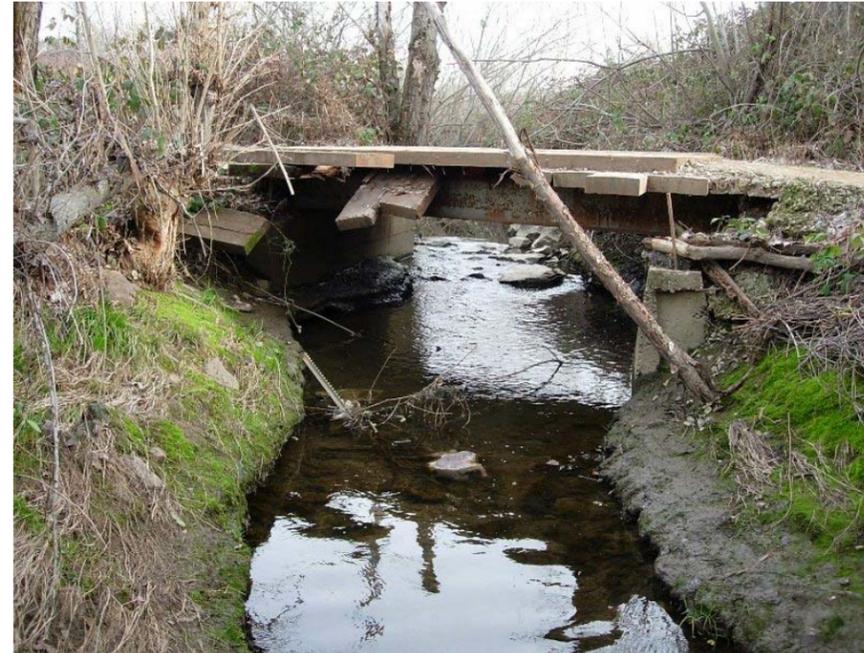
**Figure 8 — In-Stream Structure 2 (INSS2)**

The condition of INSS2 is considered fair. Stream flow conveyance is reduced by narrow concrete walls oriented at a slight angle from the upstream flow line. There is some indication of some scour and bank instability. However, the condition does not seem severe. The concrete abutments seem intact and in fair condition. The steel parallel chord support beams were observed to be in fair condition.

The wooden travel deck is in disrepair and would benefit from repair or replacement.

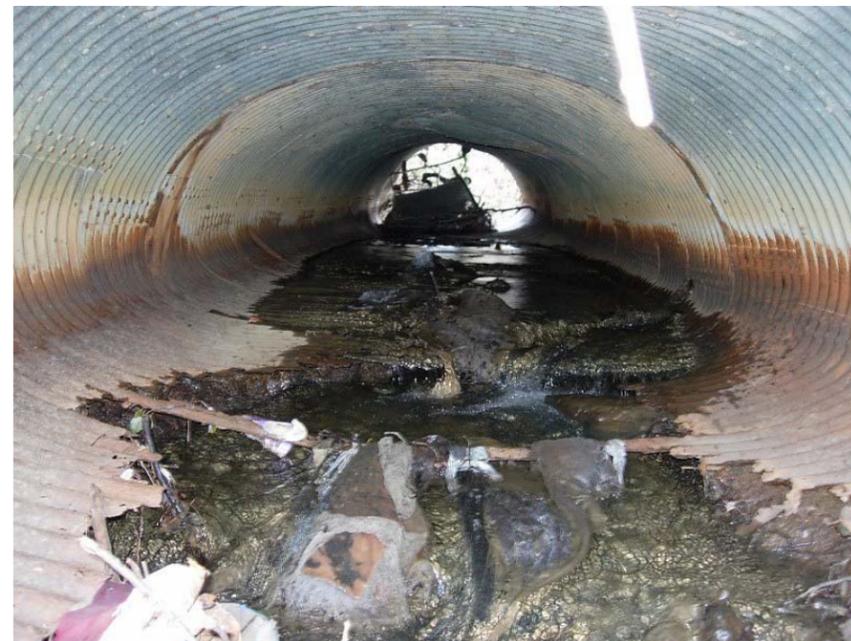
**Figure 9 — In-Stream Structure 3 (INSS3)**

The Condition of INSS3, the Rock Creek Road crossing, is considered very poor. During observation it was apparent that the culvert floor has rusted away and is virtually missing from the structure. Stream flow obstructions at the culvert inlet include shopping carts and small and large woody debris. Due to an apparent reduction in conveyance, backwater conditions are observed above the culvert inlet. This is evident due to the settling out of fines upstream of the culvert as well as the development of wetland type habitat upstream of the culvert.

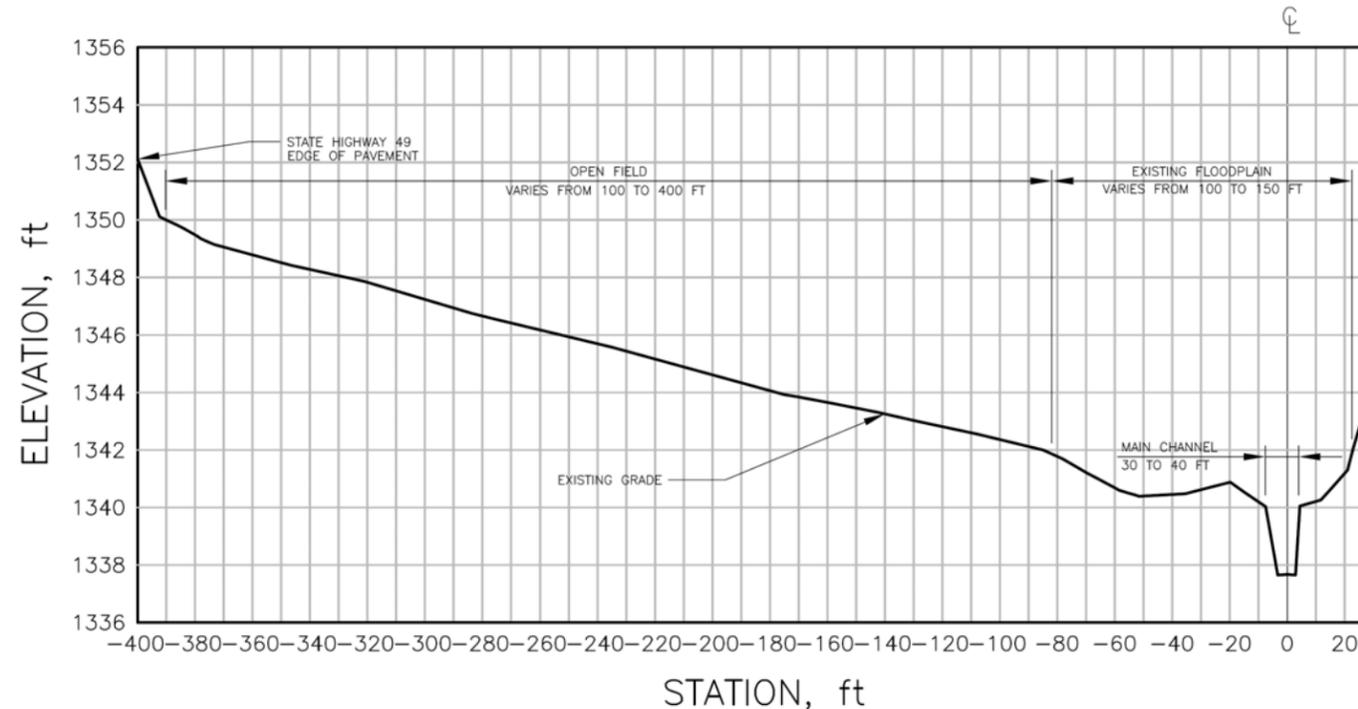
(TYPICAL FOR MAIN CHANNEL DISTANCE 7+00 TO 16+08 FT)

Observations indicate that the channel downstream of the Rock Creek Road crossing has degraded vertically exposing bedrock in many portions of the study reach. This is most likely due to the presence of erosion resistant soils and heavily vegetated banks which tend to resist lateral erosion. Channel banks are nearly vertical except at the most upstream portions of the study reach. Figure 13 provides typical existing cross-sections occurring along the project reach.
