INTEGRATED ENVIRONMENTAL
RESTORATION SERVICES, INC

**Homewood Mountain Resort Annual Report
Restoration and Monitoring
2007 – 2008**

**Prepared by Rachel Arst and Michael Hogan
July 21, 2008**

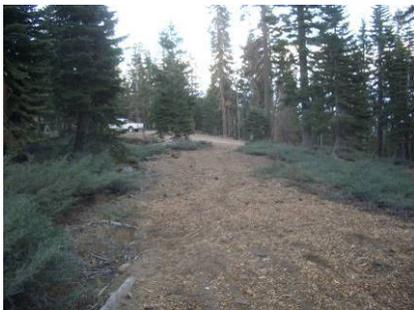
Figure 5. Site 31, before treatment.

Site 31 was a road previously used for tree removal. It had a shallow layer of surface woodchips (less than 1 inch), two water bars, and very little vegetation before treatment. It is located in a mixed conifer forest, with white fir as the dominant over-story species. The understory consists of whitethorn and coyote mint. The site has a slight slope of 8 degrees, faces east, and sits at approximately 7,107 feet above mean sea level (AMSL, Figure 4 and Figure 5).

Figure 5, Figure 6, and Figure 7 show Site 31 during treatment and post-treatment.

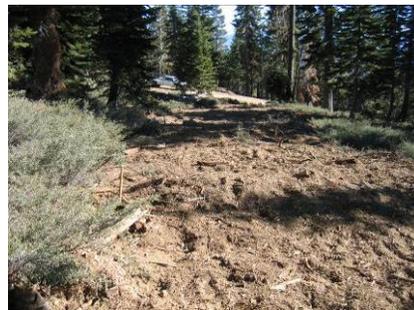
Figure 6. Site 31, after treatment.

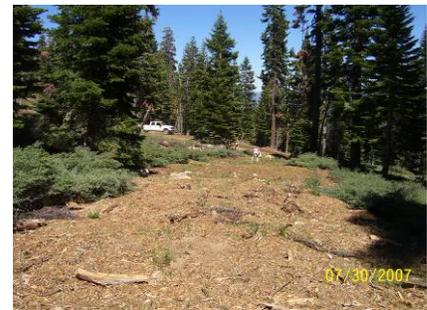
Figure 7. Site 31, one season after treatment. Grass is beginning to grow.

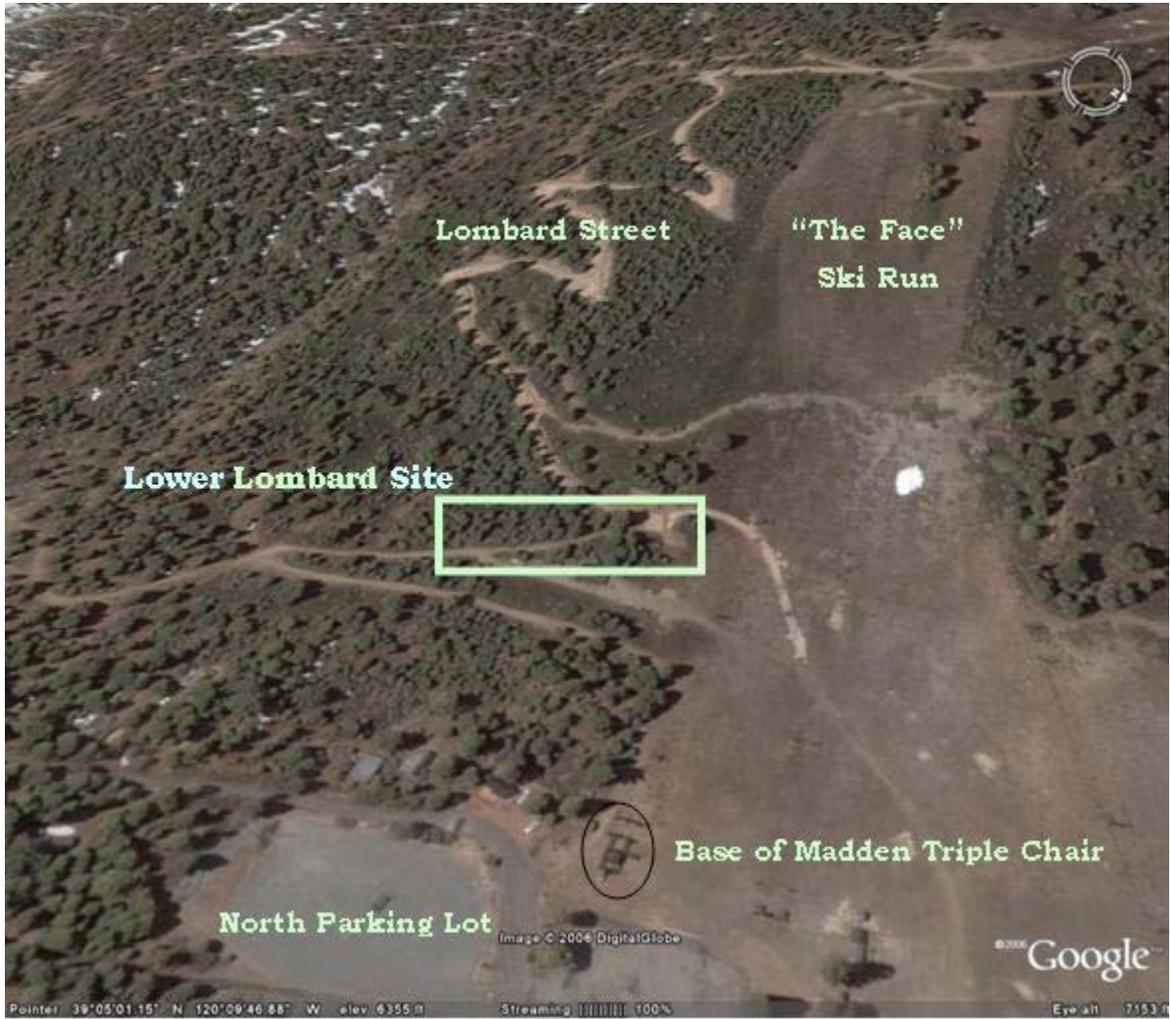
Figure 8. Lower Lombard site location.

Lower Lombard, at an elevation of 6,370 feet AMSL, is an old access road that connects the ski trail Lombard Street with maintenance building AA (Figure 8). Pre-treatment, Lower Lombard had large rills running the entire length of the slope, which were a result of water erosion (Figure 9).

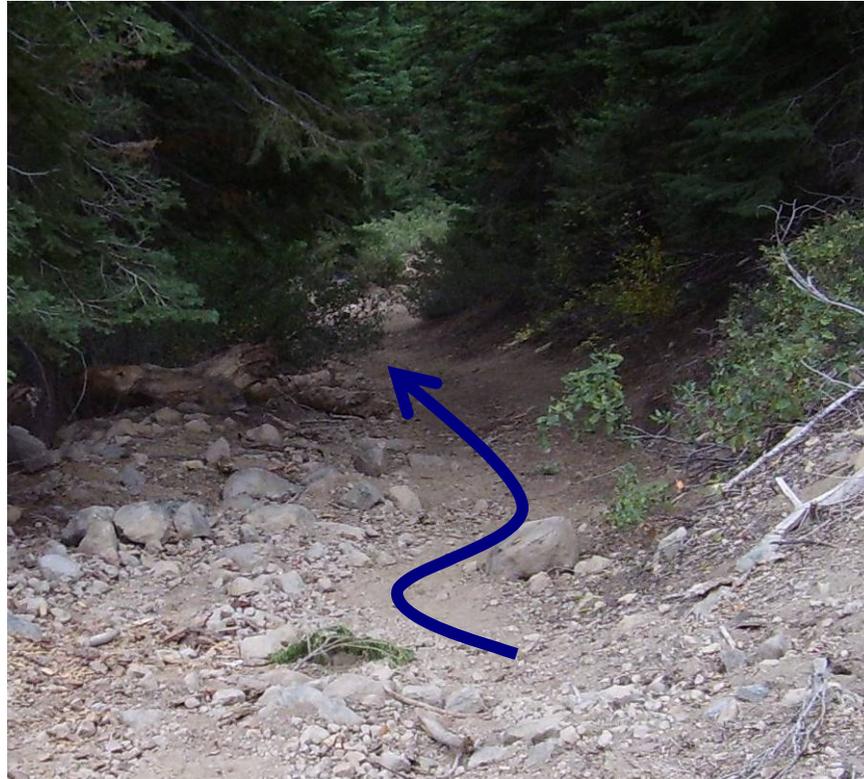
Figure 9. Water channeling path that caused erosion at the Lower Lombard site. Blue line represents the water pathway.

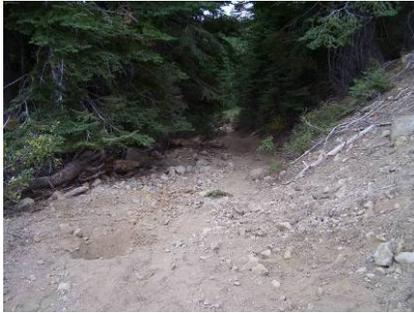
Figure 11. Lower Lombard pre-treatment. Vegetation is not present and the soil is highly compacted.

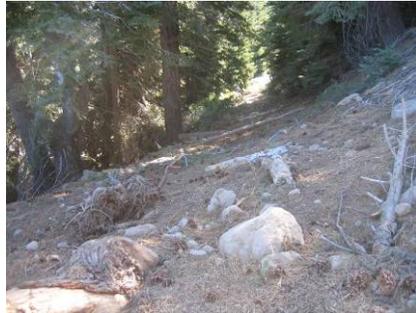
Figure 12. Lower Lombard post-treatment. Slope was re-contoured to match natural slope angle and woody debris and large rocks were added.

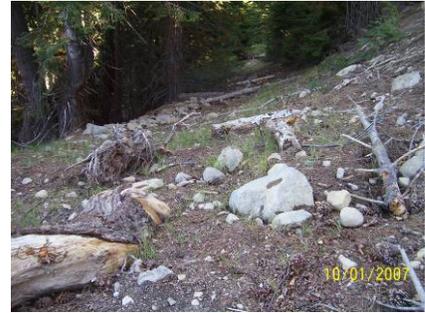
Figure 13. Lower Lombard one season after treatment. Native grass growth is visible

The entire area was re-contoured to match natural slope angles. Two inches of tub grindings were spread over both plots and material similar to compost (a blend of organic materials prepared at the Truckee Teichert yard) was then spread one inch thick over Plot A. The tub grindings and/or the compost material was tilled 12" into the soil using the bucket of a mini excavator. Biosol was then applied to the surface of the treatment area at a rate of 2,000 lbs/acre and was hand raked to 1-2 inches below the soil surface. The IERS Upland seed mix was applied at a rate of 125 lbs/acre (Table 1) and was lightly raked approximately ¼ inch into the soil with a spring rake. Pine needle mulch was hand applied to both plots to an average depth of 2 inches and ground coverage of 98%. Figure 11, Figure 12, and Figure 13 show the site pre-treatment, directly after treatment, and one season after treatment.

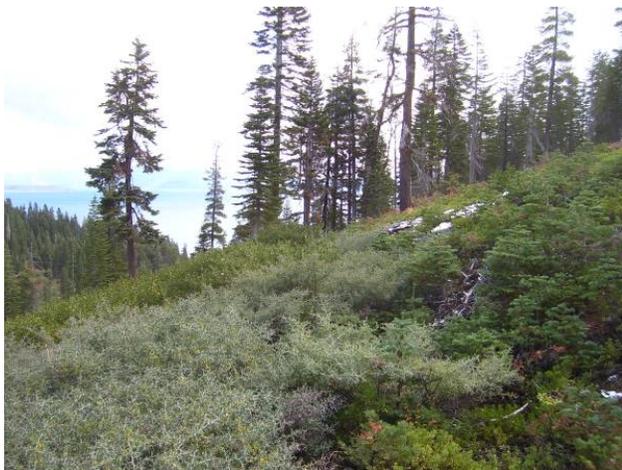
Figure 15. Site 37 pre-treatment

A different approach was taken at Site 37 than at many other Homewood restoration sites. Mature vegetation was already present, but site 37 lacked the capacity for infiltration since penetrometer depths were extremely shallow pre-treatment, indicating high soil compaction. Preservation of the mature shrubs was important during the restoration process. First, the mature shrubs along the road were mowed to a height of approximately 3 inches and the chips were left on-site. A total of 24 plots with four different treatments were applied to site 37 (Figure 14). Each treatment included targeted soil loosening and the addition of Biosol organic fertilizer. Seed was added to select plots (Table 3 and

Figure 15, Figure 16, Figure 17, and Figure 18 show each stage during the site 37 treatment

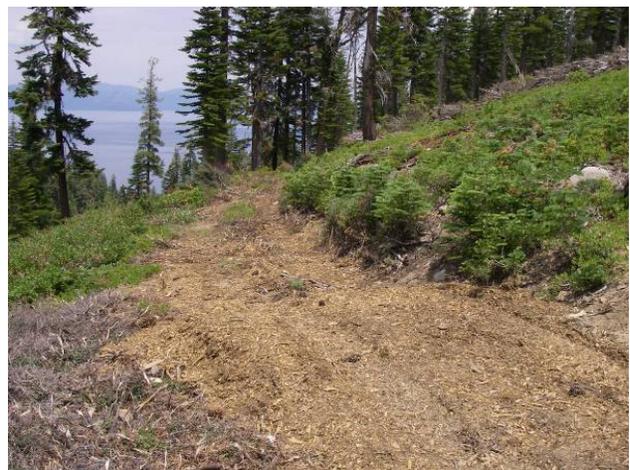
Figure 16. Site 37 after mowing and amendment application

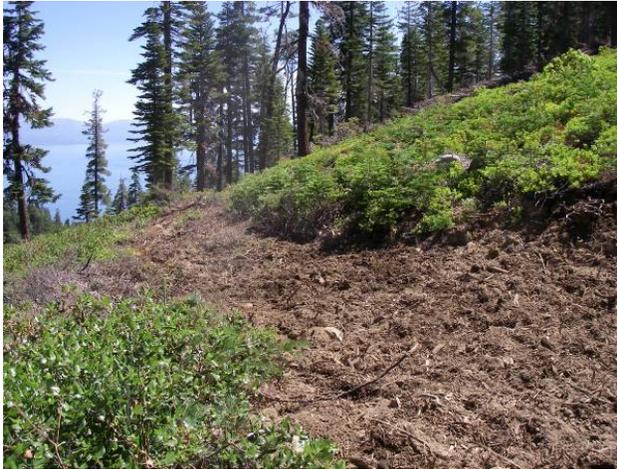
Figure 17. Site 37, after targeted loosening

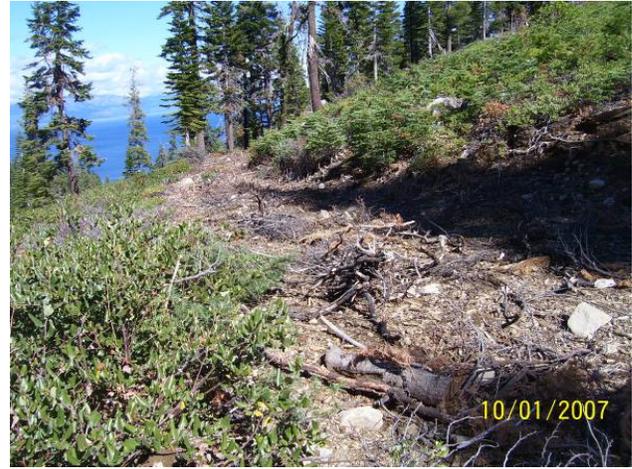
Figure 18. Site 37, one season after treatment

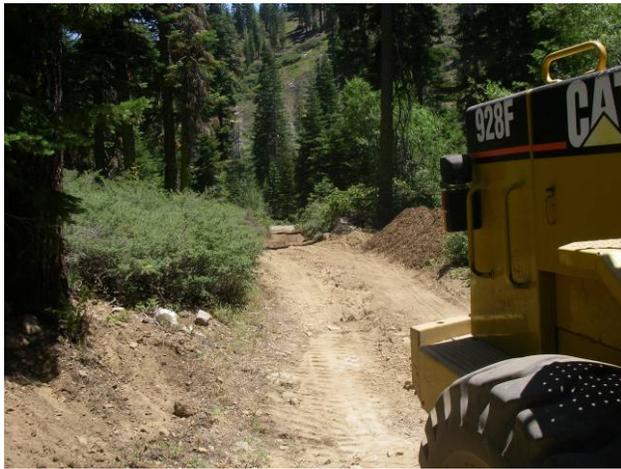
Figure 20. Creek Road pre-treatment

The Creek Road treatment was consistent over the entire length of the road. Figure 19 shows the layout of the treatment area. All treatments were completed in 2007. Treatment included, tilling 4 inches of tub grindings to 18 inches, 2,000 lbs/acre of Biosol, 125 lbs/acre of native seed, and 1 inch of tub grinding mulch (Table 5).

Figure 20 and Figure 21 show each stage during the Creek Road treatment

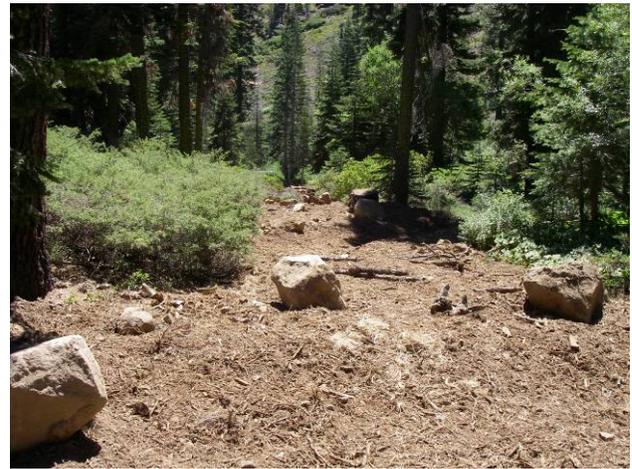
Figure 21. Creek Road post-treatment

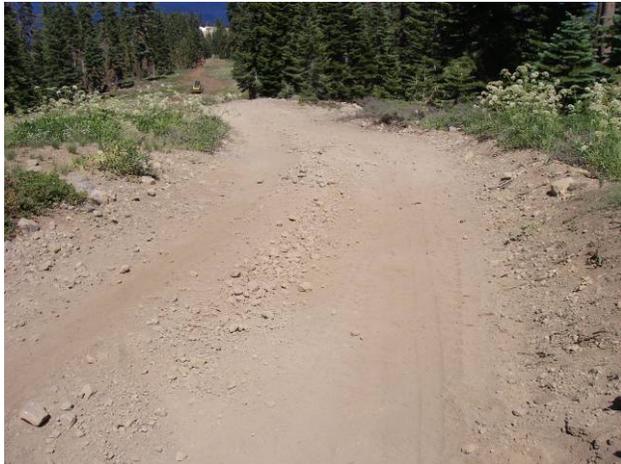
Figure 23. Rainbow ridge pre-treatment

Figure 22 shows the layout of the treatment area. The entire treatment was completed in 2007. Treatments included tilling 4 inches of tub grindings to 18 inches, 2,000 lbs/acre of Biosol, 125 lbs/acre of native seed, and 2 inches of pine needle mulch (Table 7).

Figure 23 and Figure 24 show Rainbow Road before and after treatment

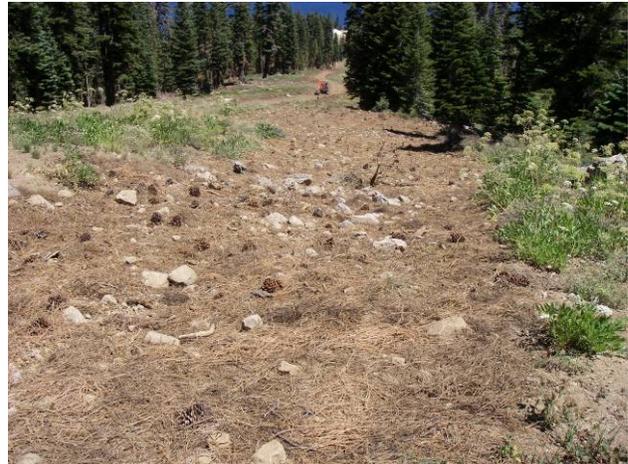
Figure 24. Rainbow ridge post-treatment

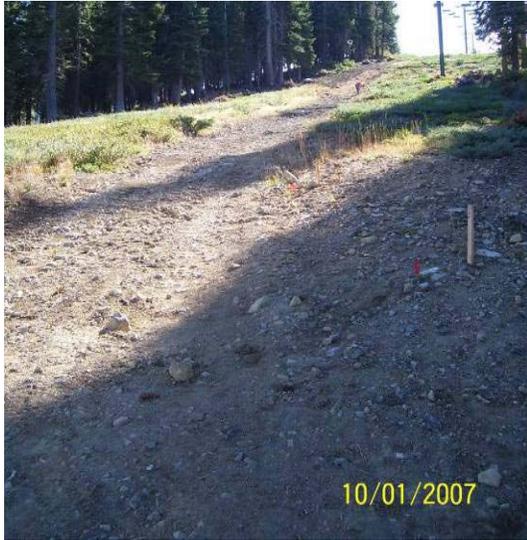
Figure 27. Wedding Road pre-treatment

Wedding Road received the standard IERS treatment including 4 inches of pine needles tilled to 18 inches, 2,000 lbs/acre of Biosol, 125 lbs/acre of native seed, and 2 inches of pine needle mulch (Table 9). A portion of the treatment area was divided into 12 sections. Each section received one of 4 different seed mixes (Table 8) or an individual species. The plot layout is shown in Figure 26. The individual species are represented in the map by their scientific name abbreviations, which can also be found next to the scientific name of the plant in Table 8. The composition of each seed mix was determined based on the performance of each species in prior research.¹

Figure 27 and Figure 28 show Wedding Road pre- and post-treatment.

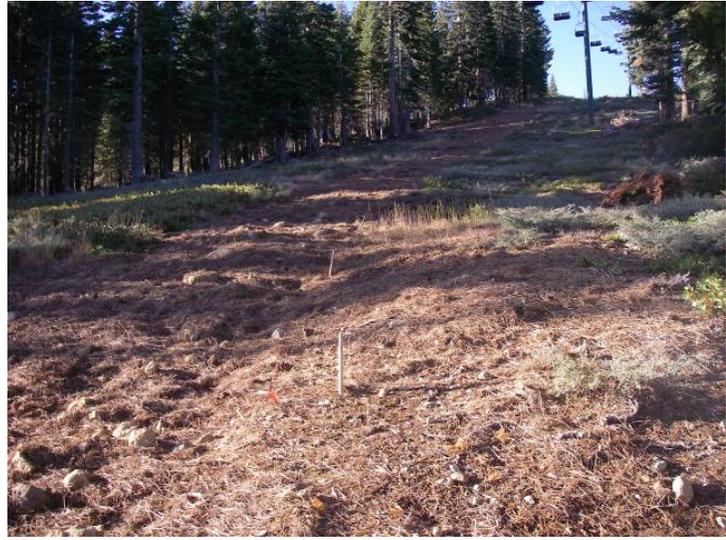
Figure 28. Wedding Road post-treatment

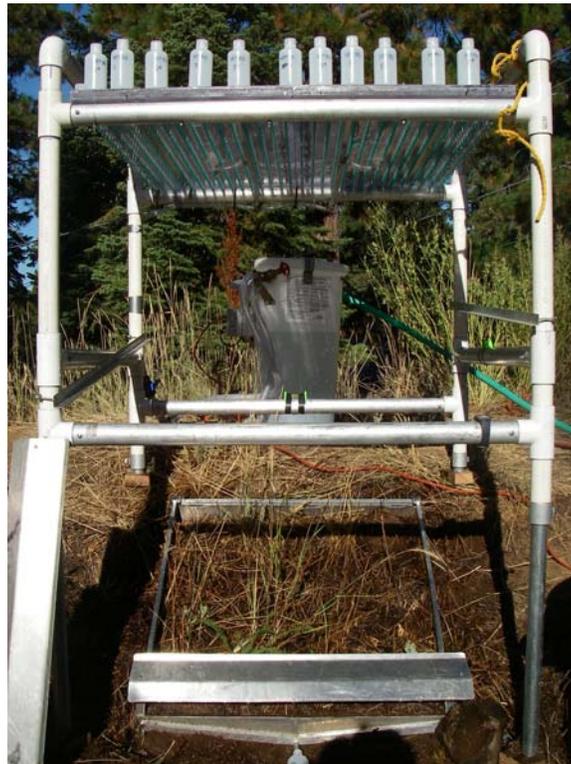
Figure 29. Rainfall simulator and frame.

a height of 3.3 feet (1 meter) (Figure 29). The rate of rainfall is controlled and recorded and the runoff is collected from a trough at the bottom of a frame that captures the runoff. The rate of infiltration is calculated by subtracting the rate of runoff from the rate of water applied to the plot during the rainfall simulation trial. The steady state infiltration rate, which will be called infiltration rate hereafter, and the average steady state sediment yield, which will be called sediment yield hereafter, will be presented to enable comparison between sites. The overall infiltration capacity for a site is calculated by taking the average of the separate rainfall simulation runs each at a different location within the site. Two to three rainfall simulations were conducted at each site if ground conditions permitted.

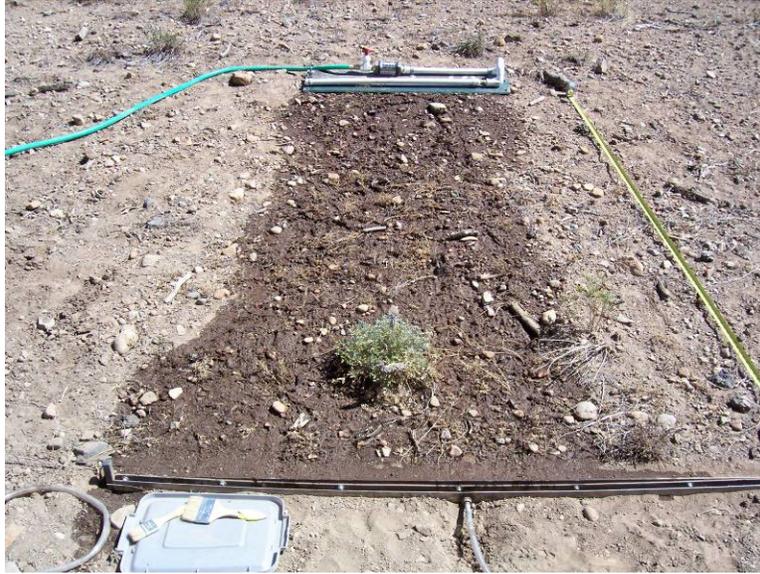
Figure 30. The runoff simulator and test area post-simulation. The PVC pipe is visible at the top of the photo and the collection frame is at the bottom.

Runoff simulation was conducted pre-treatment at the Wedding Road in 2007. The runoff simulator is a 3.3 feet (1 meter) wide PVC pipe with 50 evenly spaced holes that are one sixteenth inches in diameter (Figure 30).

When water is pumped through the pipe and exits the holes, an even flow of water across the entire width of the pipe is produced, thereby simulating snowmelt runoff through sheet flow. Snowmelt can produce a significant amount of runoff and sediment at ski areas, which can lead to severe erosion problems. The rate of water applied ranges from 2 to 19 L/min and is recorded, as with the rainfall simulation. A collection trough is installed 2 meters down slope from the runoff pipe and all runoff is collected as with the rainfall simulator. The same measurements and samples are collected for the runoff simulator as for the rainfall simulator.

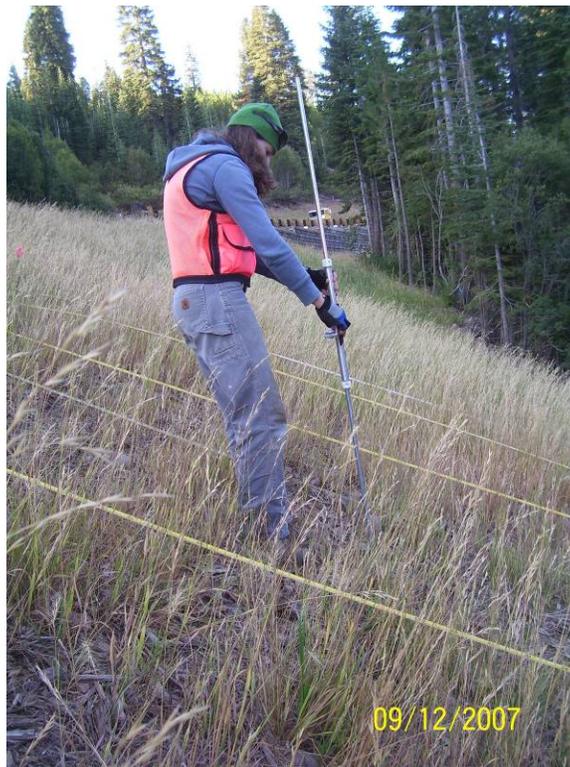
Figure 31. The cover point method. A laser pointer mounted on a metal rod determines the cover hit.

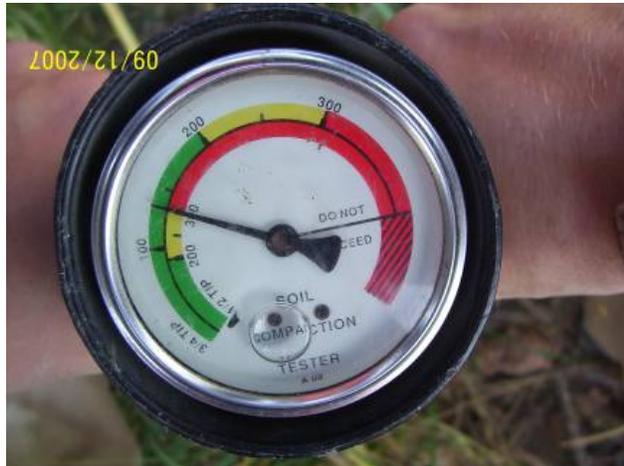
Figure 32. Cone penetrometer dial, showing pressure applied in pounds per square inch.

Soil compaction and soil moisture were measured along the same transects as the point cover data for most of the plots (Figure 32, Figure 33, and Figure 34). At Site 37, penetrometer readings were only taken at areas which were tilled using targeted loosening. Sampling on transects would not allow these areas to be sampled separate from un-loosened areas.

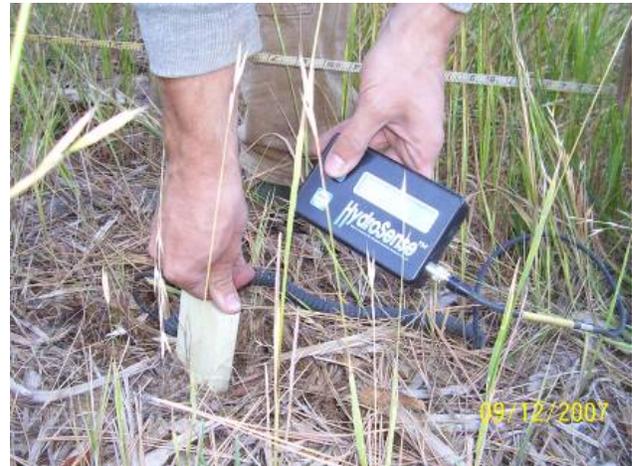
Figure 33. Conducting soil moisture readings along transects.

A hydrometer (Figure 33) was used to measure volumetric soil moisture content adjacent to the penetrometer readings at a depth of 4.7 inches (12 centimeters).

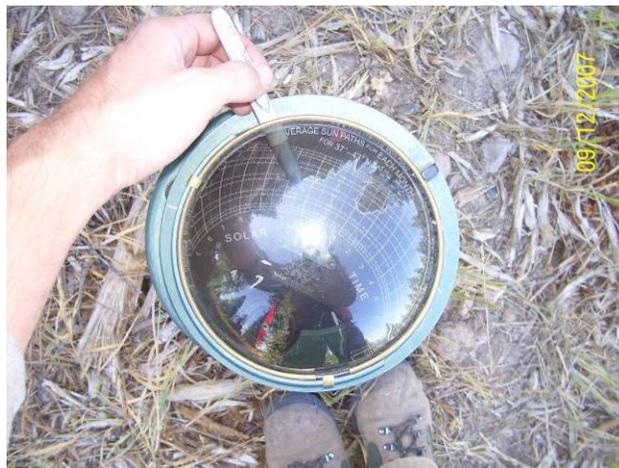
Figure 35. Solar pathfinder in use.

Solar input was determined using a Solar Pathfinder (Figure 35). Since solar input affects evaporation rates and soil temperature, which may affect time of seed germination, germination rate, rate and type of plant growth and soil microbial activity, it is an important variable to consider when monitoring plant growth and soil development.

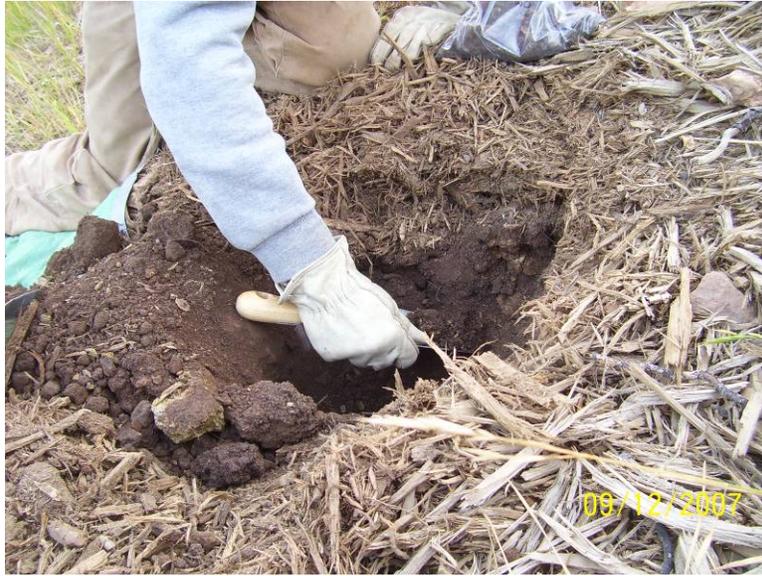
Figure 36. Soil sub-sample collection.

At each area sampled, three soil sub-samples were taken from beneath the mulch layer to a depth of 12 inches (30 cm). At Site 31 and Lower Lombard, one sample with three sub samples were collected at each plot. Small amounts of soil were collected from each part of the hole to comprise each sub-sample (Figure 36). Sub-samples collected within a plot location were combined and then sieved to remove any material larger than .08 inches (2 mm) in diameter, and sent to A&L Laboratories for S3C analysis, suite of micronutrients and organic matter, and Total Kjeldahl Nitrogen (TKN).
