***PRELIMINARY CHARACTERIZATION  
of  
ABANDONED MINE FEATURES  
at  
TIMBERLINE @ AUBURN  
Richardson Drive and Bell Road  
Auburn, California***

***Project No. 3573-01  
July 22, 2008***

**Subject:** *Preliminary Characterization of Abandoned Mine Features*

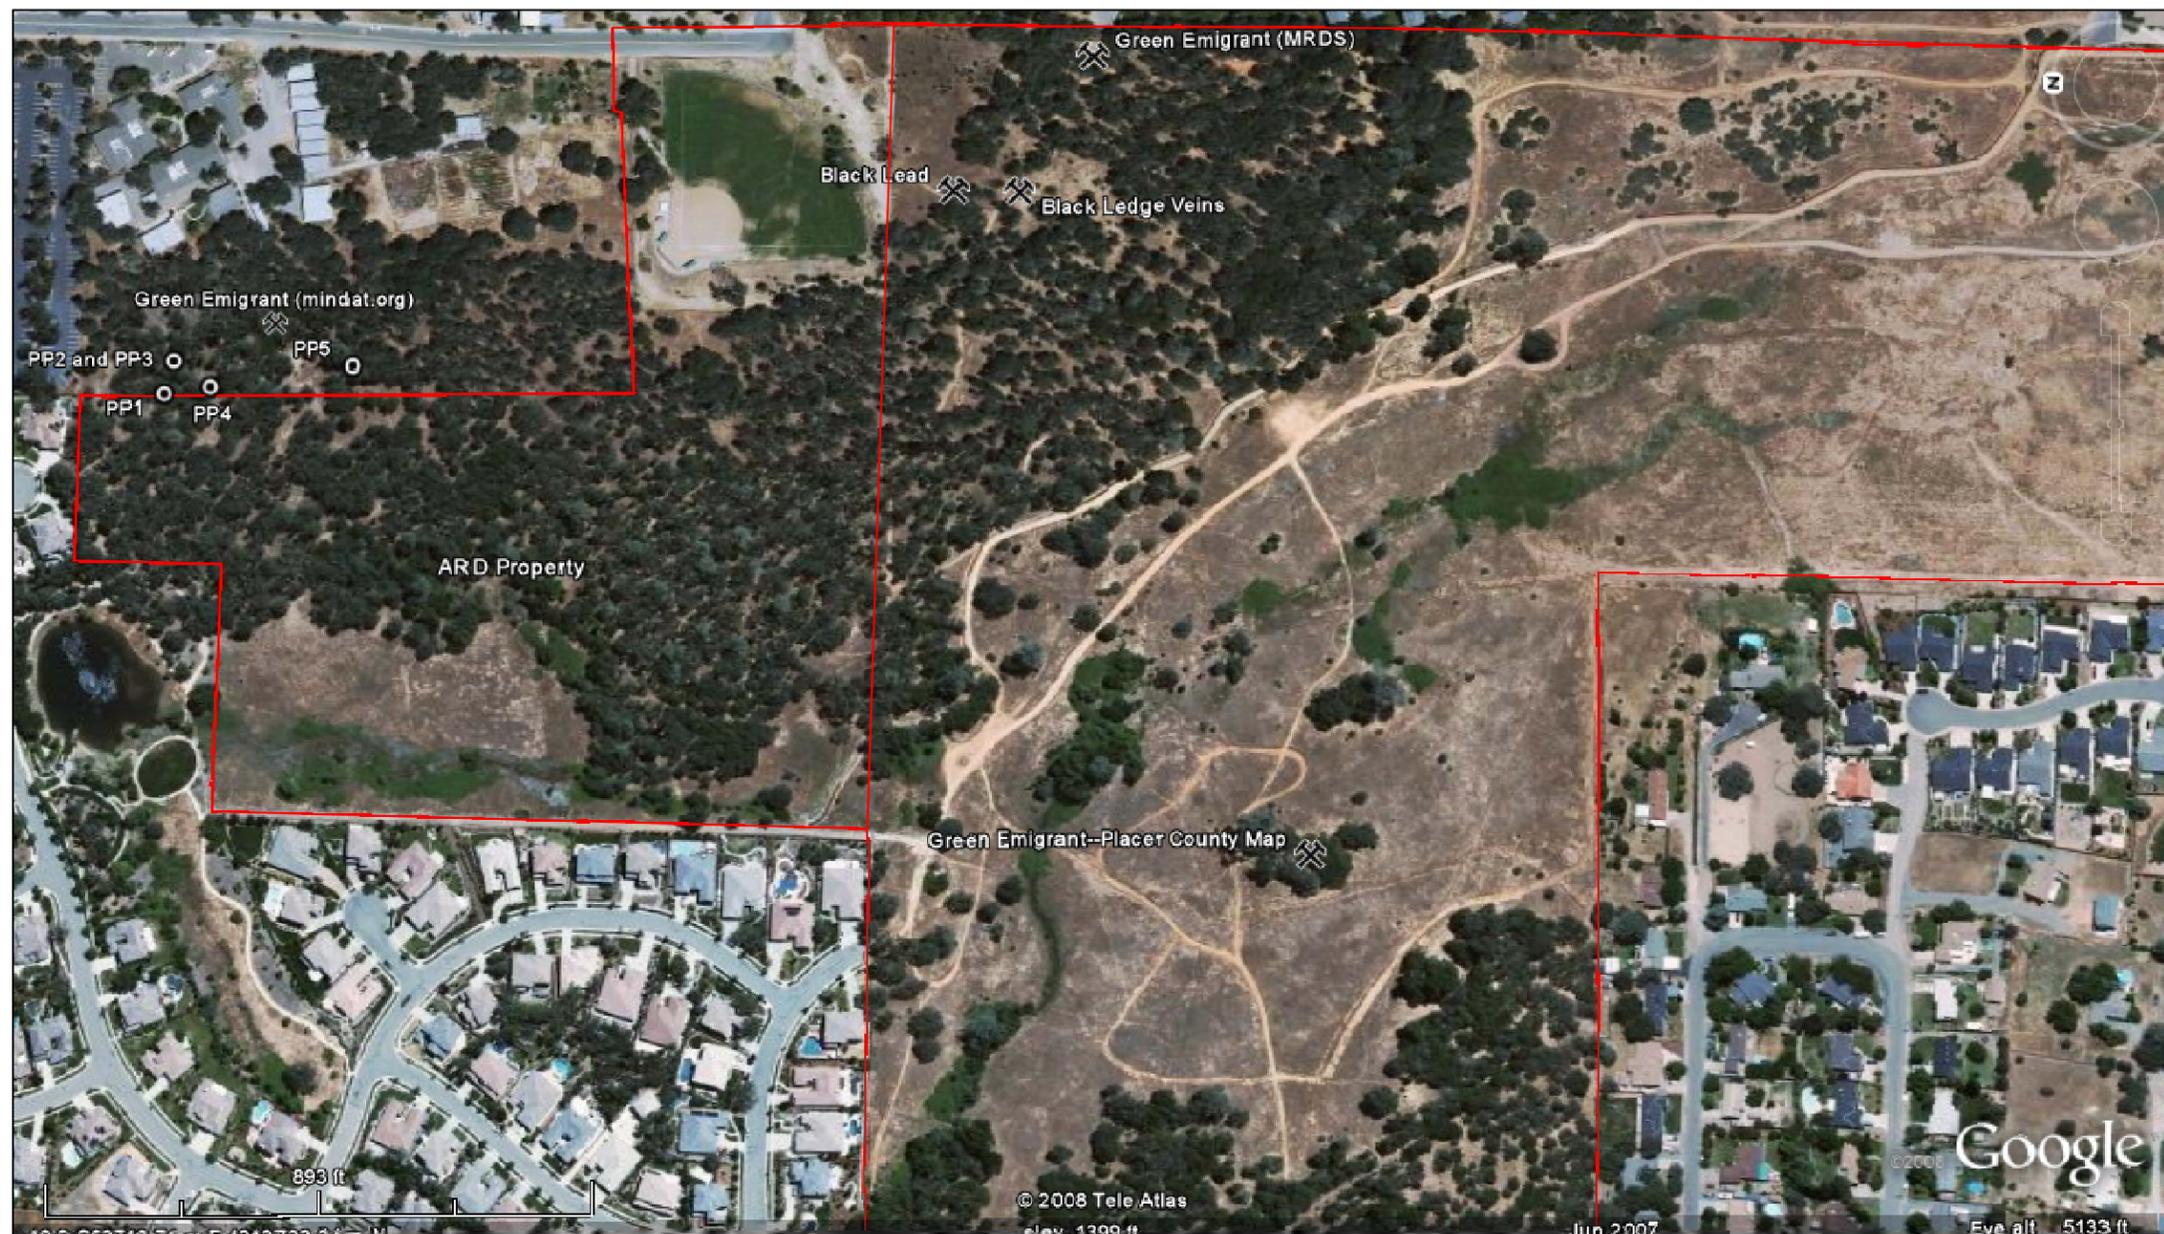
SITE MAP  
 TIMBERLINE @ AUBURN  
 AUBURN, CALIFORNIA

H&K reviewed portions of the following documents pertaining to historic mining activities in the immediate vicinity of the subject property. Figure 2 depicts the approximate locations of the recorded mine locations, which are discussed below.

Near the northeastern boundary of the 24 acre ARD parcel, H&K identified an approximate 10 cubic yard stockpile of excavation spoils adjacent to an apparent former mining excavation. This location is depicted as PP1 on Figure 2 and shown in Photo 1. The PP1 location appeared to correspond with the "Prospect Pit" described in the PMC report.

H&K identified two additional excavations approximately 50 feet east of PP1, depicted as PP2 and PP3 on Figure 2. Location PP2 was characterized by an approximately 5 to 10 cubic yard stockpile of excavation spoils and a shallow excavation measuring approximately 10 feet in diameter (Photo 2). Location PP3 was characterized by an

Approximately 80 feet south-southwest of PP3, H&K observed a shallow excavation; however, no excavation spoils were observed adjacent to the excavation. Figure 2 depicts this location as PP4.

H&K identified another excavation approximately 250 feet south of location PP4, depicted as PP5 on Figure 2 (Photo 4). Location PP5 was characterized by a minor cut/depression and an elongate stockpile (approximately 5 cubic yards) of excavation spoils.

The observed mining excavations and stockpiles of excavation spoils were marked in the field using a GPS unit. Because the identified features were not located by survey and the property boundary was not marked at the time of H&K's reconnaissance, the locations depicted on Figure 2 should be considered approximate.

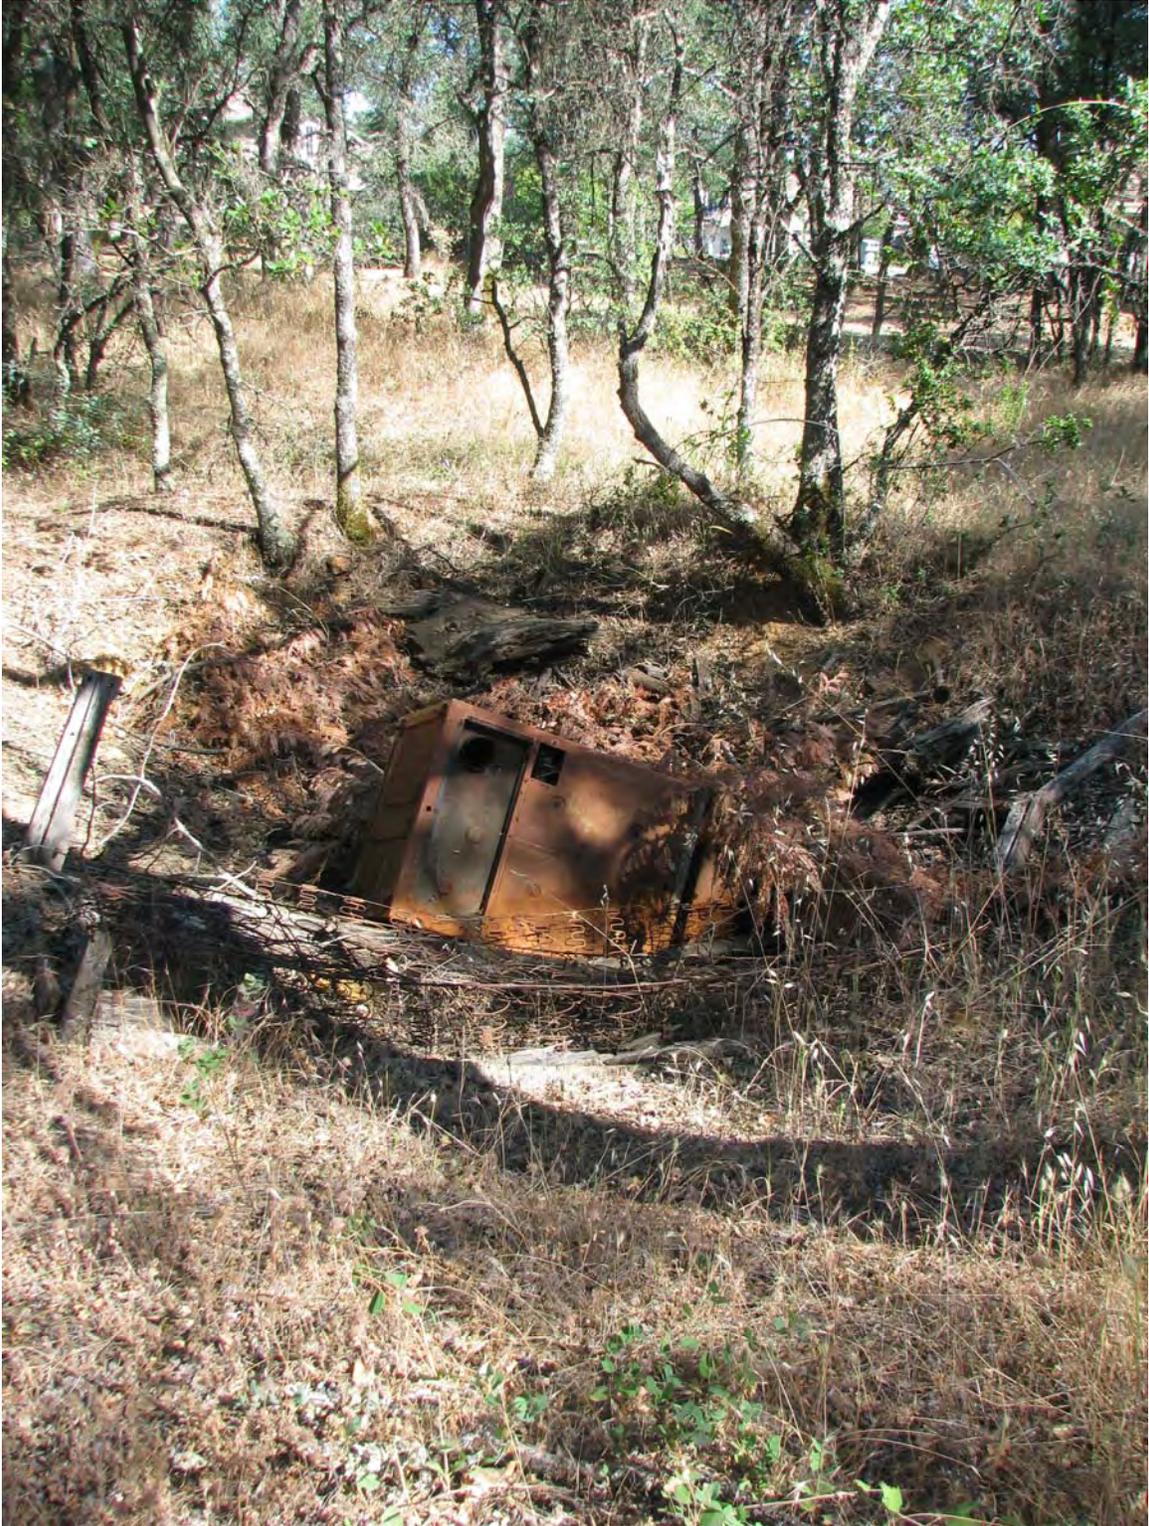
Photo 1. PP1 location, or "Prospect Pit."

H&K observed small stockpiles of excavated soil and rock at areas PP1, PP2, PP3 and PP5. The excavations may be associated with past mining or prospecting activities. Although the locations of the identified features were not determined by survey, they generally appear to be located near and east of the ARD-owned property boundary.

Other than the stockpiles and excavations described above, evidence of past mining activity was not observed during the surface reconnaissance. H&K understands that no development is planned in the vicinity of the identified mine features; therefore, H&K does not recommend further action at this time regarding characterization or mitigation of the identified mine features with respect to the proposed development.

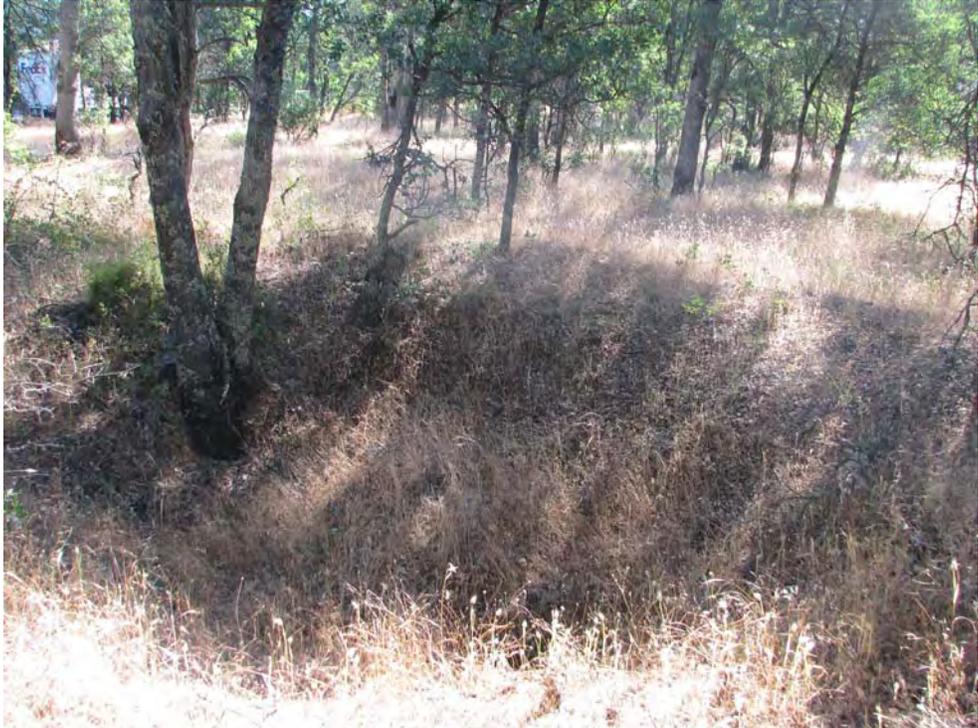
Photo 2. PP2 location.

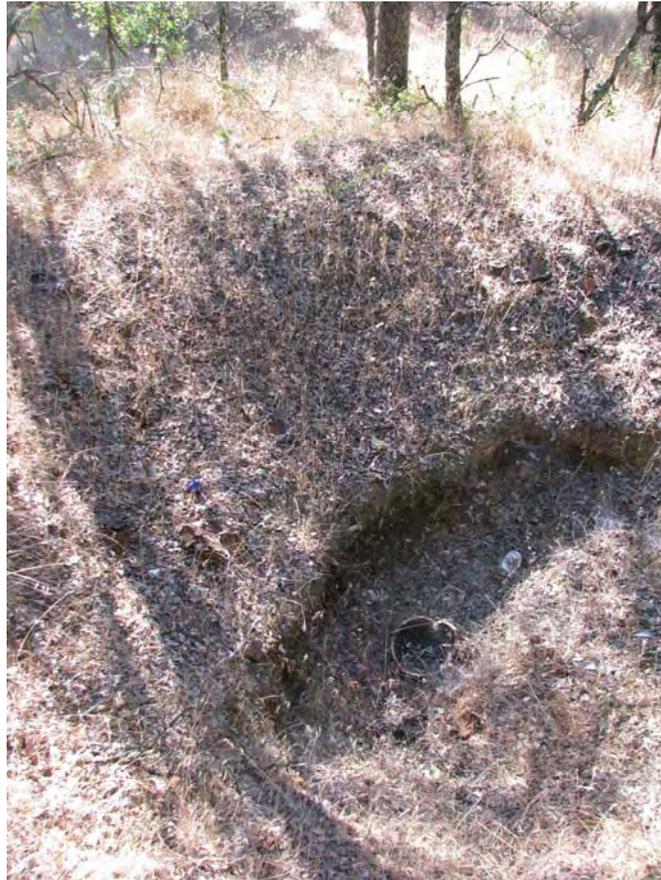
approximately 5 to 10 cubic yard stockpile of excavation spoils and a possible collapsed mine shaft measuring approximately 12 feet in diameter (Photo 3).

Photo 3. PP3 location.

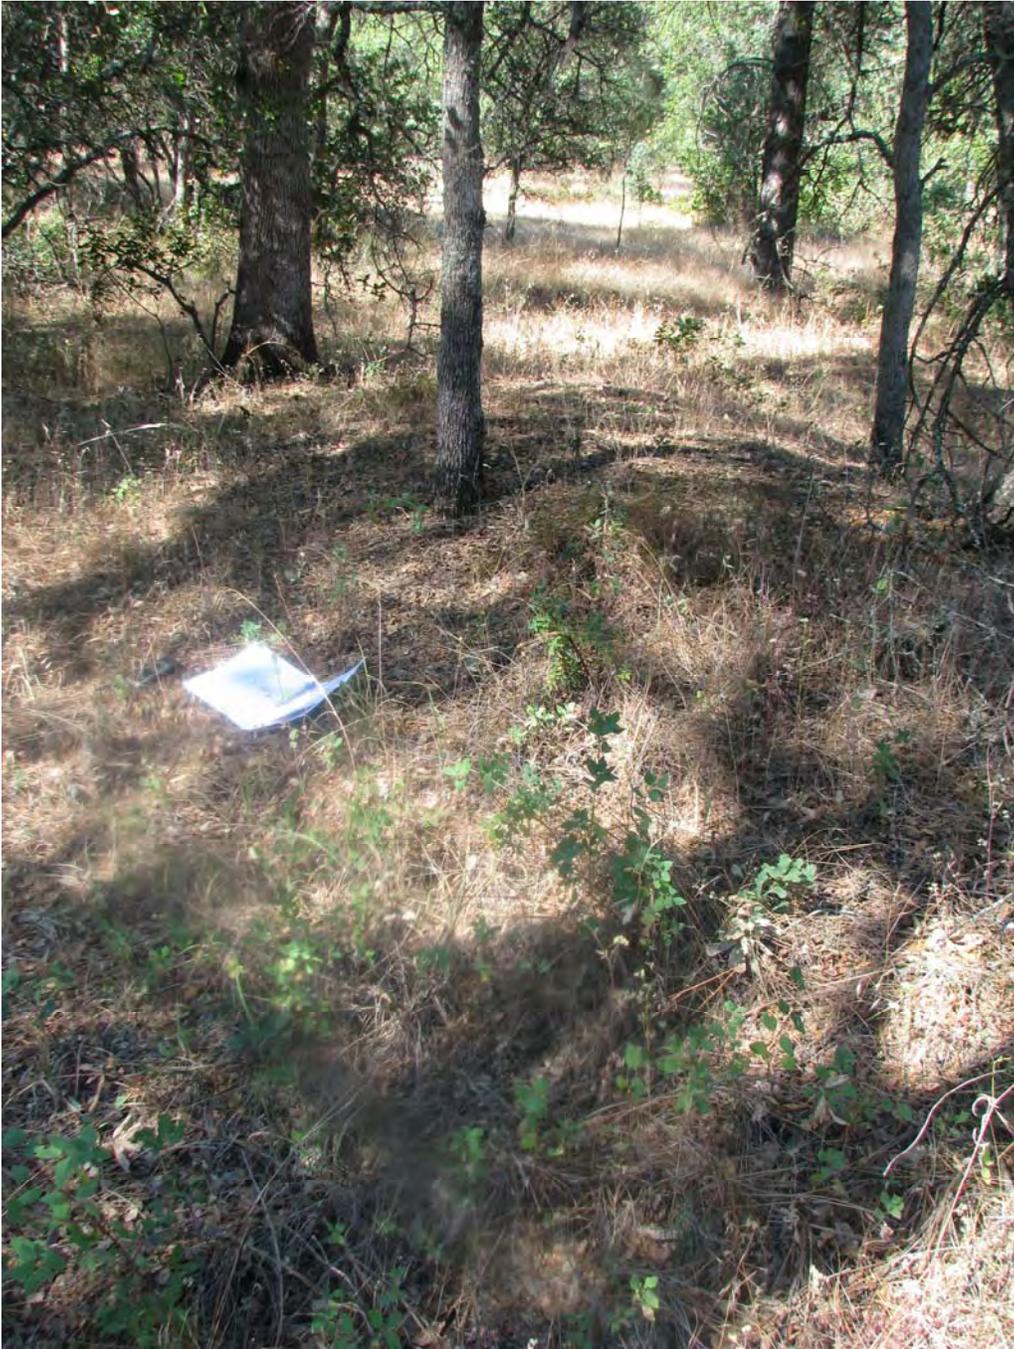
Photo 4. PP5 Location.
