Tahoe City, Placer County, California

Pedestrian & Bicycle Road Safety Audit

Conducted April 27-29, 2015

FINAL REPORT October 2015

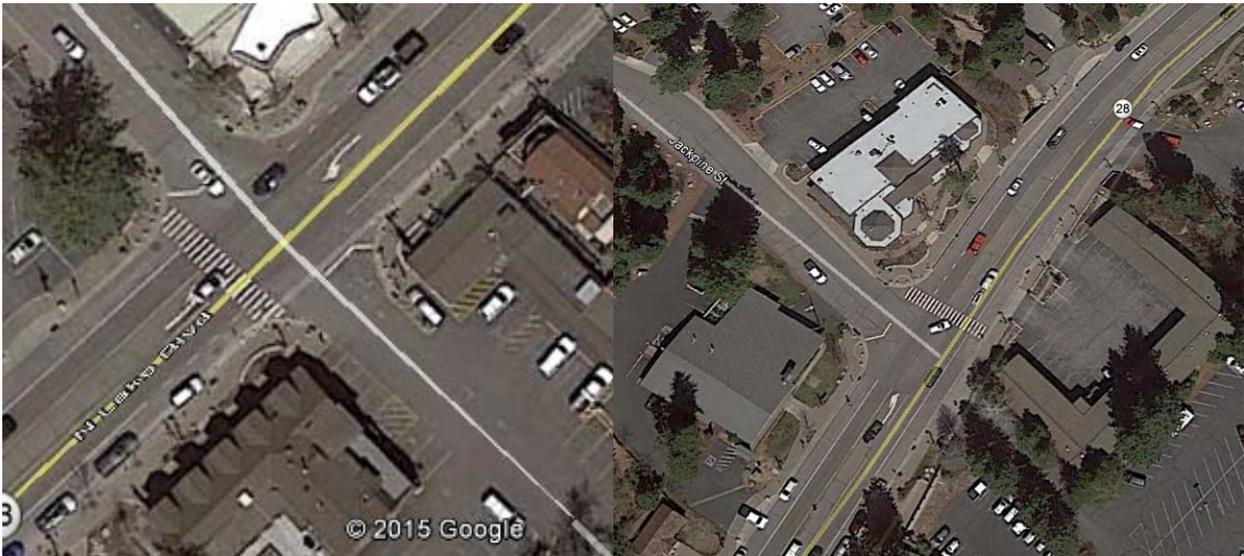
Figure 2: Study area intersections (Aerial Image Source: Google Earth)

Grove Street Intersection

Jackpine Street "T" Intersection

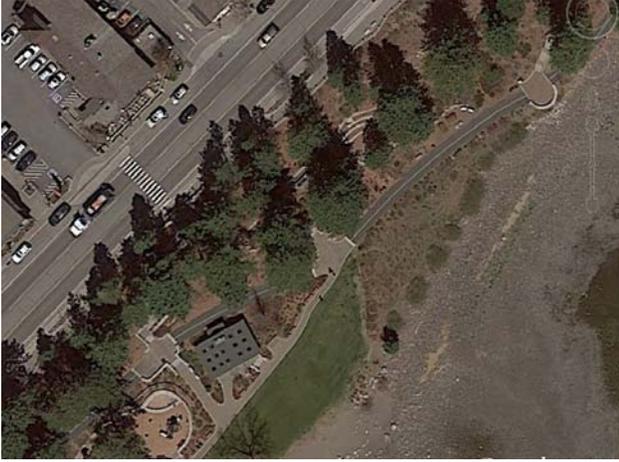
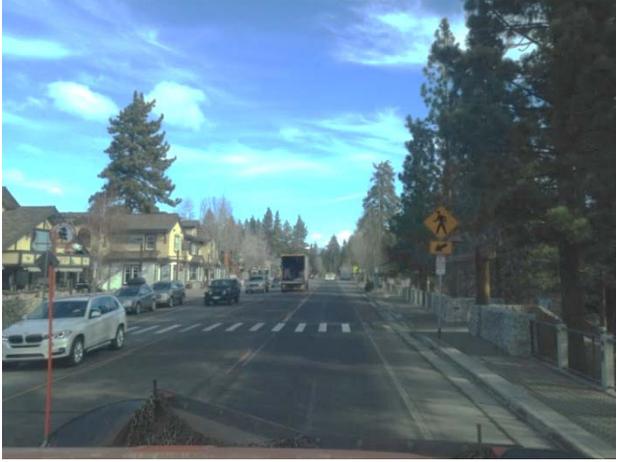
Figure 3: Midblock Pedestrian Crossings (Aerial Image Source: Google Earth; Photo Source: Isebrands)

Cobblestone Pedestrian Crossing

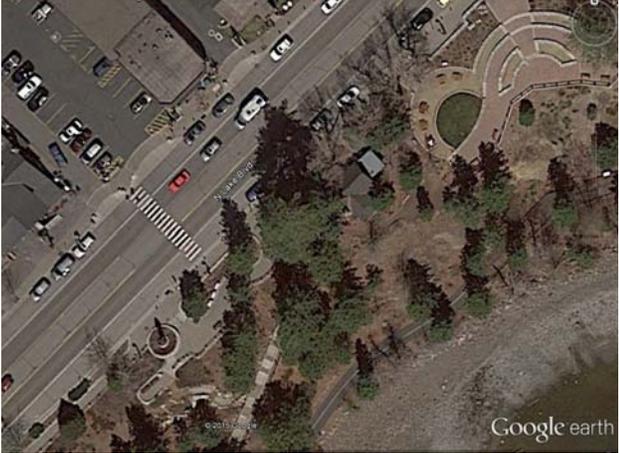
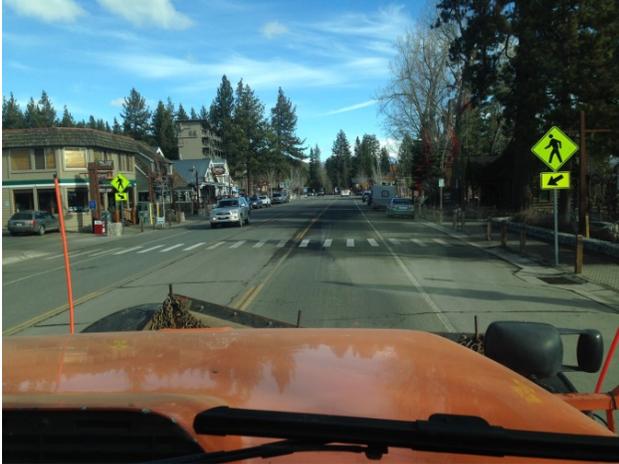
Big Tree Pedestrian Crossing

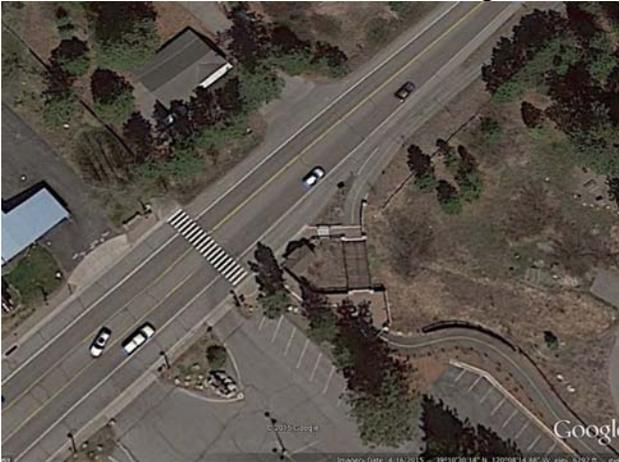
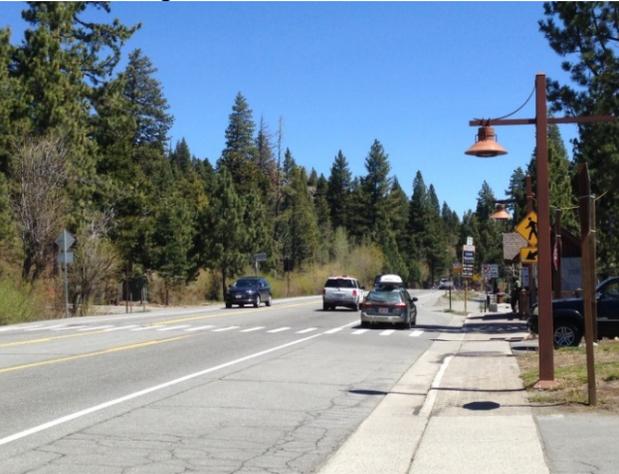
Lighthouse Pedestrian Crossing

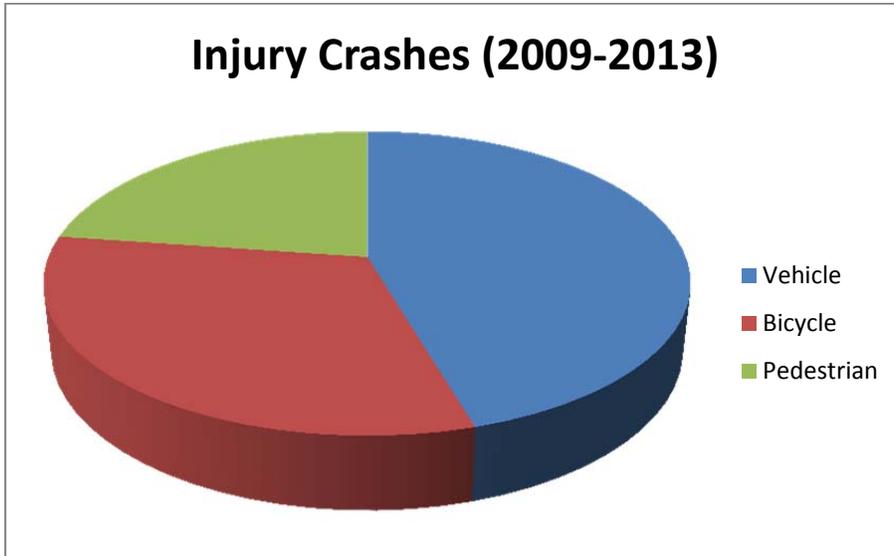
Figure 5: Crash Data for Tahoe City from 2009 – 2013

Over a five year period along the study area, from 2009-2013, there were 75 total crashes³, of which 29% were injury crashes. The crashes were concentrated near the Highway 89, Commons Beach Road and Grove Street intersections. Over the same period, five pedestrian crashes and seven bicyclist crashes were reported, all resulting in an injury. (Only one bike crash was outside of the study area.) Fifty-percent of the injury crashes in Tahoe City from 2009-2013 were pedestrian or bicycle crashes within the study area, shown in Figure 5. Over the 5 year period, an average of 1.0

pedestrian injury crash occurred per year and 1.4 bicyclist injury crash per year occurred within this corridor. Although the numbers are not large, it illustrates that if there is an injury crash, there is a 50/50 chance it will be pedestrians and bicyclist.

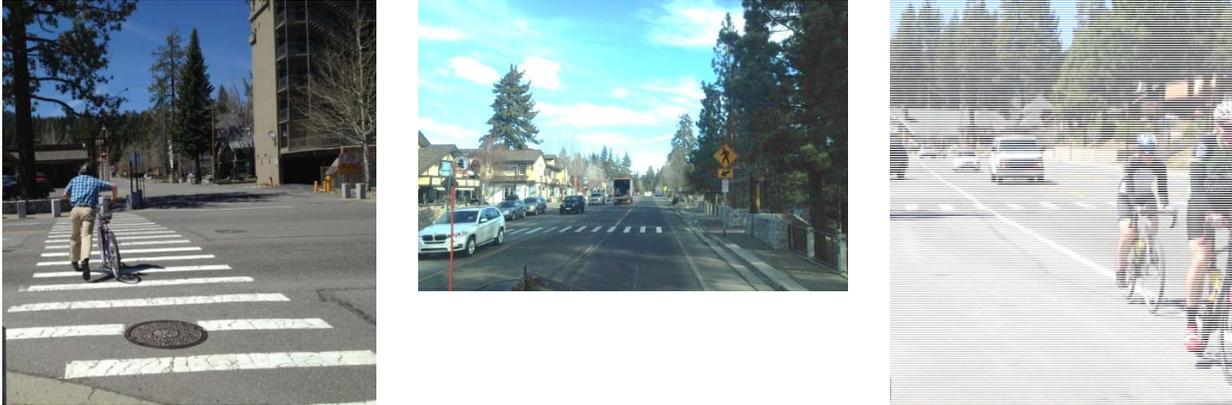
Figure 6: Photos of Existing Safety Features in Tahoe City (Photo Source: Isebrands)

- **High visibility crosswalk pavement markings:** Most of the marked pedestrian crossings on Highway 28 (between Commons Beach Road and the Lighthouse Shopping Center) had high visibility style crosswalk pavement markings.

- **Crosswalk spacing and locations:** The marked pedestrian crossings along Highway 28 are appropriately spaced (between 350 ft and 660 ft) based on destinations on both sides of the highway.

- **Sidewalk lighting:** Pedestrian level lighting along the sidewalks provided good visibility along the sidewalk.
- **Crosswalk signing:** All marked crossings included supplemental pedestrian crossing signs and temporary in-street crossing signs during late spring, summer and early fall.

- **Multimodal atmosphere:** Most sidewalk widths were desirable based on the number of pedestrians and Class I shared use paths provide options users. Many cyclists were riding with traffic on Highway 28 and complete Street design amenities such as parking, is present.

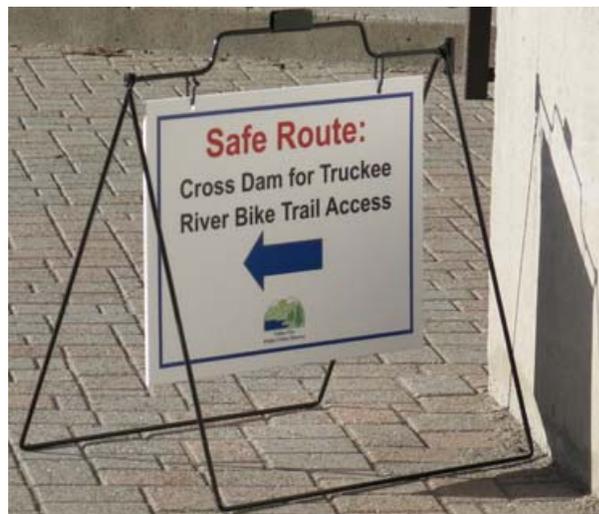
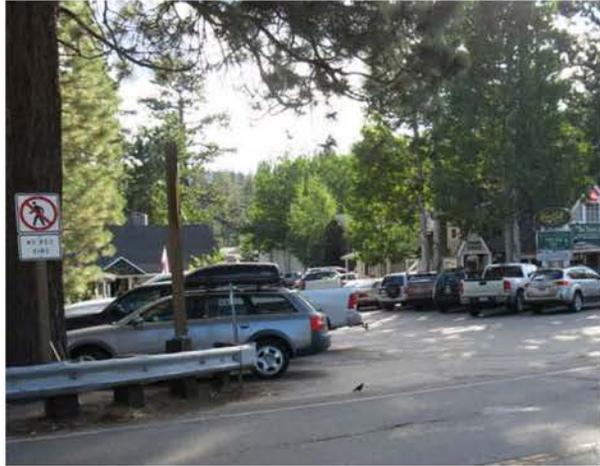
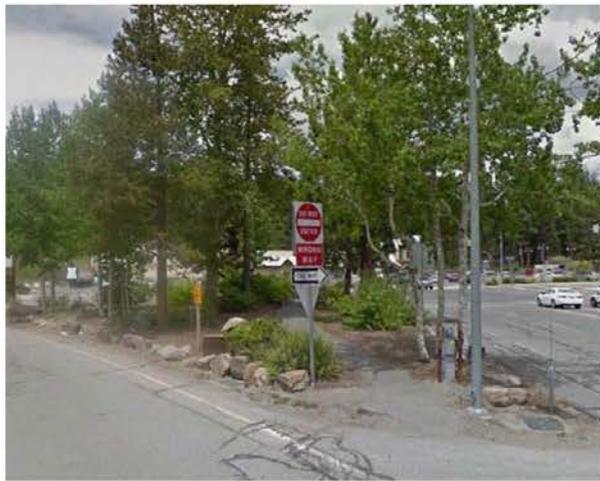
Figure 7: Examples of Pedestrian Restrictions, Access and Lack of Infrastructure (Photo Source: Isebrands)

The sidewalks/multi-use trails have several gaps in connectivity within the study area, particularly on the western terminus of the study area. Currently there is not easily identifiable pedestrian access or infrastructure to cross the “wye” intersection. Additionally, there are several pedestrian crossing restrictions (i.e. “No Pedestrian Crossing” signs) near the “wye” intersection and the Fanny Bridge area. These

restrictions are not consistent with the pedestrian and bicycle desire lines, beautiful views, common area and businesses. Examples of these issues are shown in the photos in Figure 7. The following descriptions and corresponding areas in Figure 8 show gaps in sidewalk, multi-use path connectivity and/or crossing restrictions.

1. Between Fairway Drive and the Highway 89/28 “wye” intersection (south side),
2. Within the Highway 28/89 “wye” intersection,
3. North end of Fanny Bridge,
4. Between Highway 28/89 “wye” intersection and Mackinaw Road bus stop,
5. Between the TART Transit Center, along Highway 28, to Fanny Bridge, and
6. Between Commons Beach area and Fanny Bridge.

- *Provide sidewalk infrastructure where it does not exist.*
- *Provide accessible crossings at logical origins and destinations (i.e. where people already naturally walk).*
- *Eliminate pedestrian crossing restrictions.*
- *Provide defined access (driveways) from Highways 28 and 89 to businesses (Area 1 and Area 4 in Figure 8).*
- *Re-purpose the Highway 89/28 within CalTrans right of way from Fairway Drive to Mackinaw Road to include sidewalk, bike lanes, parking, bulb outs, defined access.*

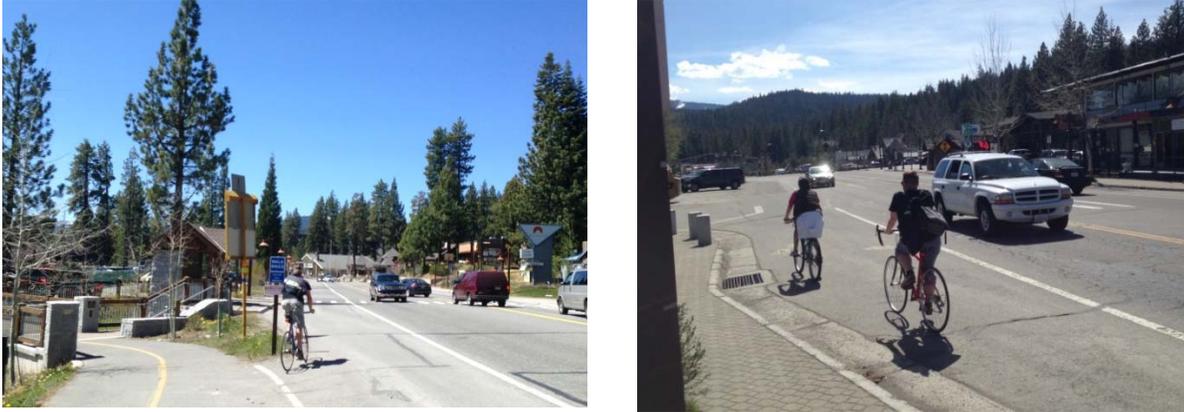
Figure 9: Wrong-way Bicyclist on Highway 28 (Photo Source: Isebrands)

The PBRSA Team observed inconsistency in bike lane markings within the study area as well as inconsistencies between the bike signing and pavement markings. Additionally, bicyclists were observed riding against traffic in several locations - near Mackinaw Road and at the Class I multi-use

trail near the Lighthouse development - where the pathway connections and/or change in type of bicycle facility was not clear. Bicyclists riding against traffic in the roadway put them at higher risk for a crash.

- *Close the gap between West Shore Bike Trail to the Lakeside Bike Trail*
- *Provide wayfinding for bicyclists where the bicycle facility type changes or ends (Near Fairway Drive and Lighthouse development)*
- *Widen sidewalk where it narrows between Commons Beach Road and Mackinaw Road, and use wayfinding signs to guide bicyclists to bike routes.*
- *Ensure consistent bike lane signing and pavement markings*
- *Re-stripe pavement markings for the travel lanes, bike lanes and parking spots in the Spring rather than the Fall*
- *Install “sharrow markings” where the roadway width does not allow for a full bike lane width*
- *Explore modifications to Mackinaw Road to provide the bicycle connection between Commons Beach and Fanny Bridge (i.e. bike boulevard, one way roadway)*

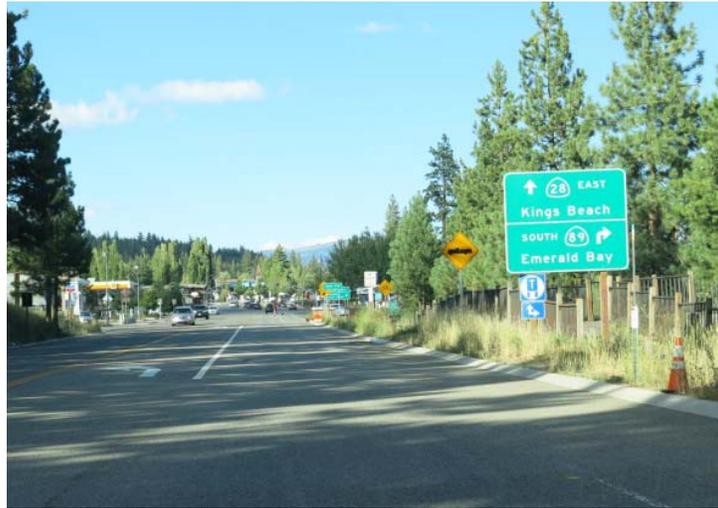
Figure 10: Entrance to Tahoe City, CA (Photo Source: Isebrands)

The PBRSA Team identified the Fairway Drive intersection as the existing Gateway into Tahoe City from Squaw Valley and Truckee; however the wider roadway width of Highway 28 appeared to encourage drivers to increase their speeds heading into the Tahoe City and the signalized intersection. The location is shown in Figure 10. Highway 28 widens from a 2 lane road to a wide three lane cross section, with approximately 55ft of pavement.

The existing Class I bike trail/multi-use path on the east side of the road ends abruptly at this intersection leaving the pathway user “stranded.”

- *Provide bump outs to shorten pedestrian crossing distance from multi use trail to Fairway Drive intersection.*
- *Consider bicycle wayfinding signs to direct Class I bike trail users over the existing bridge to the Tahoe Rim Trail. Potential bicycle road riders would be directed to Highway 89 via the pedestrian crossing.*
- *Provide sidewalk infrastructure on the south side of the roadway to connect pedestrians to the “wye” intersection.*
- *Provide defined access (driveways) to the properties on the south side of Highway 89.*

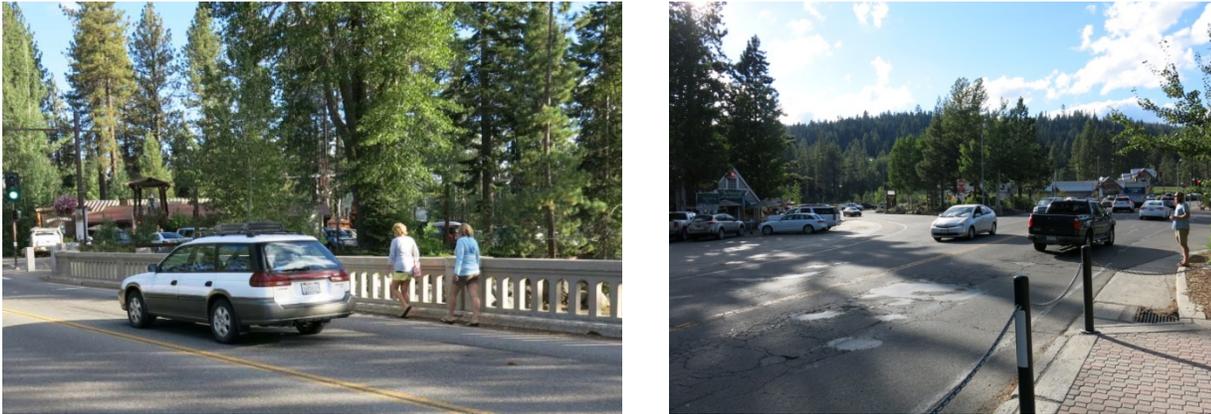
Figure 11: Photos of Pedestrian and Bicycle Activities at Fanny Bridge (Photo Source: Isebrands)

The “Wye” intersection of Highway 28/89 and Fanny Bridge provides significant access to attractions for both locals and visitors to Tahoe City and Lake Tahoe year round; yet, the pedestrian infrastructure and connectivity is significantly lacking as mentioned above. The pedestrian movement restrictions in this intersection are not consistent with a community that promotes and thrives on visitors. Desire lines exist between both sides of this intersection; however, countless observations were made of pedestrians running across the road to avoid speeding traffic in the free right turns and walking in the roadway across Fanny Bridge. The existing Pedestrian Signal on the

south end of Fanny Bridge provides for controlled, safe crossing but lacks efficiency. Figure 11 shows examples of pedestrian activity in this area. Improved safety and mobility can be achieved in this area with investments in sidewalks, traffic calming, high visibly crosswalks and efficient traffic and pedestrian traffic control.

- *Provide pedestrian infrastructure at the “wye” intersection for all movements.*
- *Provide a controlled pedestrian crossing - Pedestrian Hybrid Beacon (PHB)- on the north end of the Fanny Bridge that is coordinated with the south end treatment.*
- *Replace the Pedestrian Signal at the south end of Fanny Bridge with a PHB at Fanny Bridge and coordinate with a second PHB on the north end of Fanny Bridge.*
- *Consider using the extra width on the existing Fanny Bridge for marked bike lane or add a raised sidewalk on the west side⁵*

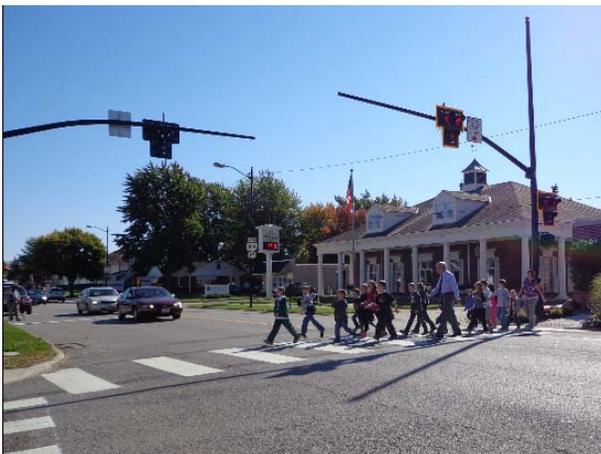
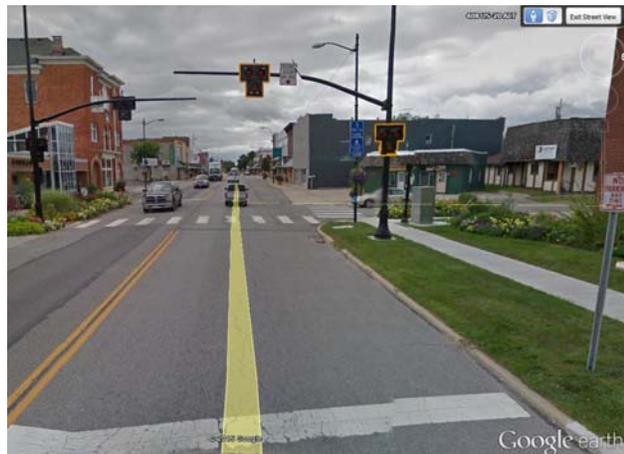
Figure 12: Example of Pedestrian Hybrid Beacon on a Hwy 20 and Wood Street - “T” intersection (Sources: Village of Delta, OH – left; Google Earth Street View - right)

- *Install a pedestrian activated Pedestrian Hybrid Beacon. Figures 12 and 13 provide locations of PHB installations that are similar in context to Tahoe City. (More information about the PHB can be found in Appendix E.)*
- *Improve the bulb outs by making them larger in order to improve sight distance.*
- *Use high visibility crosswalk markings for the two crosswalks across Grove Street.*

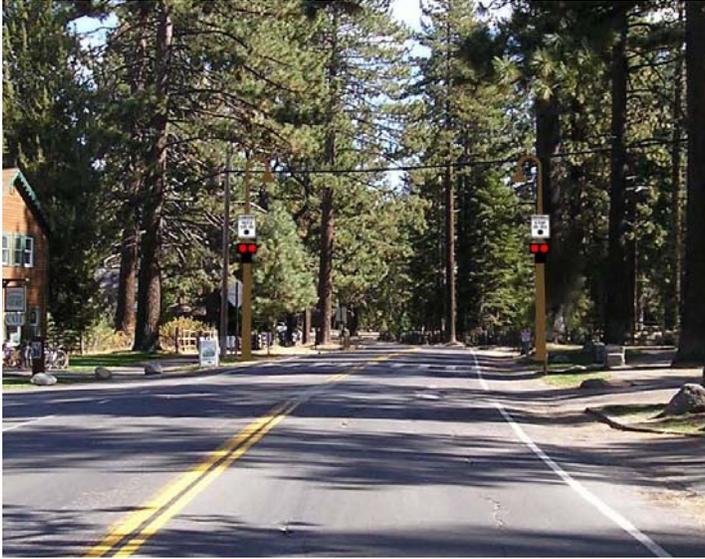
Figure 13: Mock up of Pedestrian Hybrid Beacon at Camp Richardson (Source: USFS)

The USFS is installing a Pedestrian Hybrid Beacon at Camp Richardson during the Fall of 2015. Figure 13 shows a mock-up of the Pedestrian Hybrid Beacon.

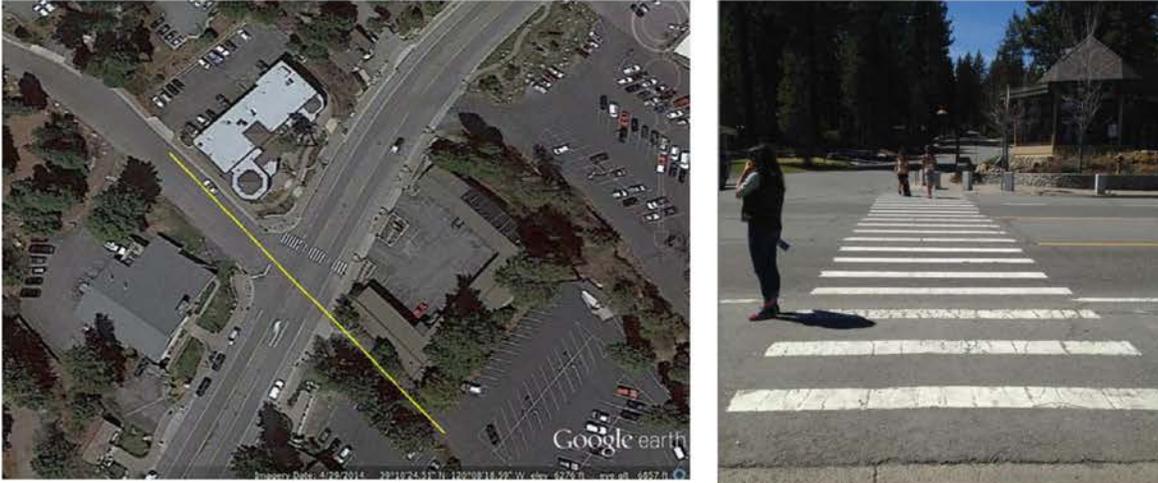
Figure 14: Re-alignment of Jackpine St and Long Pedestrian Crossing Distance (Aerial Image Source: Google Earth; Photo Source: Isebrands)

The Jackpine Street intersection had more pedestrian activity than was expected and the crossings appeared unpredictable in terms of where pedestrians were crossing at this intersection. Highway 28 traffic speeds were observed to be higher in this area, perhaps due to the wider roadway cross section. The intersection has a slight skew and aligns with one of the driveways to the Tahoe City Marina and shopping area. Because of the skew, the left turn movements for one direction can block the movement from the other direction. An exclusive right turn lane is marked in the southbound direction where it appears parking is still allowed. The pedestrian crosswalk is over 65ft in length. For an average pedestrian, it would take 20 seconds to cross the roadway with higher observed speeds and numerous driveway conflicts. Figure 14 illustrates the skewed nature of the intersection as well as the lengthy crossing distance.

- *Re-align Jackpine Street by adding curbing to the south radius. This will square up Jackpine Street to Highway 28.*
- *Provide curb bump outs on both sides of Highway 28 to improve sight distance for pedestrians and vehicles exiting the Marina and to reduce the crossing distance*
- *Eliminate right turn lane from westbound direction.*
- *Optional: Add a second crosswalk at Jackpine Street but consider additional conflict points and impacts to sight distance.*
- *Optional: If ingress and egress of the Marina can be modified, consider the west driveway as an exit only (better sight distance) and the east driveway as right-in-right-out only movements.*

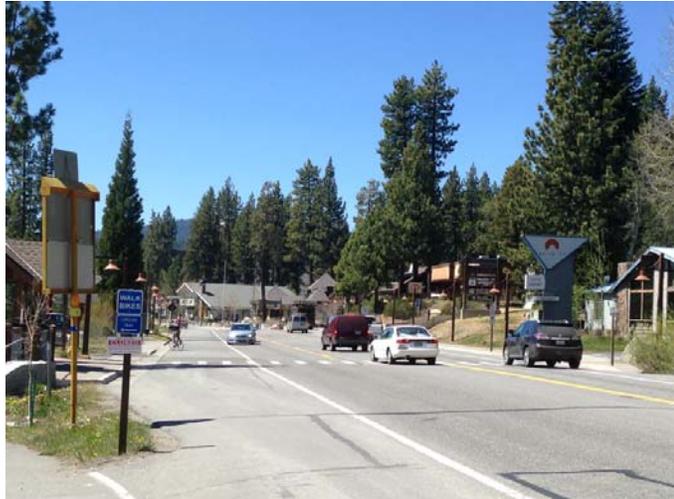
Figure 15: Lack of Pathway Connectivity near Lighthouse Development (Photo Source: Isebrands)

The east end of the study area appeared to have the highest speeds as drivers were entering and leaving Tahoe City. There is weak connectivity between the Class I bike pathway and the sidewalk network and roadway bike lanes as shown in Figure 15. Numerous pathway riders rode against traffic to transition either to the sidewalk on the south/west side of the road or to cross over to the east side and ride on the shoulder. Substantial sign clutter exists and potential wayfinding issues were observed where the Class I bike trail, road shoulder, pedestrian crosswalk and transit stop/bus shelter converged. Four driveways leading to the same parking lot also seem to allow unnecessary conflict points for all users.

- *Provide a raised median in advance of the crosswalk and transit stop to serve as a Gateway to Tahoe City from the North Shore.*
- *Complete a connection from the Class I multi-use trail to the sidewalk, crosswalk, and bus stop*
- *Consolidate driveways at the Lighthouse development.*
- *Provide bike lane markings on both sides of Highway 28 through this area. Roadway width appears to be available.*

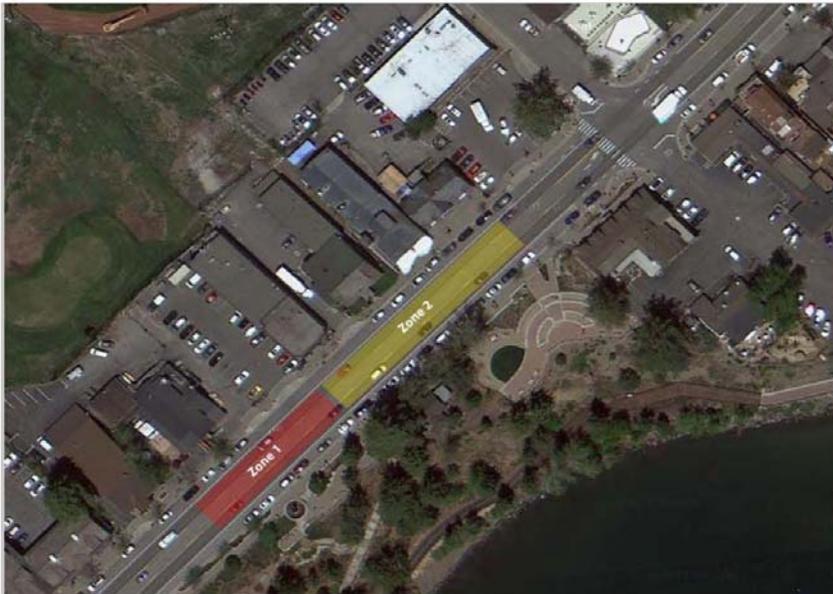
CalTrans Pedestrian Counts

Caltrans 03 - PLA - 028 PM 0.510 / Grove St.
Tahoe City, CA
CALIFORNIA DEPARTMENT OF TRANSPORTATION

Northbound and Southbound volumes represent pedestrian movements at the marked crosswalk at Grove Street.
