Phase I Environmental Site Assessment–Bruin Ranch

BRUIN RANCH

Vicinity of Auburn Valley Road and Bell Road
Placer County, California

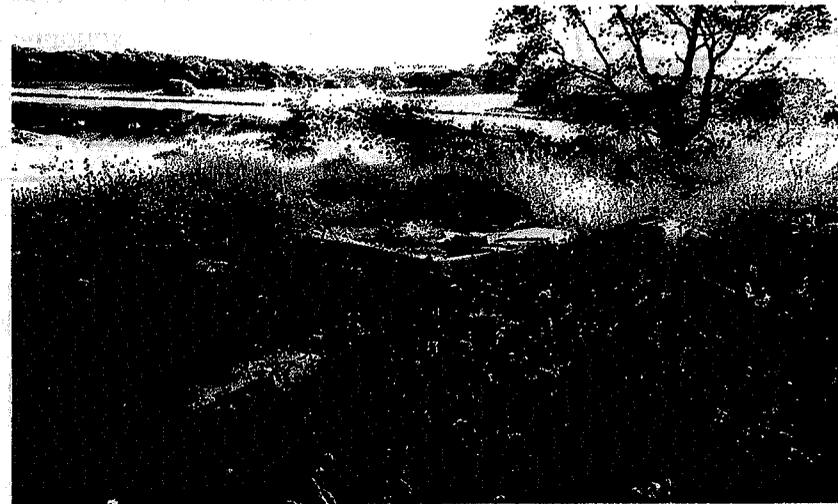
Metal debris, metal boxes (possibly for livestock feed), irrigation and clay pipe debris were also observed on the east-central and southeast sides of the site. No unusual stains, odors or stressed vegetation were observed around debris during the field reconnaissance.

View of metal debris located southwest of the south reservoir near the southerly boundary

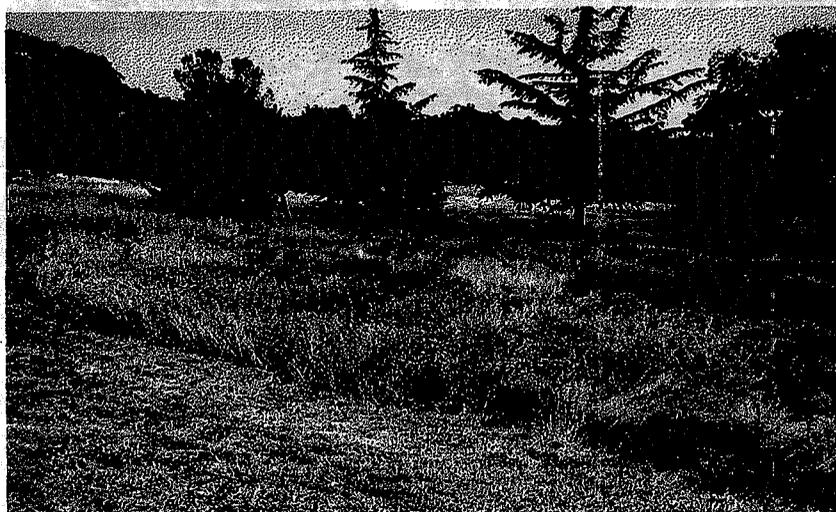
Southwesterly view of the southeast portion of the site as seen from Auburn Valley Road.

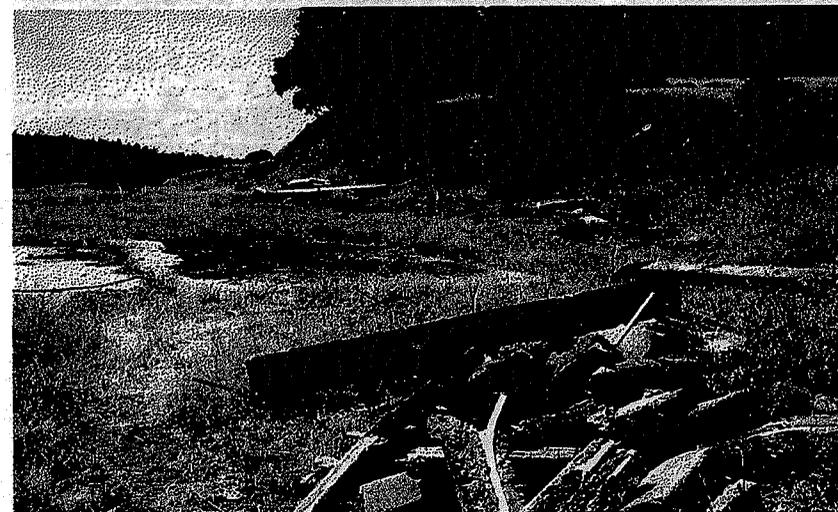
The former building and debris area is located on the east-central portion of the site, west of the Country Club's driving range. The shape and slope on the northerly side of this location suggests its use was previously an old rock or soil borrow area. Two concrete slabs were observed on the northeast side of the former building and debris area. Several vertical steel pipes were observed protruding from the concrete slabs or between and just south of the slabs. One pipe in the concrete held a remnant piece of PVC piping, which suggests the pipes in the concrete supported an overhead horizontal pipe. The two vertical steel pipes located between the slabs were cut close to the ground surface and appeared to be a remnant fence section. No evidence of a third vertical pipe was observed, which might have suggested the pipes were a fill port, a dispenser line and a vent pipe of a UST. Metal, plastic and wood debris and concrete rubble were observed near the concrete slabs. The soils beneath the debris were not visible during the field reconnaissance. No unusual stains, odors or stressed vegetation were observed on or around the concrete slabs and debris during the field reconnaissance.

Northwesterly view of one of the concrete slabs and debris located in the former borrow/structure area.

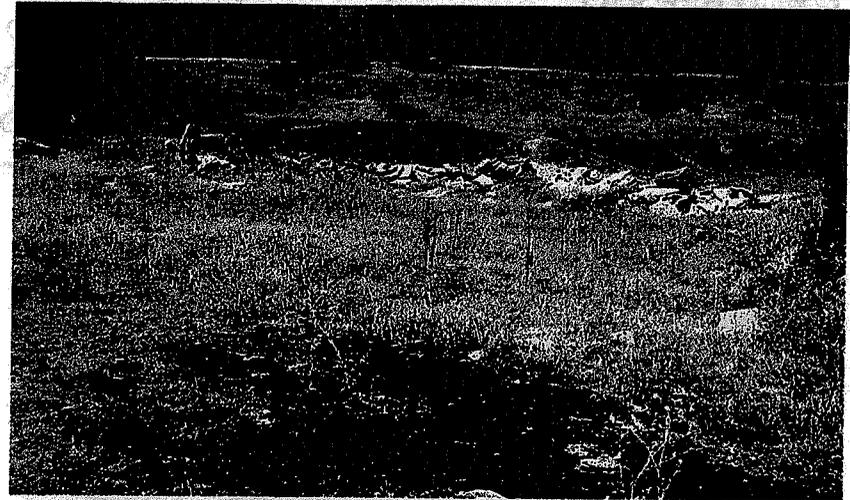
reconnaissance. One stained soil area was observed west side of the debris piles. The stain is approximately ten feet diameter and consists of a black hardened substance. WKA staff was unable to break through the hardened substance to observe the underlying soil. No other unusual stains, odors or stressed vegetation were observed in or around the debris piles and abandoned items.

View of the hardened black substance and debris and soil piles on the west side of the former borrow/structure area.

As indicated in a previous section of this report, the site contains debris and soil piles and abandoned items. As indicated previously, surface soils beneath these items were not evaluated for potential hazmat impacts. However, since most of the items and debris do not appear to be of an obvious hazardous materials nature, WKA simply recommends that all debris and rubble, including the hardened black substance, be removed and appropriately disposed or recycled off site. WKA recommends that surface soils on these areas of the site be visually inspected following the removal of the items, debris and hardened substance. If visual or olfactory evidence of potential soils contamination is observed in the soils beneath the items, debris and hardened substance, soils sampling and testing may in fact be warranted.

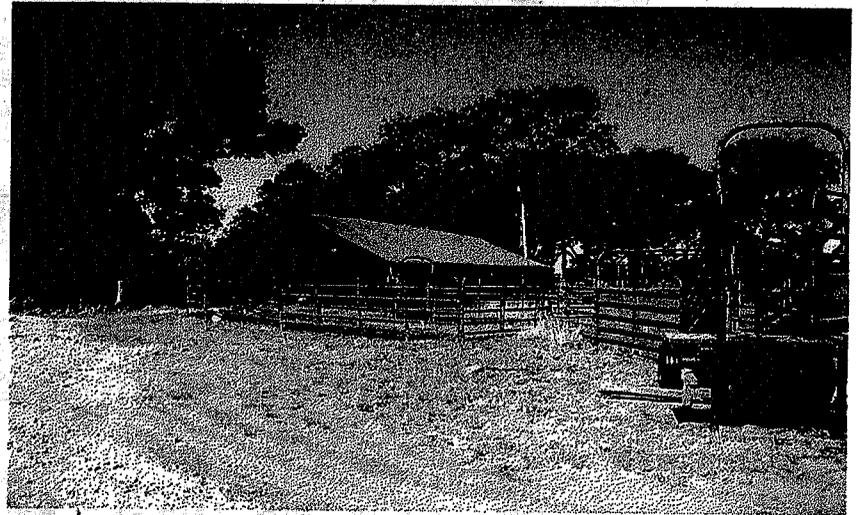
Grazing livestock were observed on the site at the time of our field reconnaissance. Three livestock dusting bags that contain over-the-counter pesticides (not restricted use) for fly control were observed on the east-central portion of the site. The corral and two livestock holding areas are located on the east-central side of the site, north of the Auburn Valley Country Club. The livestock holding areas are simply fenced and gated. Stored piping, spools of cable and wood pallets were observed in the general vicinity of the westernmost livestock holding area. The corral area consists of a livestock holding area, an aluminum frame and tarp livestock shelter, and an aluminum frame and tarp cattle workspace. The workspace contains cabinets, a cattle chute. A one-gallon container of antibiotics for livestock was observed on the top of the cabinets. A pile of cow manure was observed east of the corral area. Additionally, a five-foot diameter pile of what appeared to be ash was observed east of the cattle workspace. The pile is several inches high and a barbeque was observed in close proximity. The soils in the livestock holding areas and corrals have been densely compacted by the livestock and vehicles, and little to no vegetation exists in these areas. No unusual stains, odors or stressed vegetation were observed around the livestock holding areas and corral.

View of the corral and sheltered cattle work area.
