Phase I Environmental Site Assessment

6-ACRE PRUETT PROPERTY

Antelope Road
Roseville, California
WKA No. 10216.01
August 25, 2014

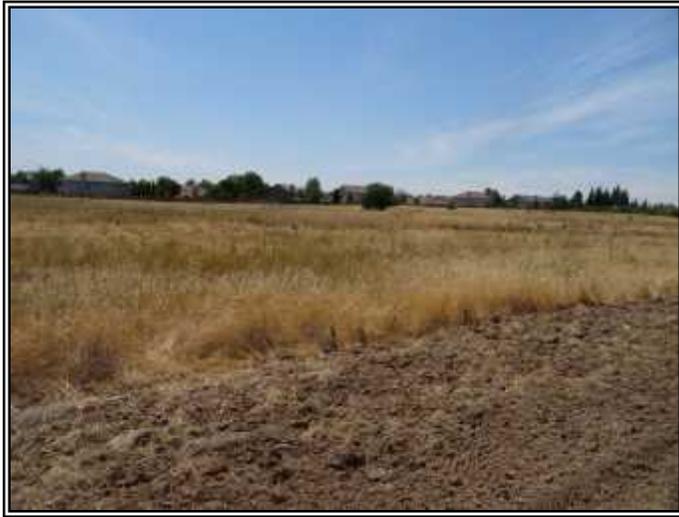
Looking southwest at the general view of the Site.

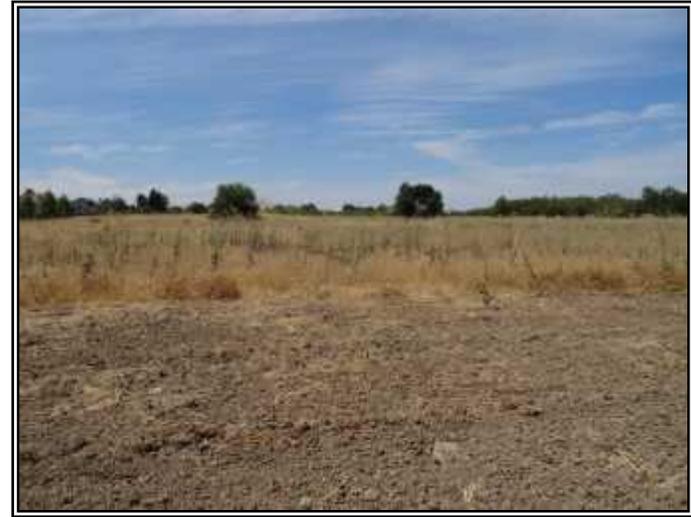
Looking west at the general view of the Site.

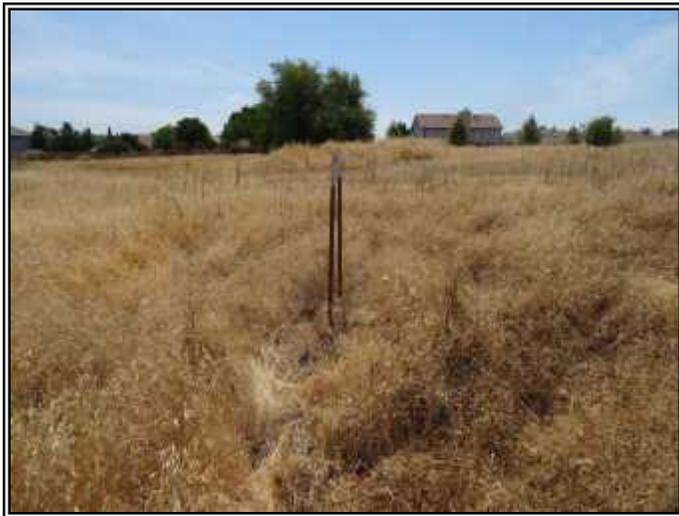
On the day of field reconnaissance the Site was vacant land. A fire break of disced land was located on the northern, eastern, and southern portions of the Site. The remained of the site was covered in dense, low-lying volunteer vegetation. A capped well was observed on the central portion of the Site.

Looking at the location of the capped well on the central portion of the Site.

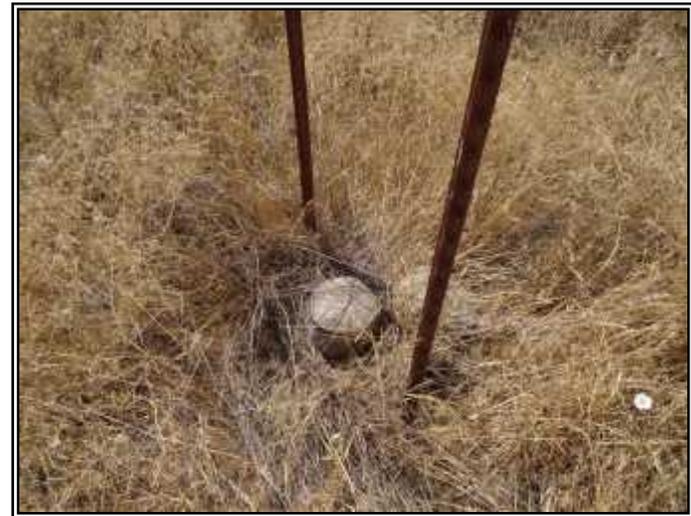
- A capped well is located on the central portion of the Site. The well was installed by the previous owner in anticipation of building a house on the Site; however, the owner passed away before construction began. A septic system may have been installed at the Site; however, no information regarding its location was available for review.

Looking at the capped well.
