*Phase I Environmental Site Assessment*

**12-ACRE HAIGHT PROPERTY**

2751 & 2755 PFE Road

WKA No. 10217.01

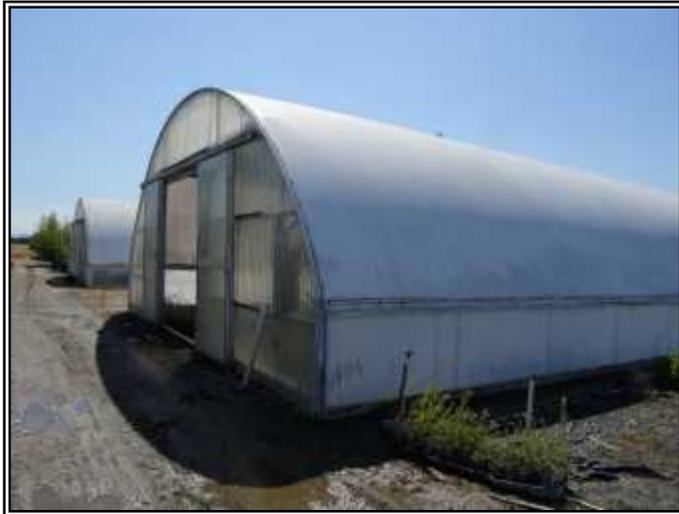
Looking southeast at the two Quonset Huts located on the southern portion of the Site.

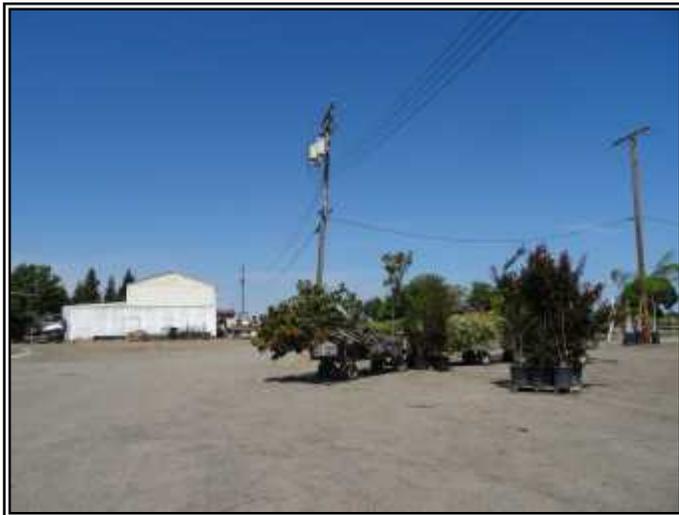
WKA observed three pole mounted transformers and piping associated with a boiler that was located on the southern adjoining property to the west-northwest of the office. A maintenance shop is located to the northwest of the pole barn.

Looking west at the three pole-mounted transformers and the maintenance shop.

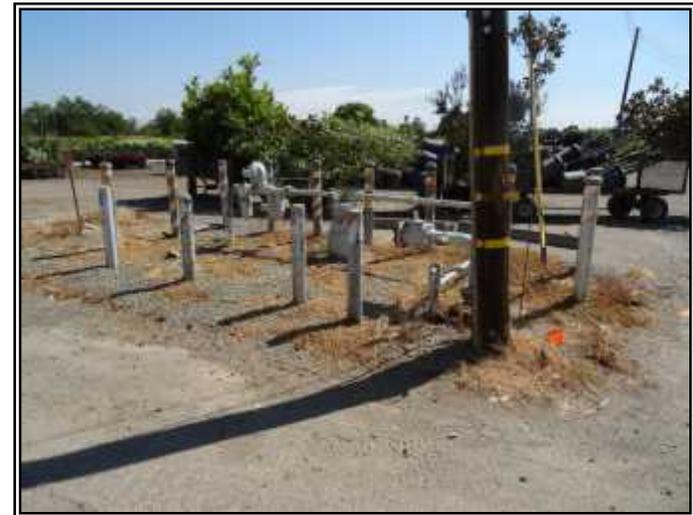
Looking at former piping associated with a boiler that was located on the southern adjoining property.

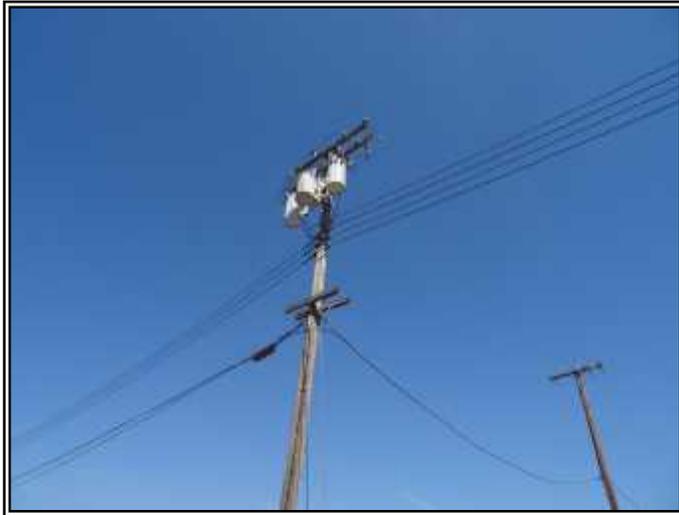
Looking at the three pole-mounted transformers.

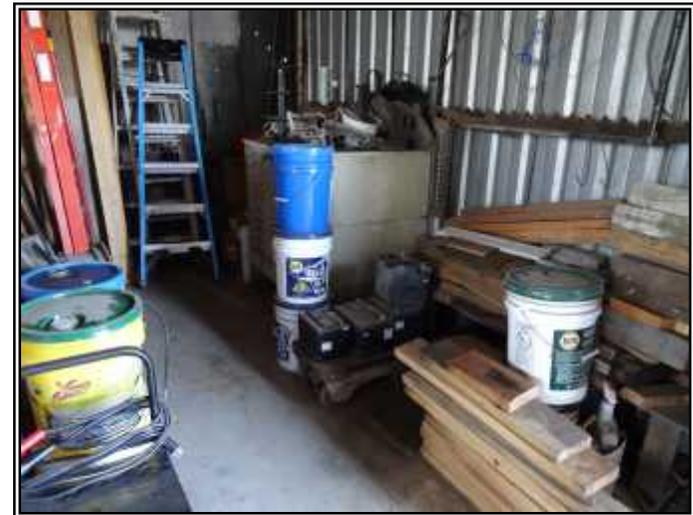
The maintenance shop has a concrete floor and where equipment used for nursery operations is maintained and repaired. WKA observed tools, spare parts, empty buckets, nine buckets of hydraulic oil, a 55-gallon drum of new oil, one and five-gallon buckets of paint, and scrap metal in the maintenance shop. The concrete floor of the maintenance shop appeared to be in good condition with minimal staining. A surficial stain that measured six inches by 12 inches and less than one-quarter inch deep was observed to the north of the maintenance shop.

Looking at nine hydraulic oil buckets located in the maintenance shop.

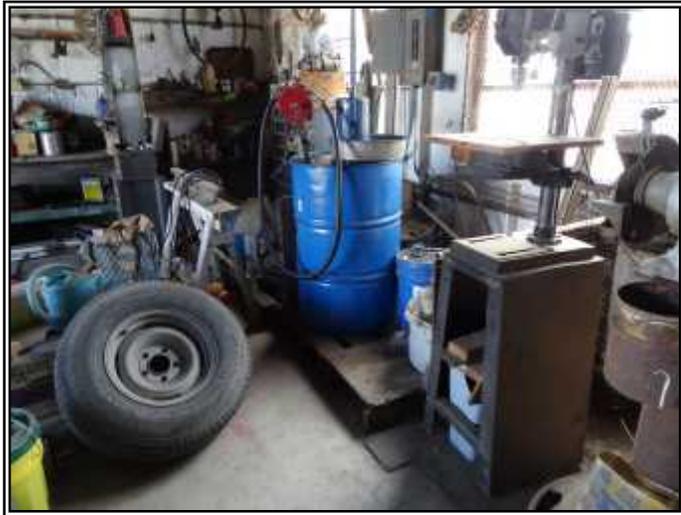
Looking at the 55-gallon drum of new oil in the maintenance shop.

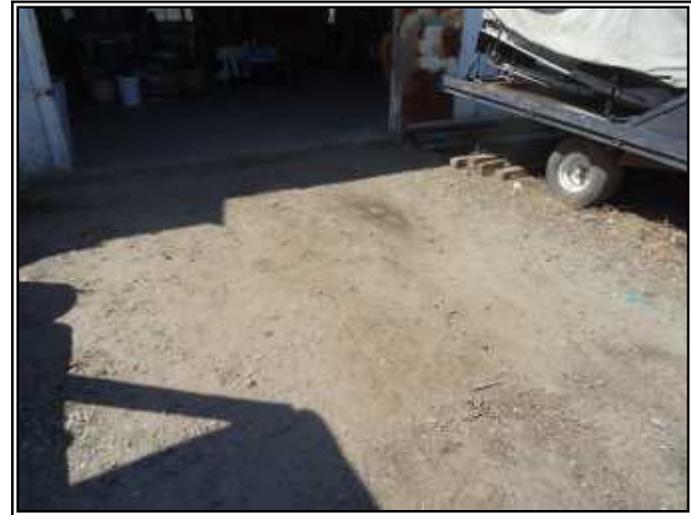
Looking at the stained soil located to the north of the maintenance shop.

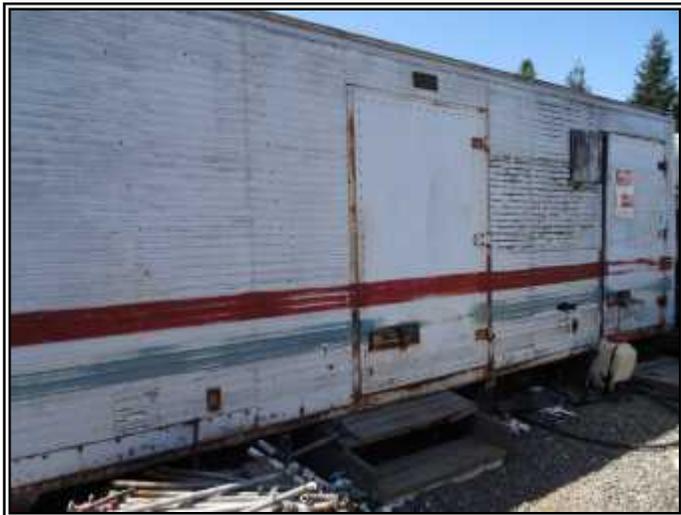
A metal-sided mobile trailer used for pesticide storage was observed to the west of the maintenance shop. A pesticide sprayer that is mounted on a trailer was observed to the north of the pesticide storage trailer.

Looking southwest at the trailer used for pesticide storage.

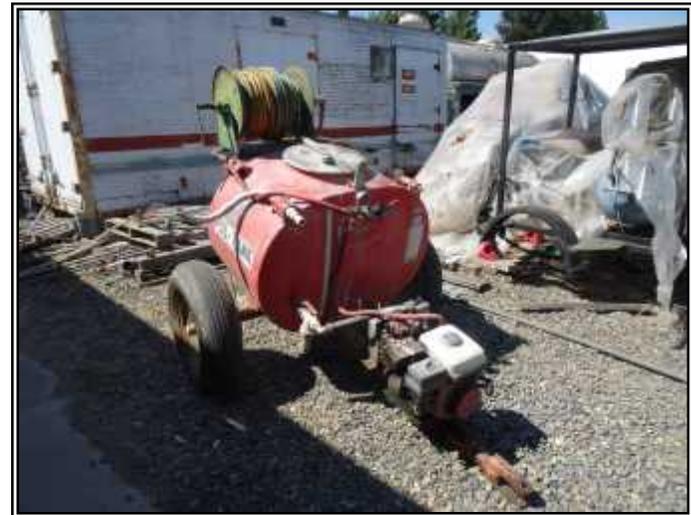
Looking at the pesticide sprayer.

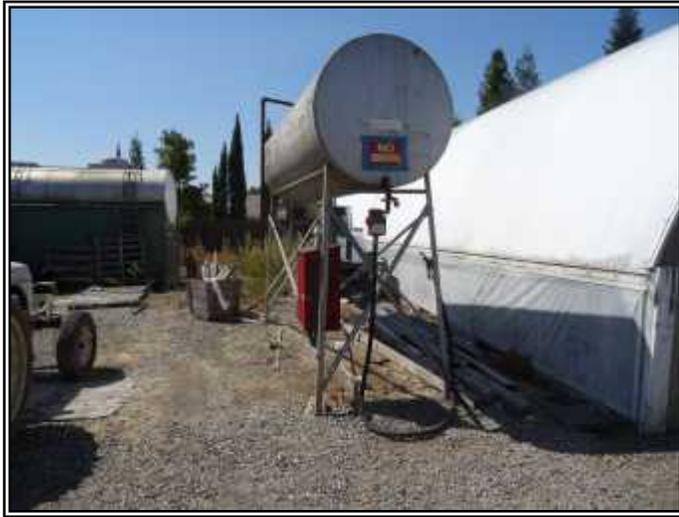
- A 1,000-gallon unleaded gasoline aboveground storage tank (AST) is located to the east of the western-most Quonset hut (Figure 4). The AST was installed between 1993 and 1995. Mr. Charles Haight, site owner, stated that no major spills have occurred at the location of the AST. WKA observed minor surficial soil staining that measured 12 inches in diameter and did not appear to penetrate more than one-half inch into the soil.

- On-site concerns were noted from the presence of the 1,000-gallon unleaded gasoline aboveground storage tank (AST). The AST has been located at the Site since at least 1995.
- On-site concerns were noted from the operations of a wholesale nursery since at least 1964 and the potential for residues of historically applied persistent pesticides to be present in shallow soil.
- On-site concerns were noted from the presence of the residence, shed, and detached garage since 1964 and office since at least 1971 and the potential for residues of historically applied persistent pesticides (termiticides) around the foundations of the former structures or residues of lead from lead-based paint to be present in shallow soil.

Looking south at the 1,000-gallon unleaded gasoline aboveground storage tank.

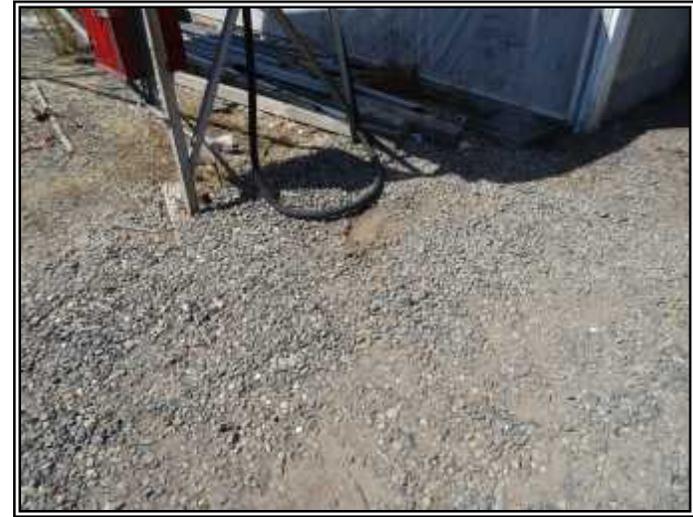
A 1,000-gallon unleaded gasoline aboveground storage tank is located to the west of the pesticide storage trailer. WKA observed minor surficial soil staining that measured 12 inches in diameter and did not appear to penetrate more than one-half inch into the soil.

Looking at stained soil located to the north of the 1,000-gallon aboveground storage tank.

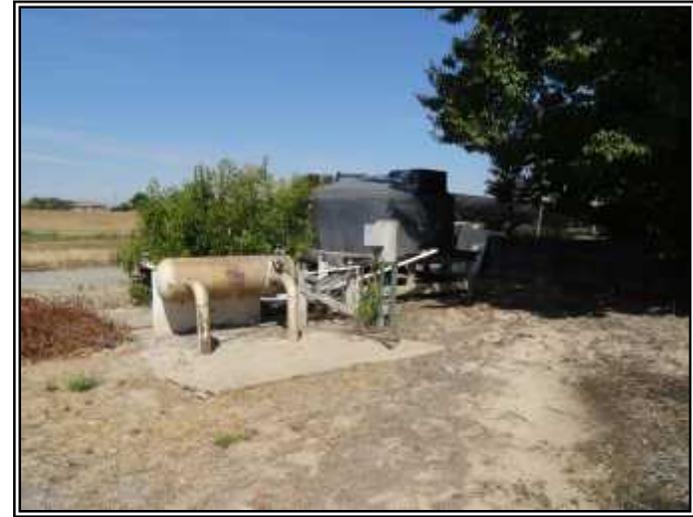
A bulk fertilizer storage tank is located to the southwest of the residence. A distribution system was attached to the storage tank; however, several parts are missing and it is in disrepair.

Looking northwest at a bulk fertilizer storage tank.

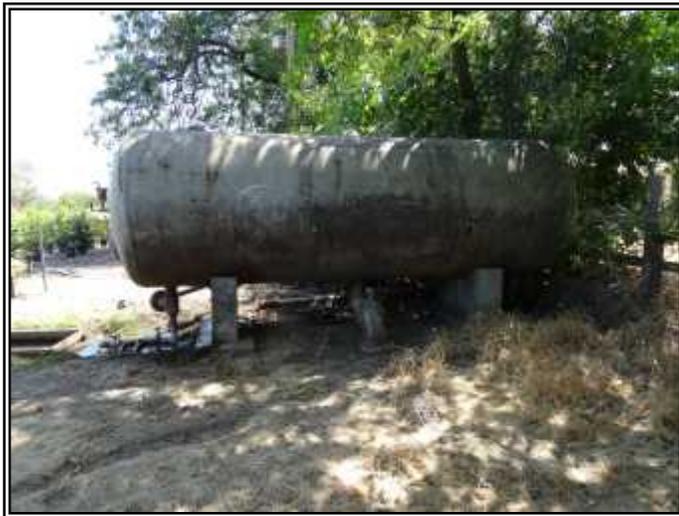
WKA observed a water supply tank and well to the north of the residence.

Looking at the water supply tank adjacent to the well located to the north of the residence.

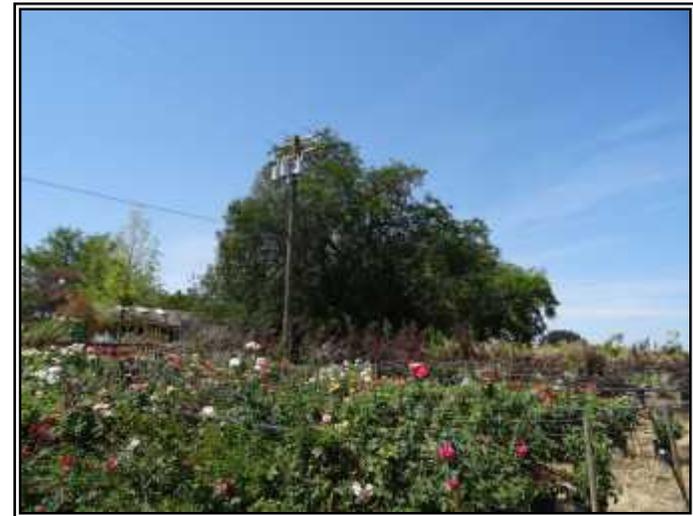
mounted transformers were observed to the northeast of the residence. According to the Site owner, Mr. Charles Haight, the transformers are owned by SMUD. No evidence of spills or leaks, such as stained soils, was observed at the base of either power pole.

Looking at a pole-mounted transformer located to the northeast of the residence.

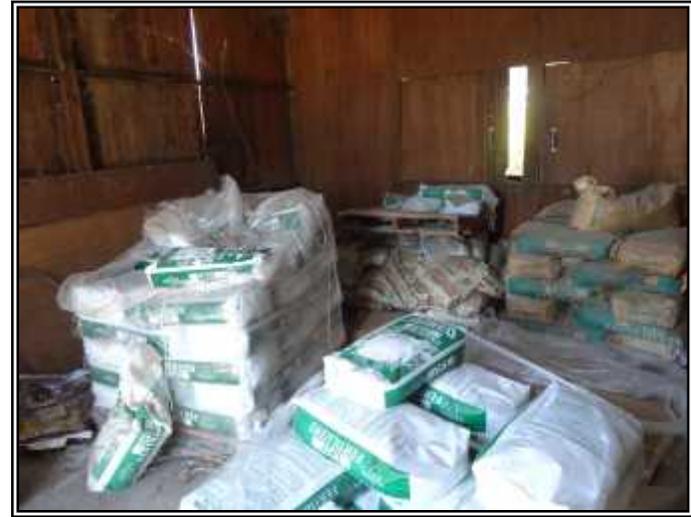
WKA observed a wood-sided shed to the south of the tail-water pond. The shed is used to store granular fertilizer.

Looking at the storage of granular fertilizer in the storage shed.
