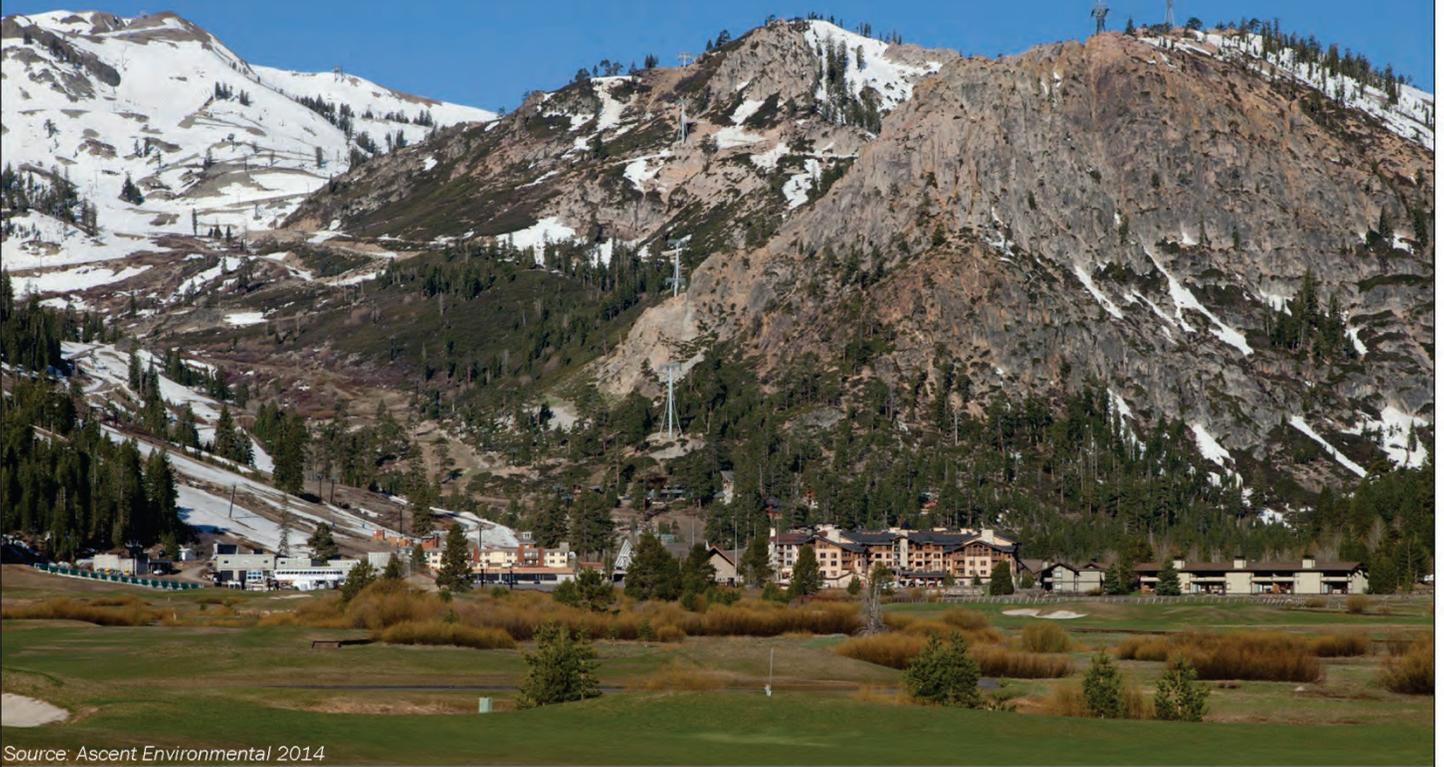
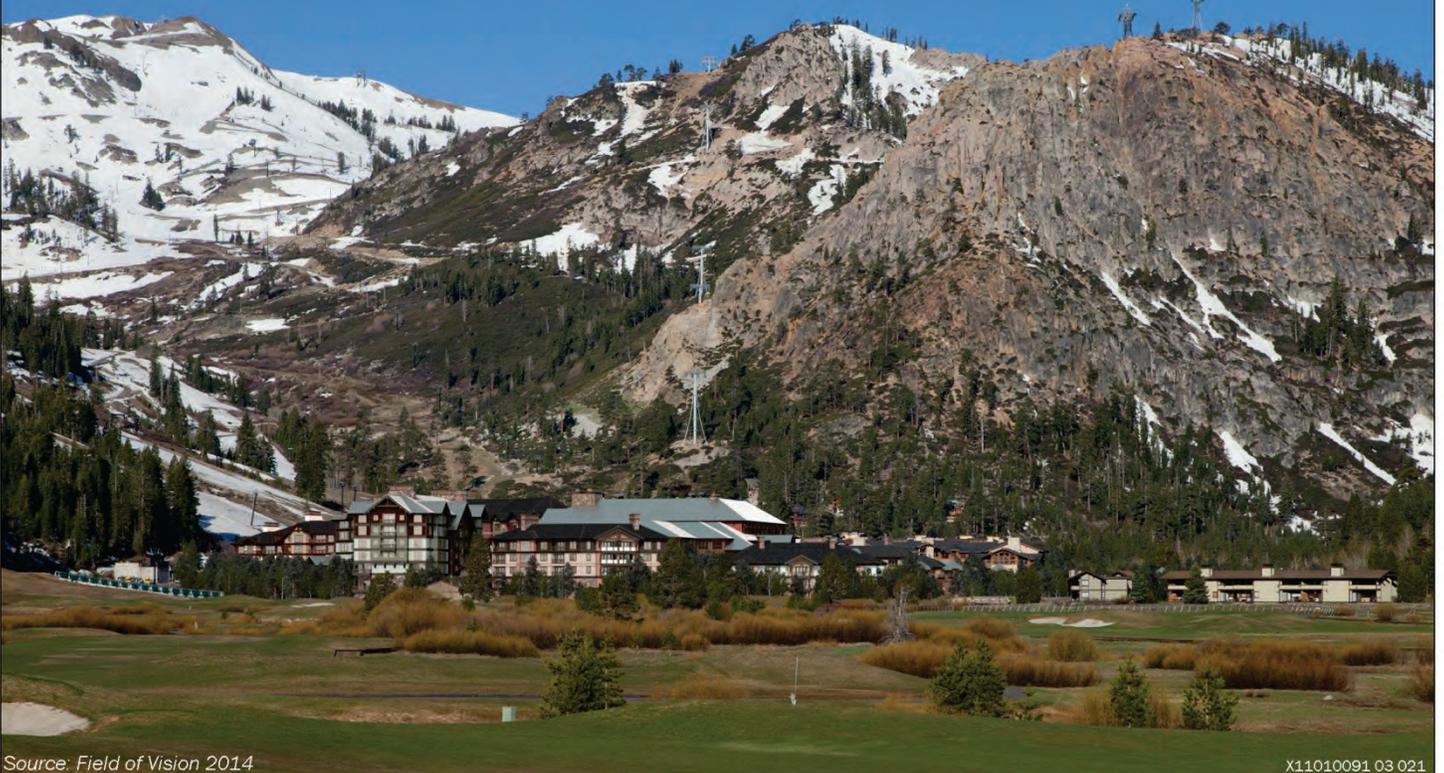
Existing view to the west from the meadow/golf course of the project site in spring

Simulated view to the west from the meadow/golf course of the project site in spring

Viewpoint 6: Views near the Resort at Squaw Creek in Spring (Exhibit 8-14, Existing View)

This viewpoint is representative of the panoramic views of the western end of Squaw Valley under conditions with little or no snow (late spring, summer, early fall) as viewed from the area east of the project site. Foreground views are of the golf course and meadow. The existing Intrawest Village structures and Squaw Valley Meadows condominiums are visible in the middleground. The ski resort support facilities (snow making building, maintenance buildings) are visible to the south of the resort buildings. The rocky slopes of the mountains enclosing the west end of the Valley are in the middleground behind the existing resort. Lift towers are visible on the mountain.

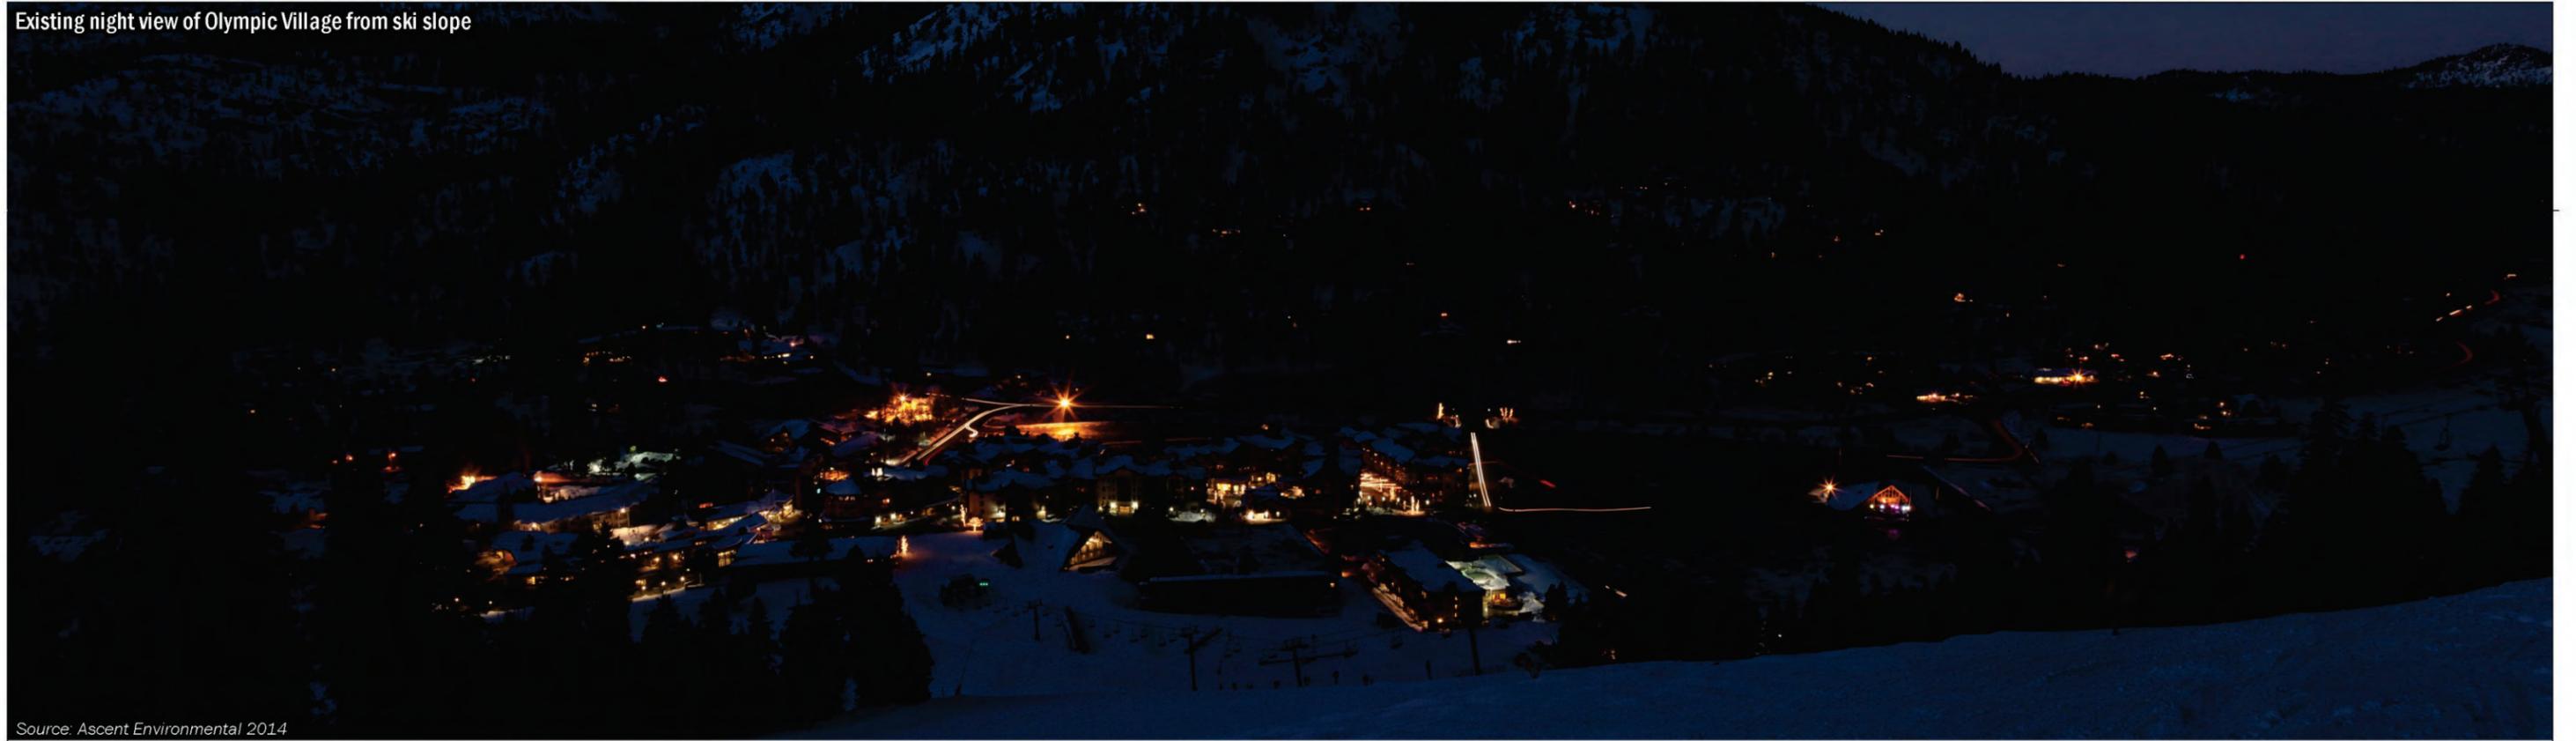
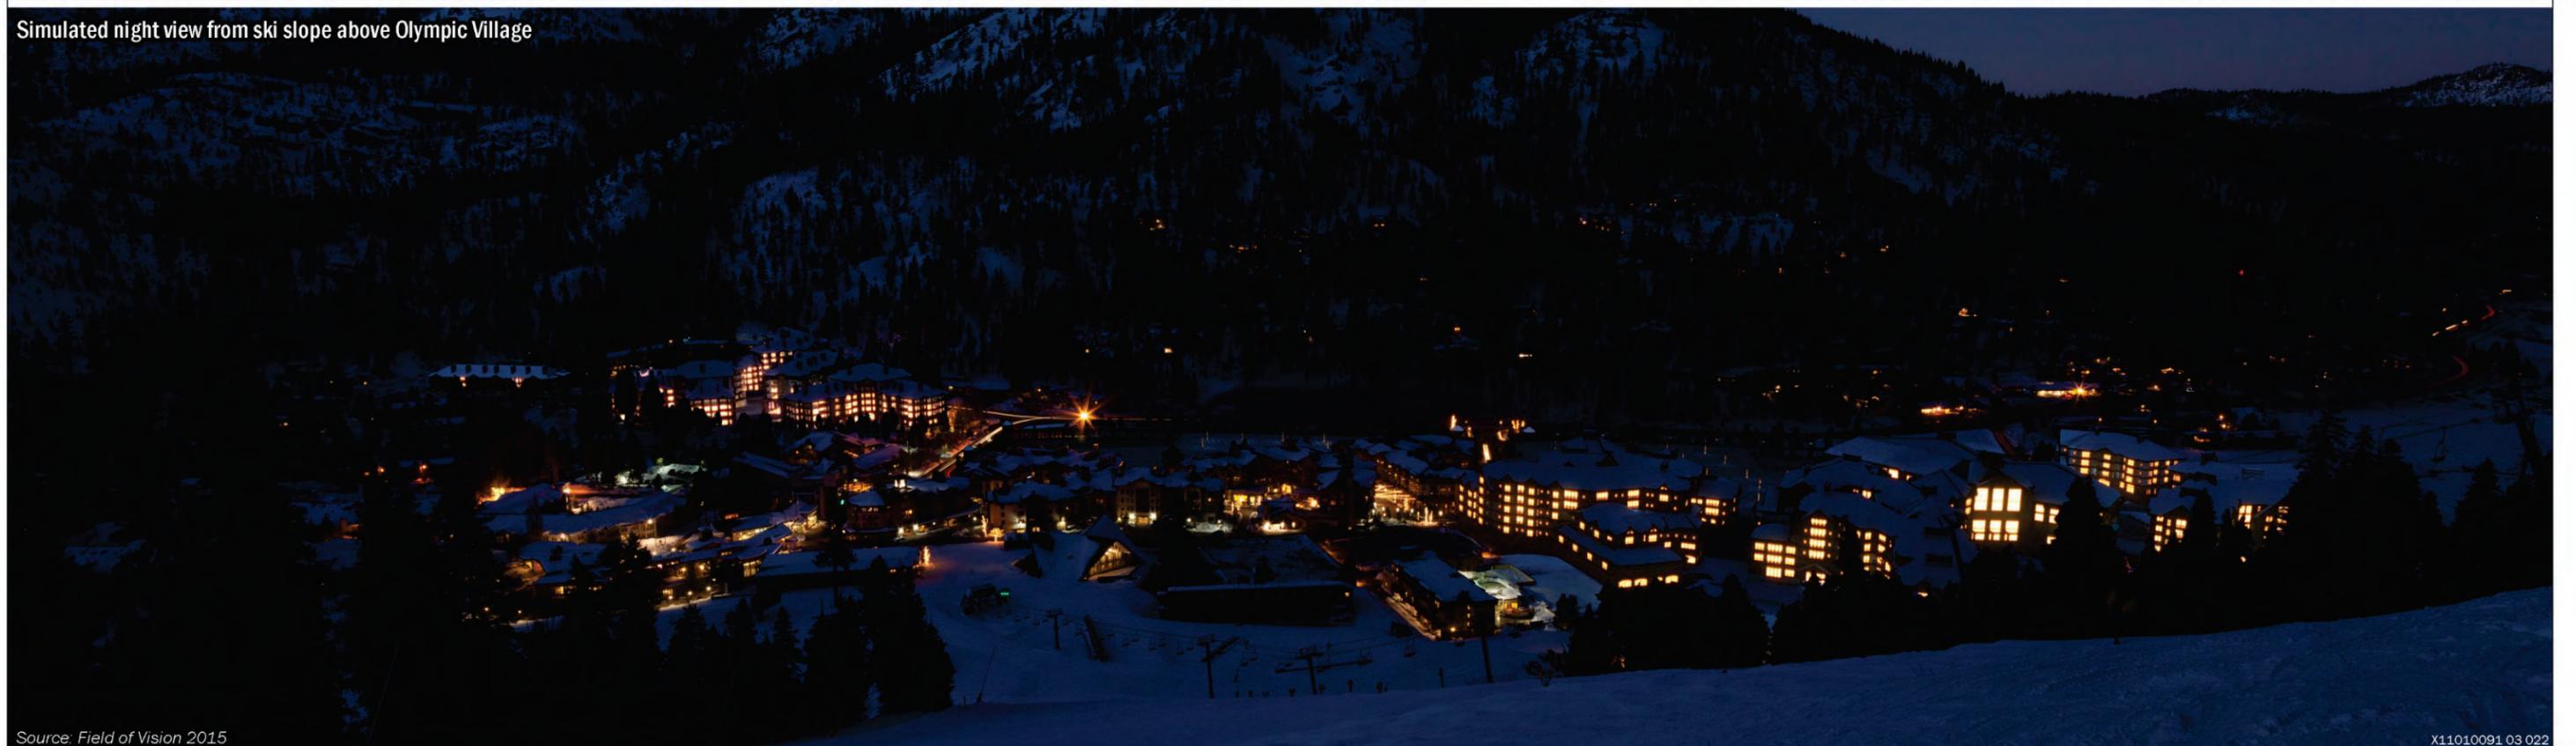
Existing night view of Olympic Village from ski slope

Simulated night view from ski slope above Olympic Village

Viewpoint 7: View of Squaw Valley from Ski Slope – Night (Exhibit 8-15, Existing View)

This viewpoint provides a representative view of nighttime lighting conditions under existing conditions. The view is from the ski slopes on the south side of the Valley. Lighting is visible from the resort in the foreground, and lights from residences on the north slopes of the Valley are visible in the middleground.

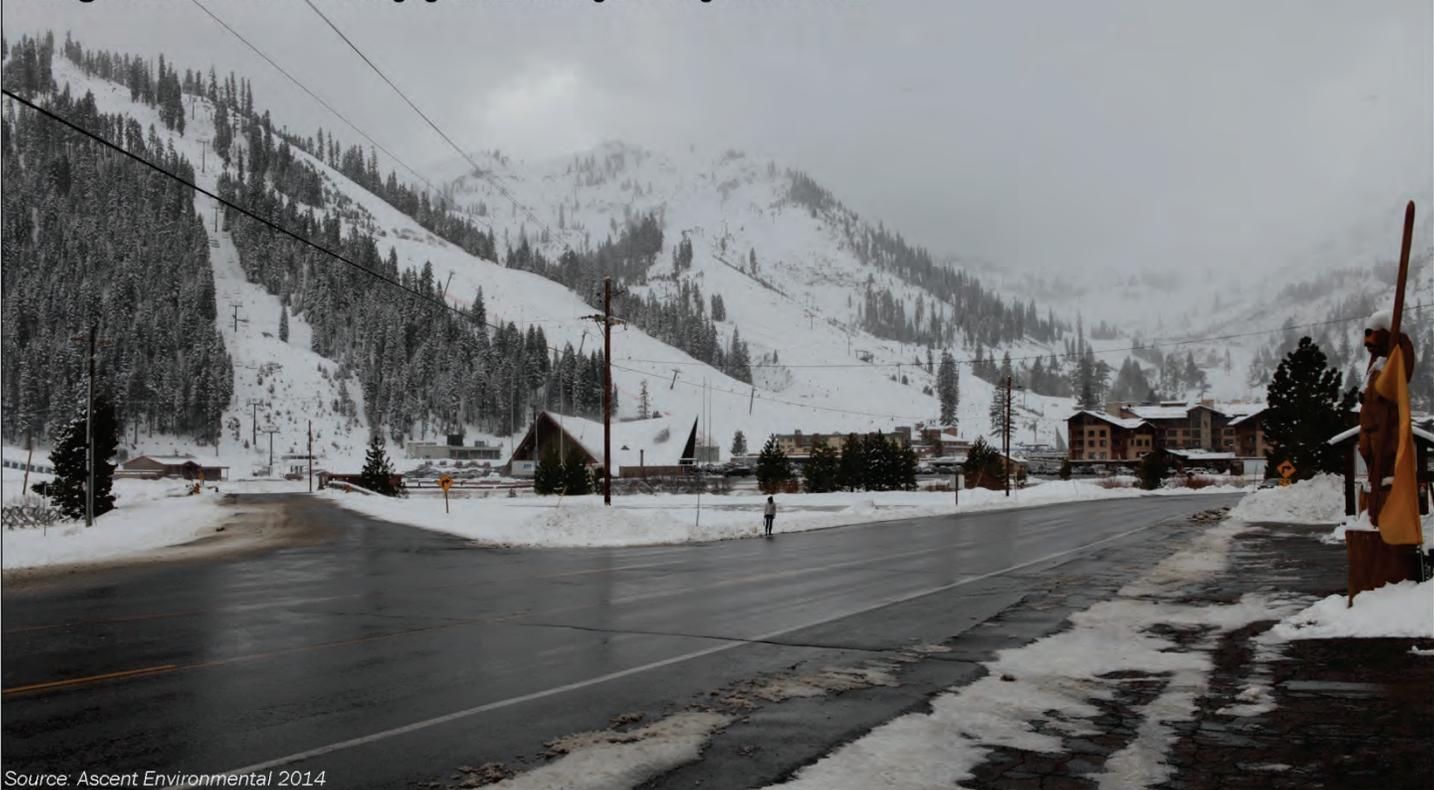
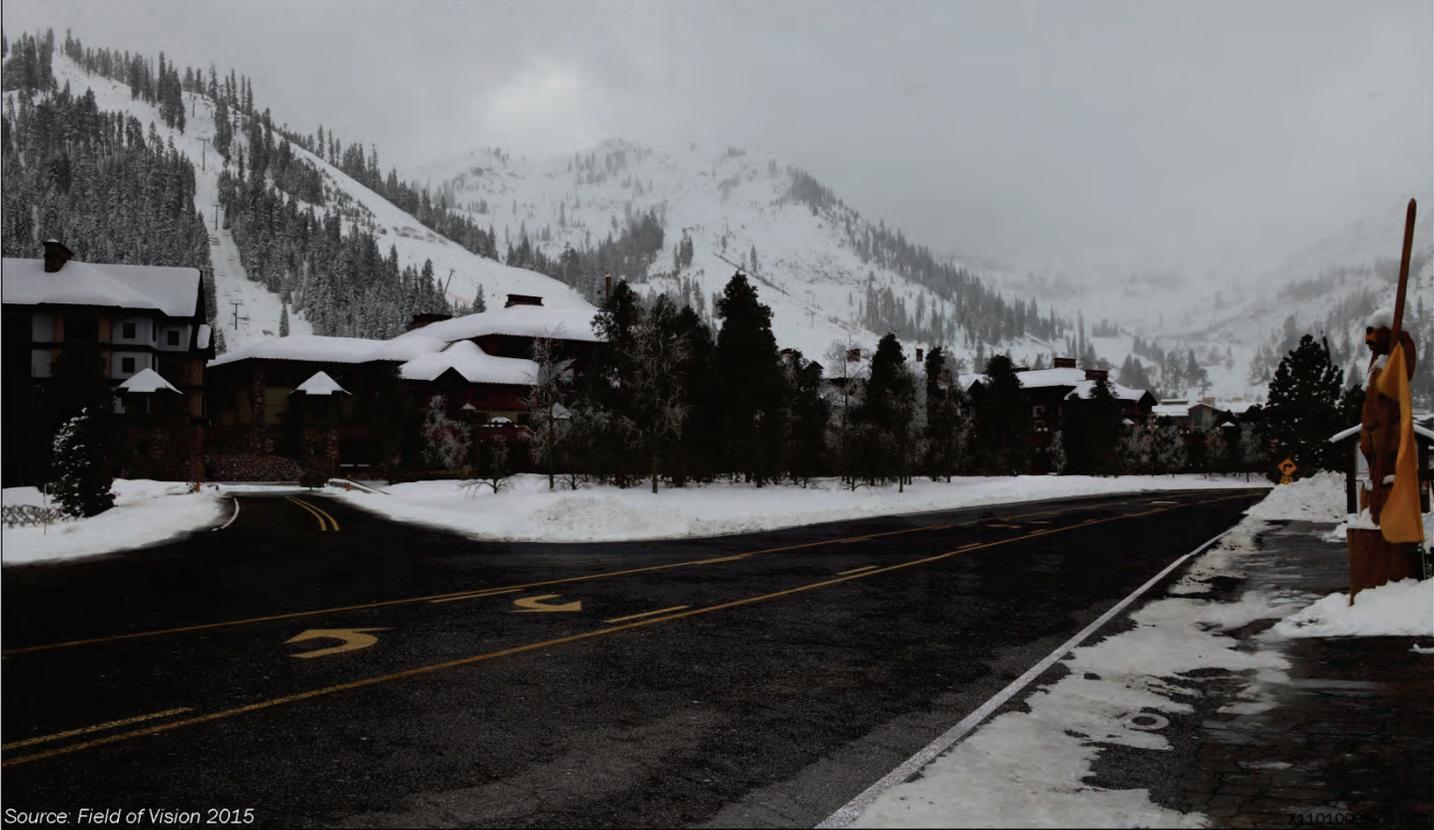
Existing view to the southwest of the project site from Squaw Valley Road in winter

Simulated view to the southwest of the project site from Squaw Valley Road in winter

Viewpoint 8: View of Project Site from Squaw Valley Road in Winter (Exhibit 8-16, Existing View)

This view is representative of how viewing conditions may be altered during overcast winter weather. The view is from Squaw Valley Road near Far East Road to the southwest. Foreground views are of the Far East Center, and utility poles and lines. A garage and hotel are in the middleground, partially obscured by vegetation in this view. Low clouds and mist obscure more distant views of the ski slopes and mountain tops.

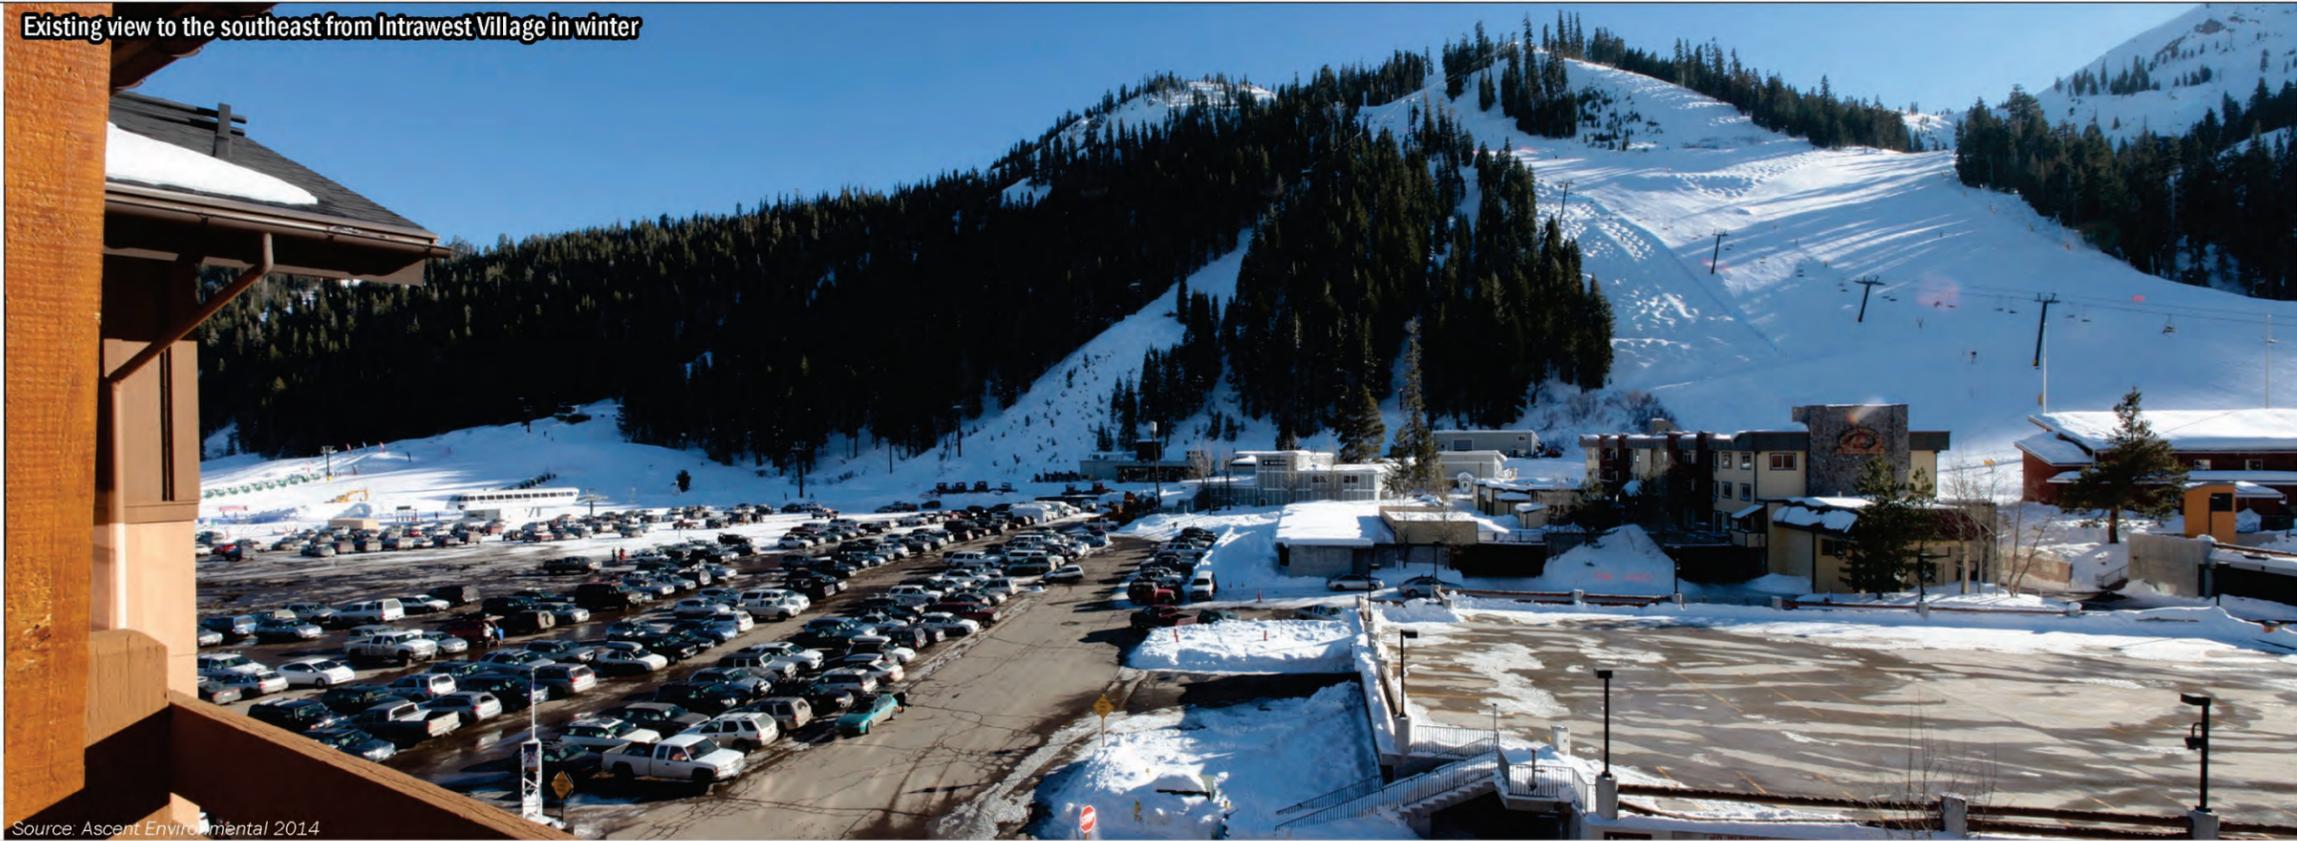
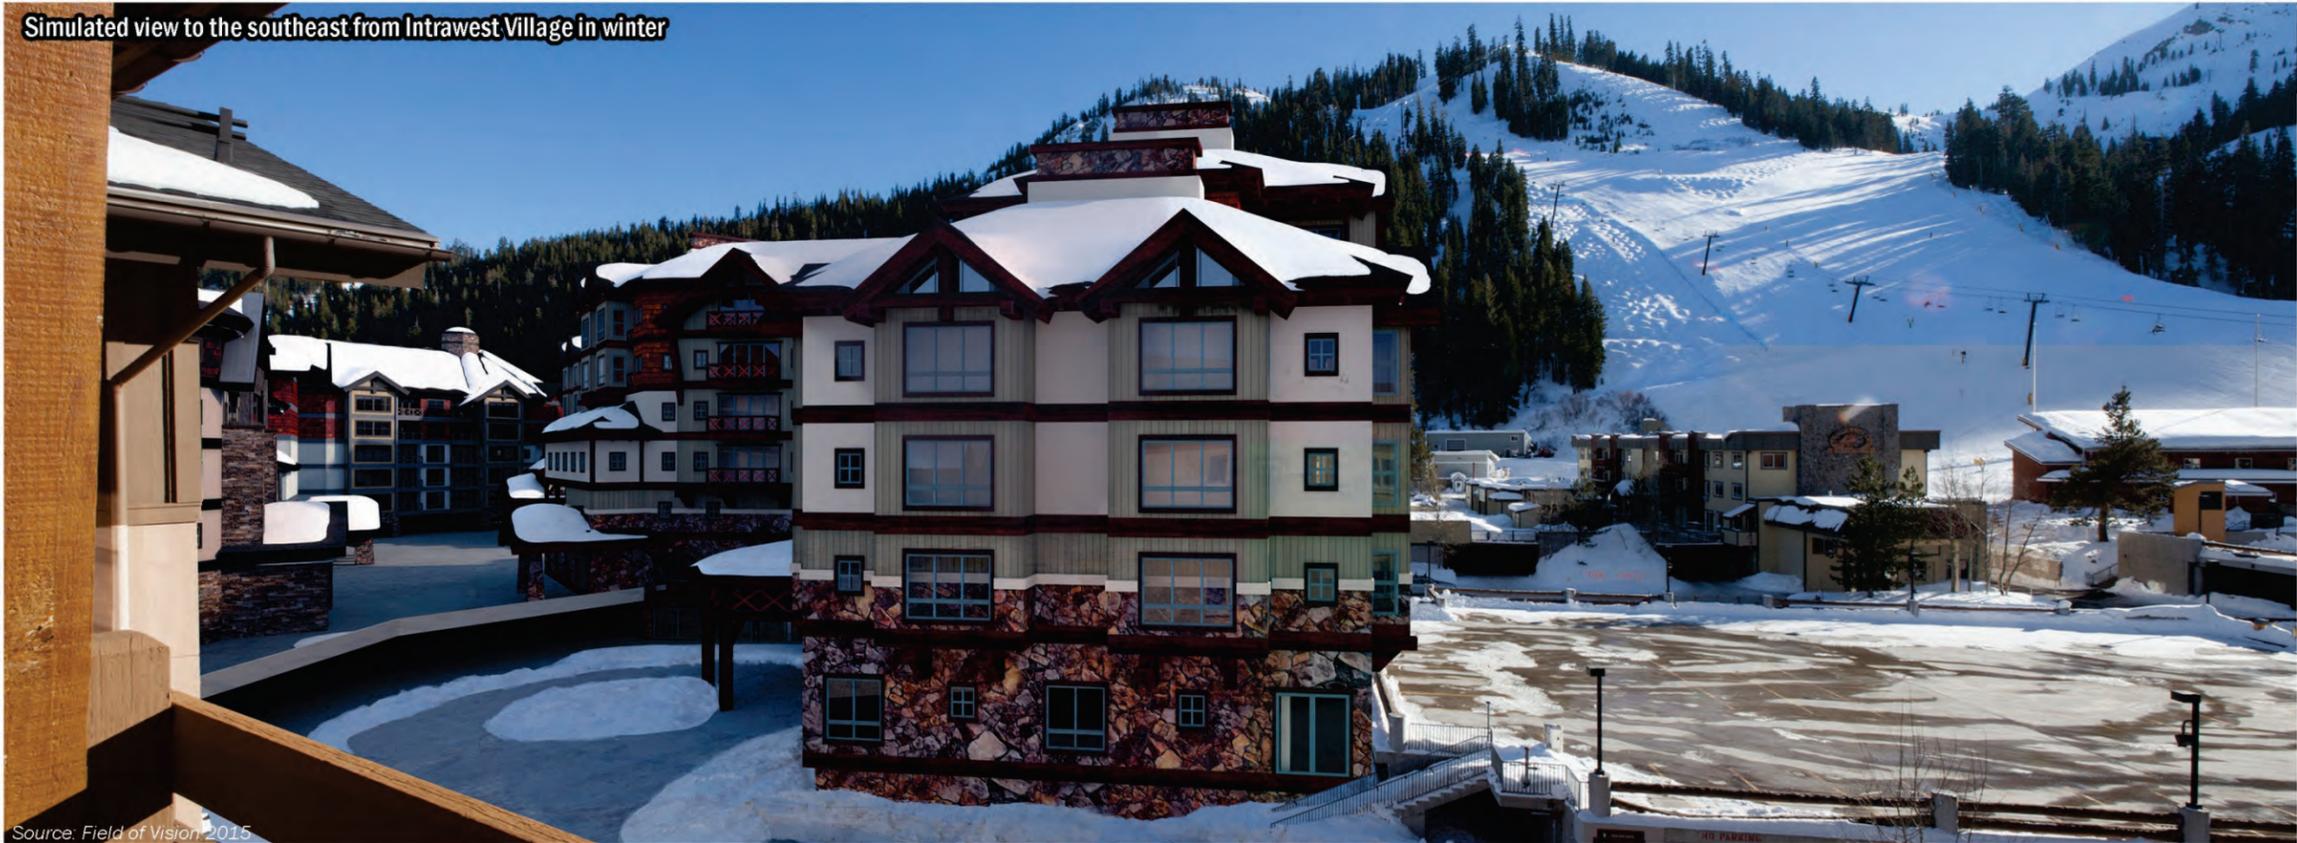
Existing view to the southeast from Intrawest Village in winter

Simulated view to the southeast from Intrawest Village in winter

Viewpoint 9: View of Project Site from Intrawest Village in Winter (Exhibit 8-17, Existing View)

This viewpoint is representative of views from guest rooms facing south in the Intrawest Village lodgings, located to the west of the project site. Views in the near foreground to the south include the parking lot; and parking structures, Red Dog Lodge, another hotel, and maintenance buildings are in the more distant foreground. The lower slopes of the ski runs and ski lifts on the south side of the Valley are also visible.

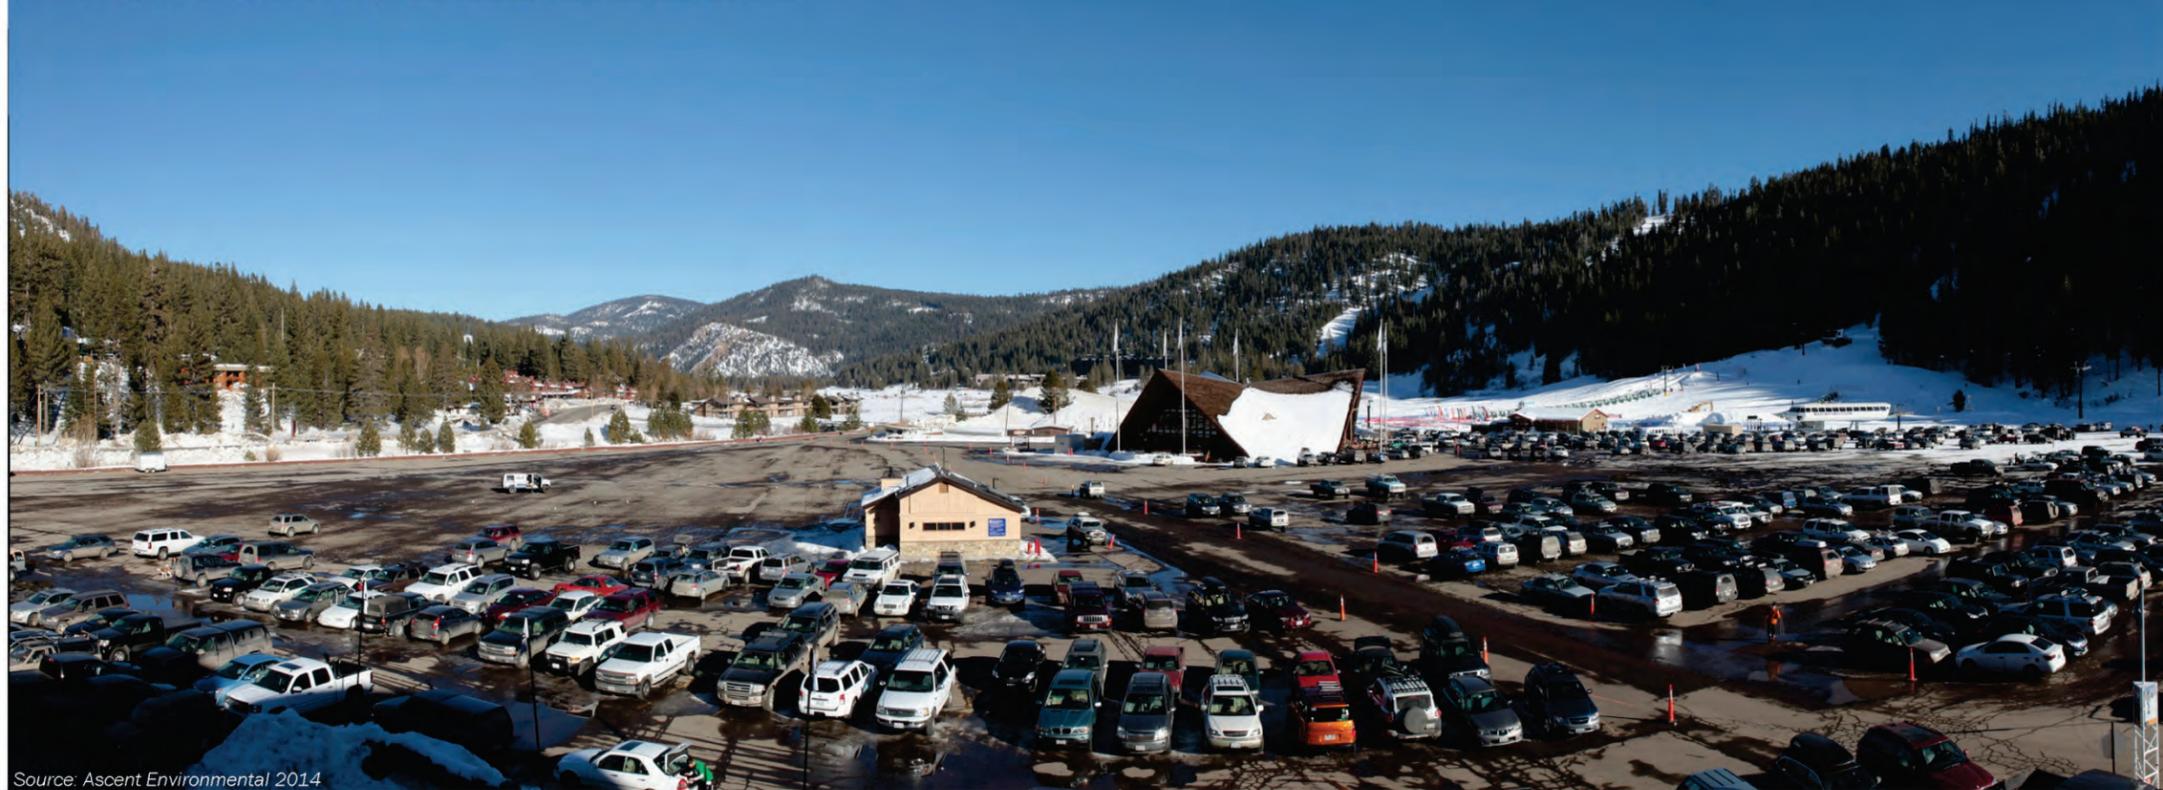
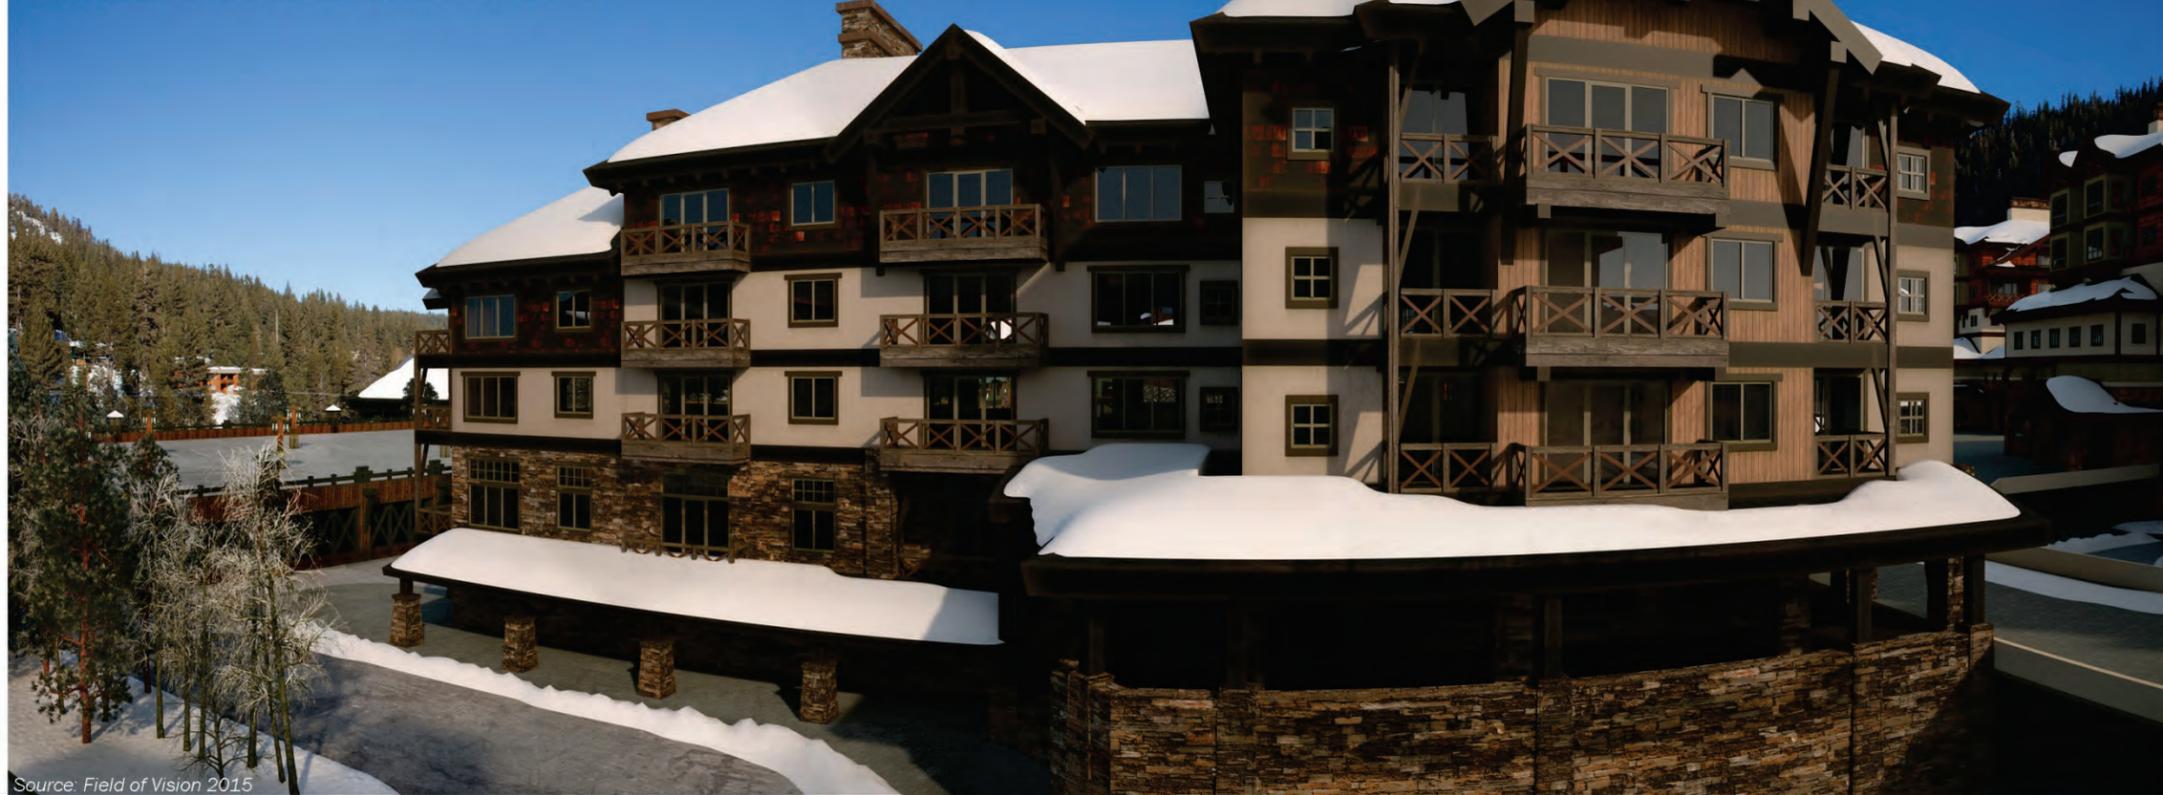
Existing view to the east across the project site from Intrawest Village in winter

Simulated view to the east from Intrawest Village in winter

Viewpoint 10: View of Project Site from Intrawest Village in Winter (Exhibit 8-18, Existing View)

This viewpoint is representative of views from guest rooms facing east in the Intrawest Village lodgings. Views to the east include parking lots, the Red Wolf Lodge, Red Dog Maintenance structure, and a portion of the Squaw Kids building. The Far East Center is in the near foreground and lower slopes of the ski runs are visible on the south side of the Valley in the more distant foreground. Forested slopes on the north side of the Valley and residential buildings are partially visible in the foreground as well. The Resort at Squaw Creek is visible in the middleground, partially obscured by trees at the edge of the meadow and golf course. Background views with forested ridges are visible beyond the east end of the Valley.
