PHASE I ENVIRONMENTAL SITE ASSESSMENT

for
PLACER VINEYARDS
Placer County, California

Project No. 99-426

Re: **PLACER VINEYARDS SPECIFIC PLAN EIR**
Placer County, California
Phase I Environmental Site Assessment

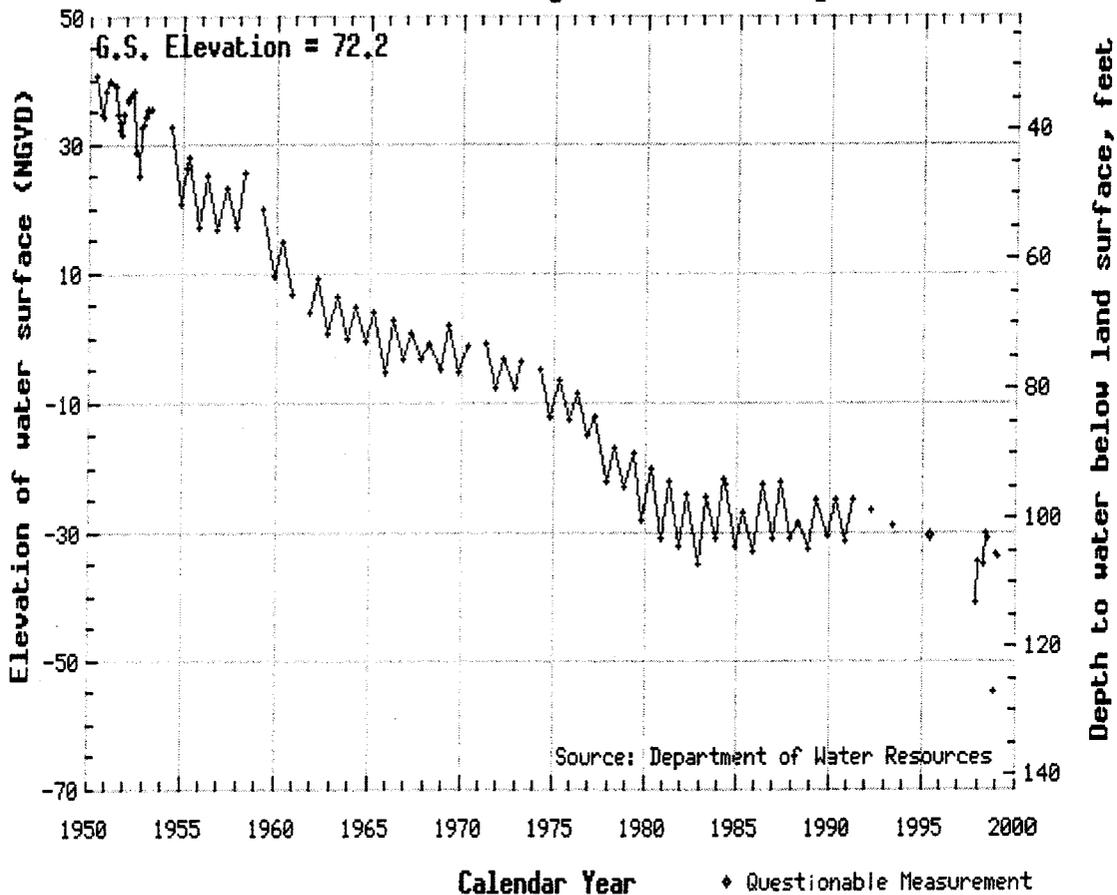
3

Groundwater Levels, 10N05E04Q01M
 Sacramento Valley (Placer County)

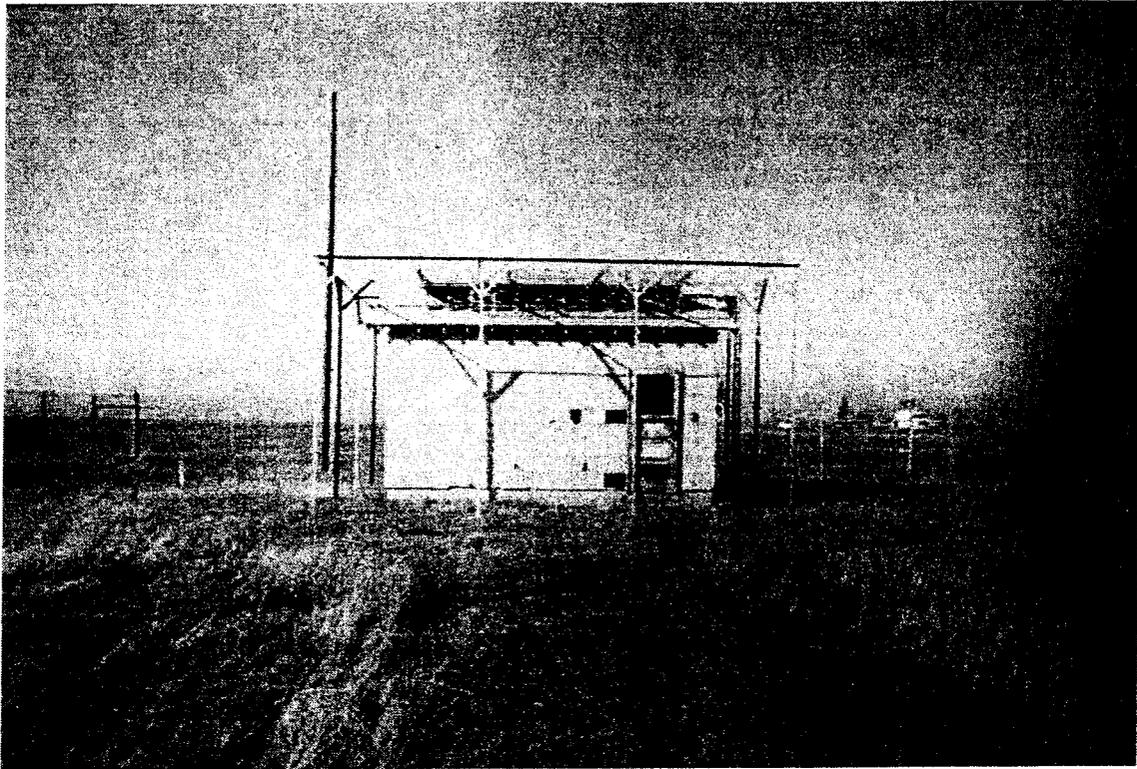
Top Photo: PG 7 Former Navigation Marker Building. Looking West - Base Line Road on Right of Photo.

The *Formal Environmental Assessment* described the property as 0.25 acres enclosed by a chain link fence with one small building of approximately 150 SF of floor space. The building was described as being serviced with power and telephone; however, there was no water or sewer. CEI observed the facility in January and February, 2000. Photographs in Figure 4 indicate the current conditions.

A wooden and metal platform exists on top of the radio beacon building. The power and telephone lines have been severed but wire remnants are still hanging from the building. The building is divided into two rooms, one with a raised platform and one with a level floor. Conduits for wiring exist in the concrete foundation; some are open and contain pipe and wires, while others have been sealed with concrete. The massive concrete floor has utility trenches for wire and conduits covered with non-skid solid metal grates. The trenches connect the two rooms. The walls have louvered vents for air circulation. Electrical wiring and fuse boxes exist inside the building. The outside of the building is covered with what appears to be green asbestos board siding which is broken in places.

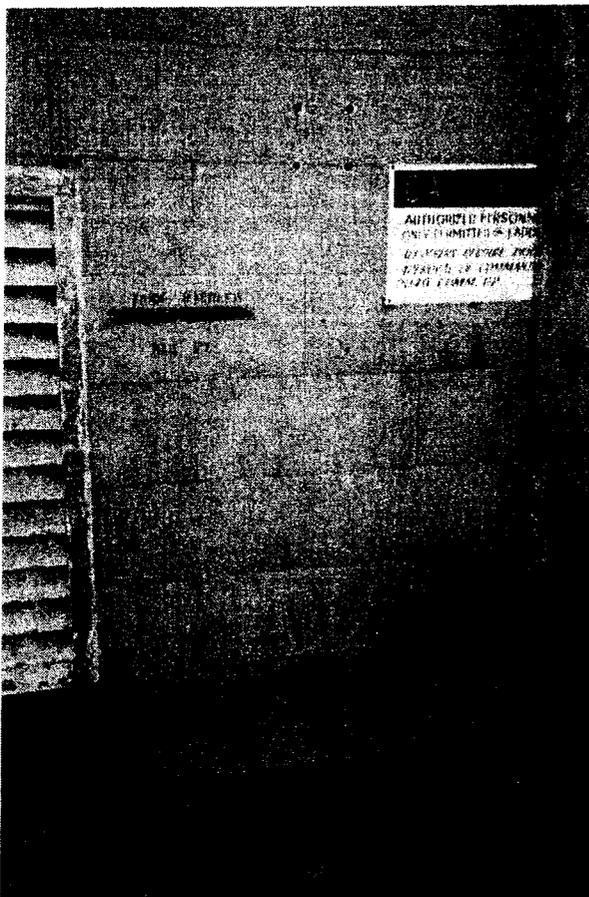
Left Photo: PG 7 North End of Former Navigation Marker Building Showing Conduit in Foundation, Possible Tank Vent Pipe, and "Tank Pickled Mar 77" Stencil.

As noted in Figure 4, stenciled with black paint on the siding on the north side of the building are the words:

- possible existing UST or former AST and contaminated soil at navigation marker beacon building,
- possible asbestos-containing siding on the navigation marker beacon building,
- possible soil contamination in the vicinity of the oil filters observed near hill,
- possible physical and environmental hazards posed by open irrigation well.

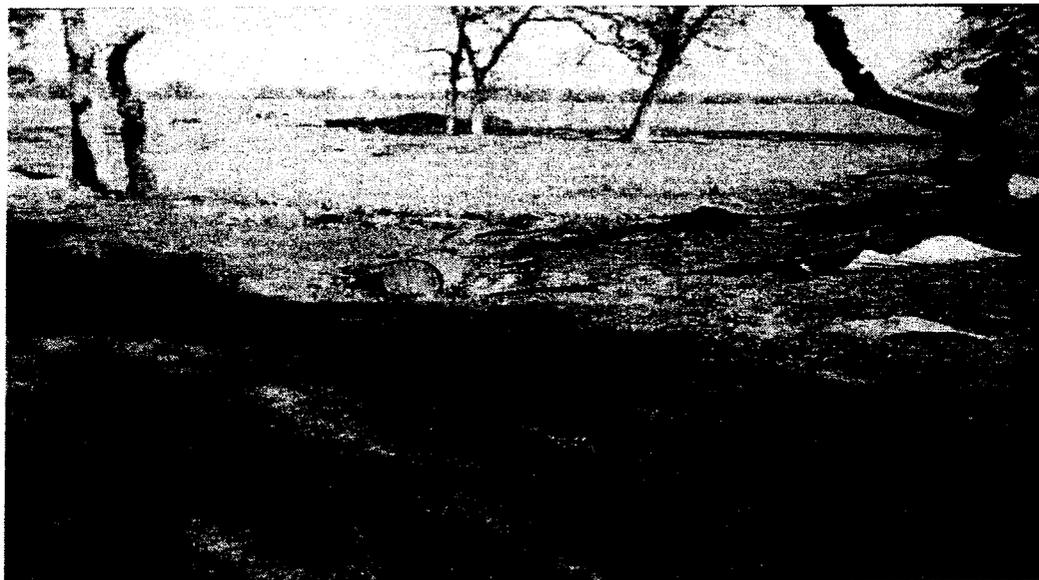
PG 9 Burn Pit and Debris

- possible soil contamination in vicinity of burn pit and debris piles.
- possible soil contamination in the vicinity of the former almond orchards in existence prior to the 1952 aerial photography.

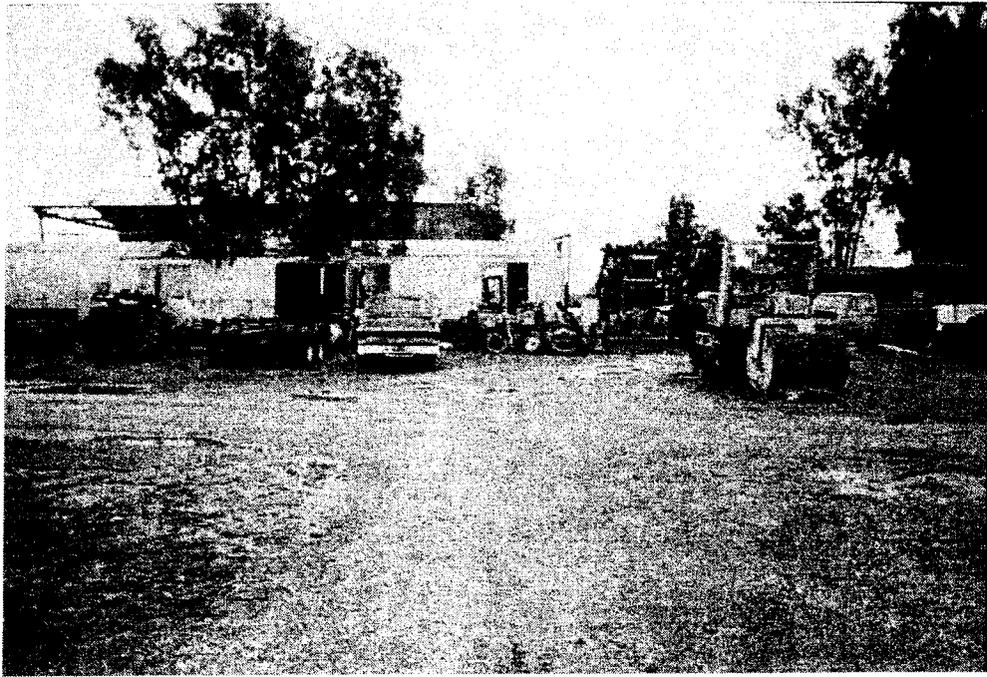
PG 15 Equipment Storage and Maintenance Area
Looking South from Petroleum Storage Area

Much of the ground surface around the outbuildings is being used for maintenance, repair and storage of farm and construction equipment and vehicles in various stages of disrepair. Additionally, miscellaneous debris, scrape parts, buckets and drums clutter the area around the buildings. Photographs in Figure 8 illustrate typical conditions in the vicinity of the outbuildings. Patches of soil staining were observed in the vicinity of equipment suggesting leakage of oil during storage and repair.

- accumulated petroleum products, paint products and other miscellaneous substances scattered around property,
- derelict equipment and machinery, with particular regard to petroleum products, batteries, tires, and components containing hazardous substances,

- possible soil contamination in vicinity of ASTs, petroleum drums, oil filter drain container, and waste oil tank
- possible soil contamination in vicinity of stored and parked vehicles and machinery, miscellaneous containers, and stained soil,

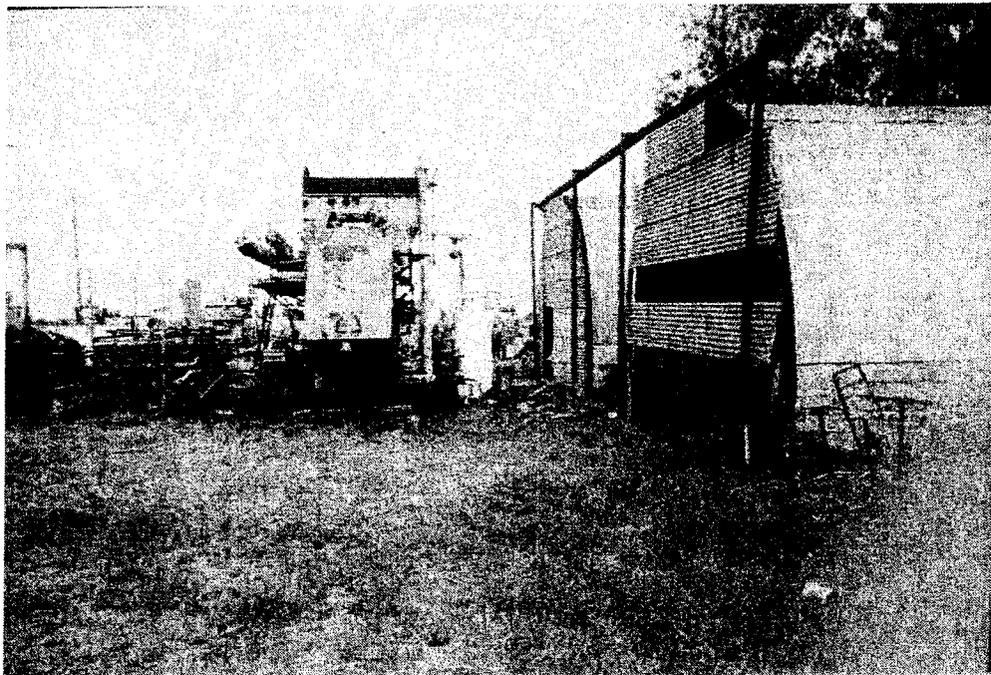
PG 15 Equipment Storage and Maintenance Area
Looking North, Quonset Buildings # 6 and 7 on Right

Structure #6 houses the repair shop which includes the machine shop in the west end and the welding shop in the east end. The machine shop includes a drill press and other standard metal working and repair tools. The shop also includes a parts washer; CEI was informed by Mr. Slight that only kerosene has been used for parts cleaner (no de-greasing solvents were reported to have been used on the ranch at any time). The washer was self-contained and not piped to any floor drain.

The other Quonset-style building (structure #7) is currently used, and reportedly always has been used for storage of feed, oats, and sheared wool. The western half of the building floor was covered with oats and wool and was not observed.

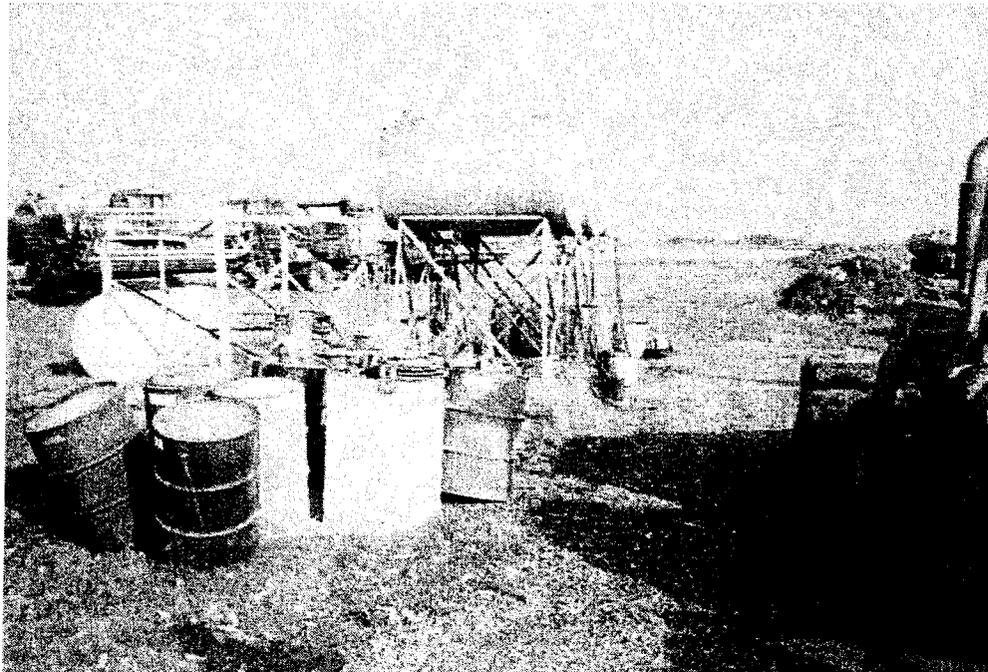
PG 15 Fuel Tanks, Petroleum Products Storage Area,
and Waste Oil Tank. Looking North

As noted on Figure 7, the fuel tank area is located on the north side of the property. The fueling area consists of a concrete pad (approximately 10 X 30 feet) with one 500-gallon regular-unleaded agricultural gas above ground storage tank (AST) and one 300-gallon diesel AST. As shown in the photograph in Figure 9, these two ASTs were elevated on metal stands on the concrete pad. Small drip zones were observed under the nozzles.

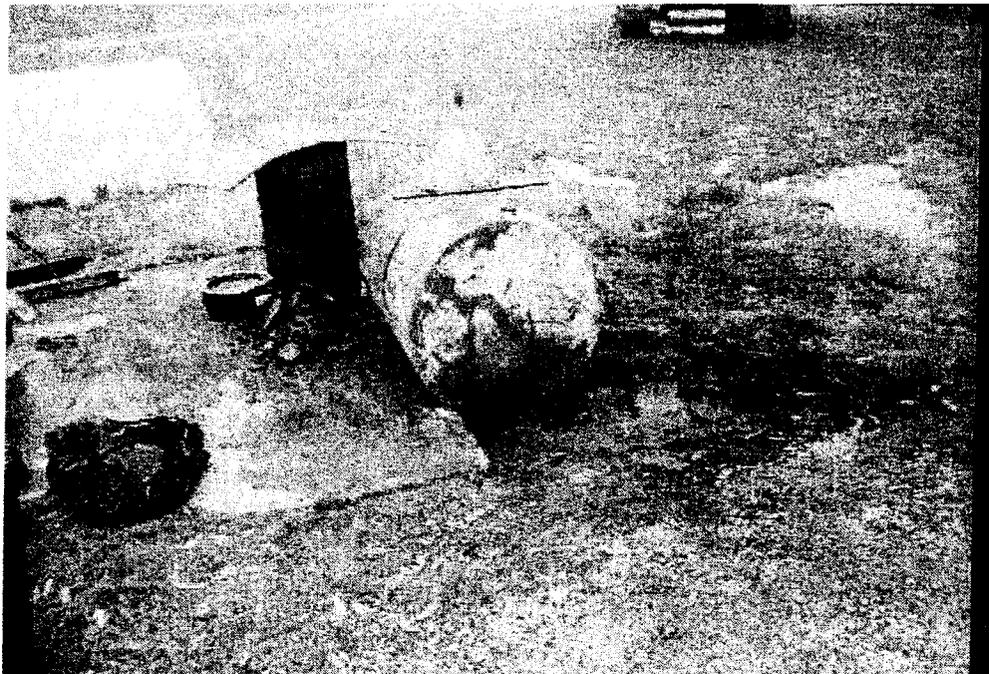
PG 15 200-Gallon Waste Oil Tank
Looking West

Spent kerosene was reported to have been stored in the waste oil tank for licensed disposal and recycling. The machine shop contained numerous cans of partially used oils, jack oil, soluble oil for drill press operation, cutting fluids, paint products and raw metal stock. The welding shop contained a welding machine and farm equipment in the process of repair, and raw metal material. No floor drains were observed in structure #6; however, there were patches of hydrocarbon staining on the concrete floor.

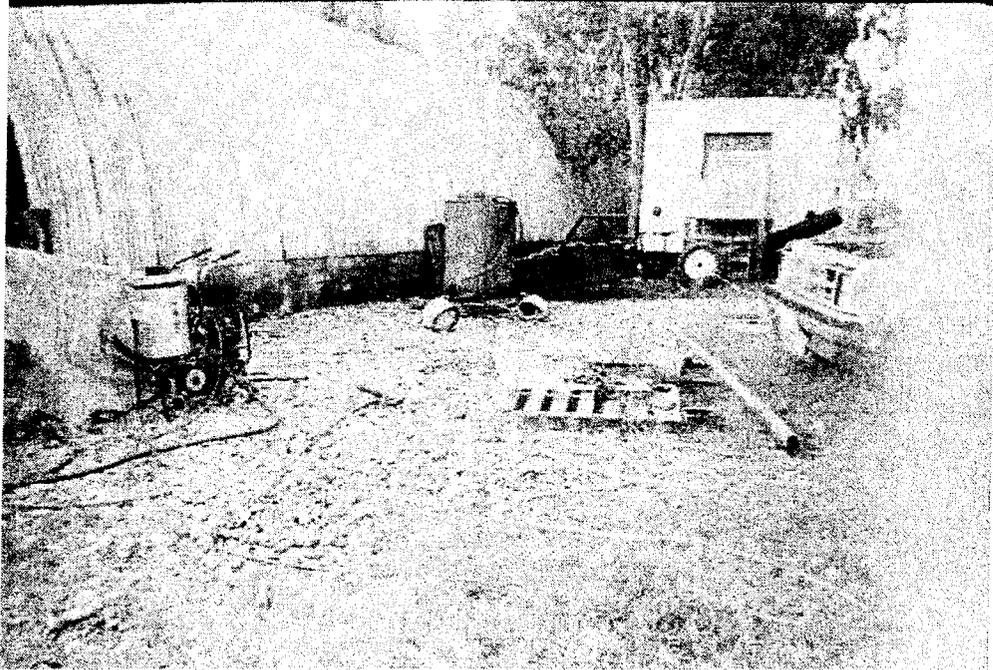
PG 15 Steam Cleaning Area Adjacent Building # 6
Looking Southwest

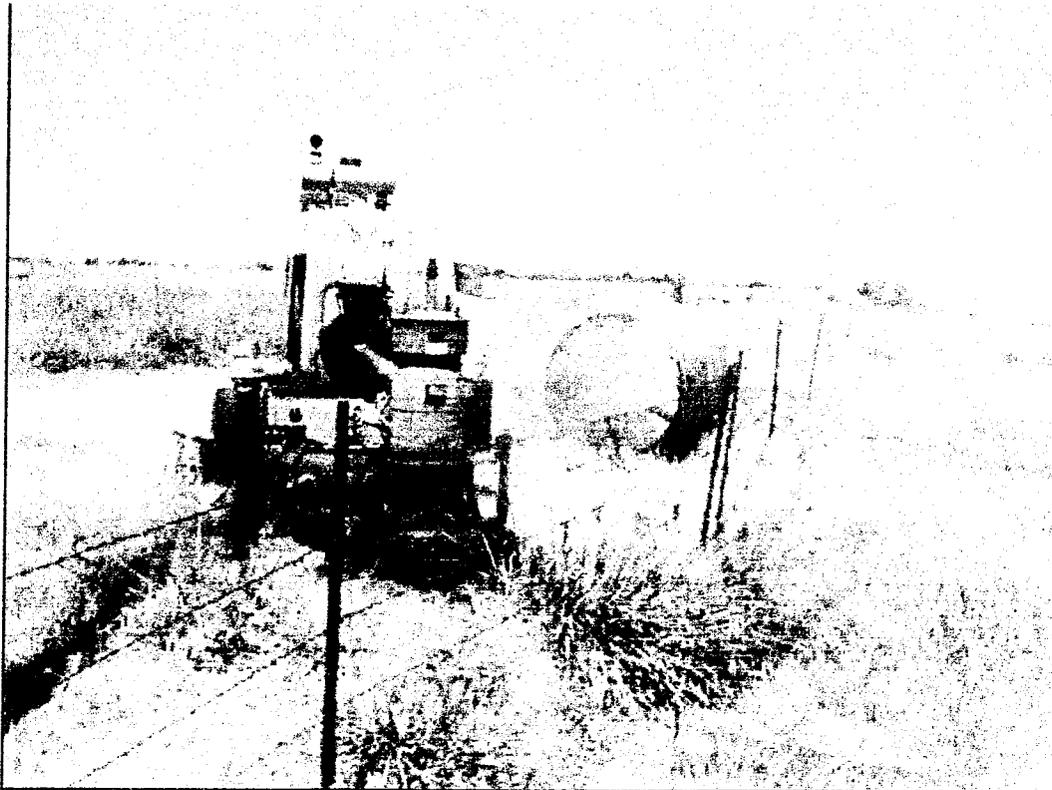
Pump, Well and Fuel Tank on PG15, West Side of Fence at West Property Boundary of PG 12 (looking north)

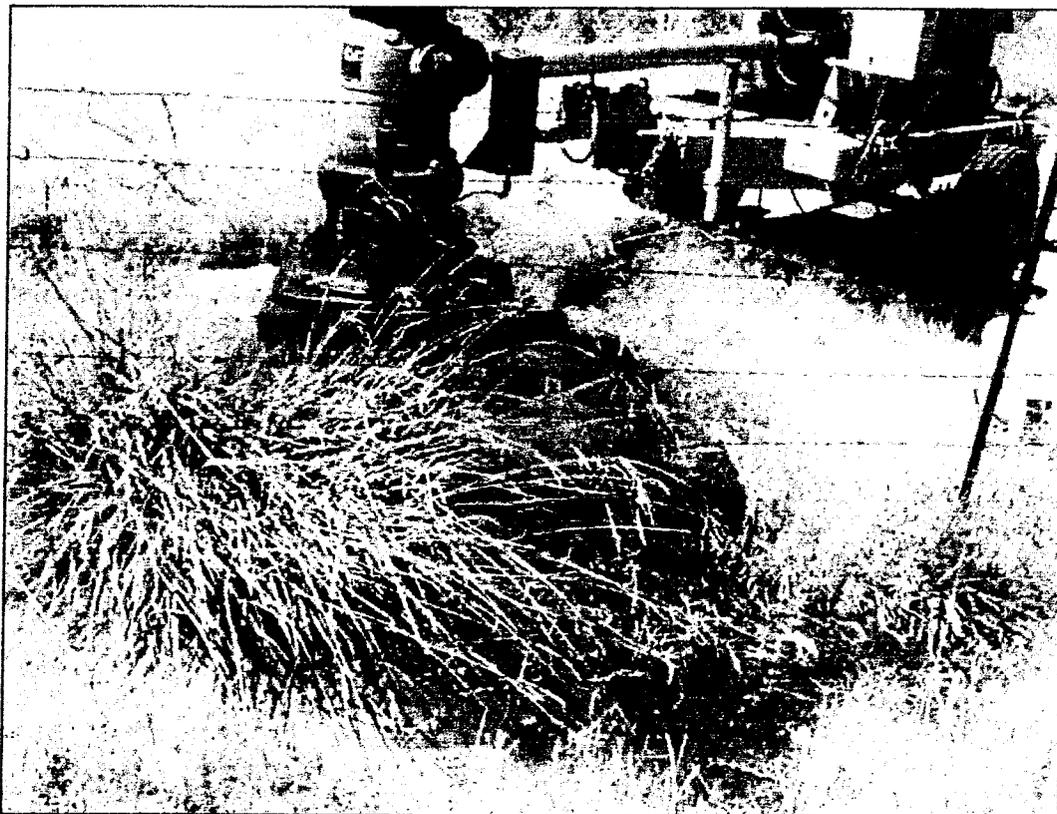
Oil Stained Soil on Pump Pad, and East Side of Fence

Considering the nature of the identified petroleum hydrocarbon constituent in the stained soil, it is not anticipated that the impacted soil would be classified as a hazardous material, and could be removed from the Site property in conjunction with remediation activities on other property groups during project development. Remediation activities should be conducted under the oversight of a California Registered Environmental Assessor II, with oversight from the Placer County Division of Environmental Health, and with applicable permits.

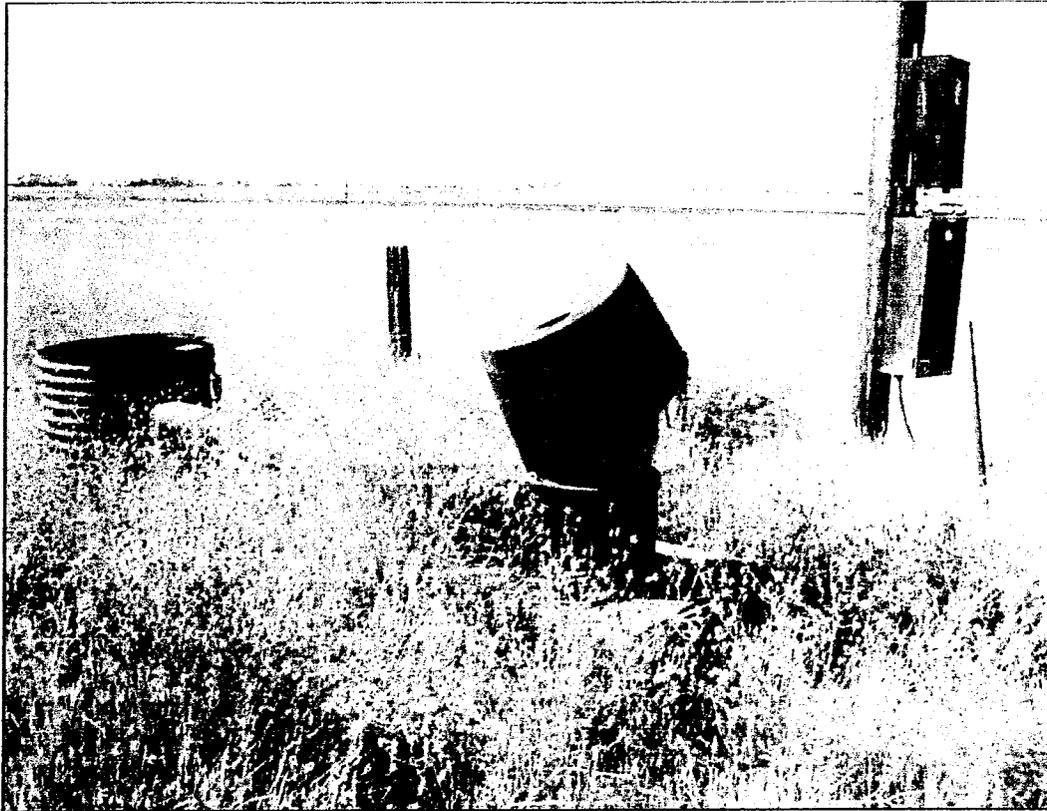
Pump Near Corral at Northeast Corner of Site (looking northwest)
