6.3.4 Type E Nodes

Antelope Creek at Johnson Springview & Antelope Creek Parks

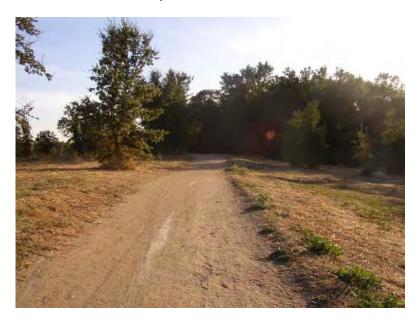
Figure 6-35 Creekside Multipurpose Trail

Antelope Creek passes through Antelope Creek Park in within the city of Rocklin. In this area, Antelope Creek Park combines with Johnson Springview Park to form a regional recreational center. Johnson Springview Park contains baseball, soccer, and field hockey fields as well as a skatepark and tennis courts. Antelope Park includes several multipurpose, unpaved trails that parallel the creek (Figure 6-35). In between the two parks is a Frisbee golf course, set amidst native oaks. Drainage is handled above ground in vegetated swales in both of these parks.

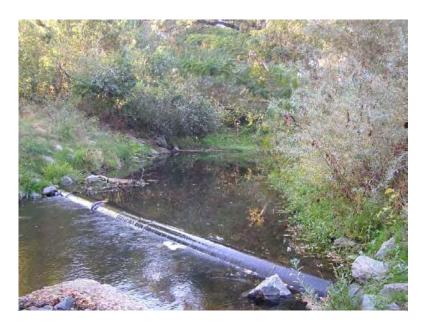
Figure 6-36 Sewer Crossing on Antelope Creek

At one location on the creek in Antelope Park, an informal pathway leads from the creekside unpaved trail to the streambank, and continues on the opposite bank near a private residence. The streambanks are riprapped with stone at this location. A sewer line also crosses the stream at this location, presenting a barrier to migrating salmonids. Water was just spilling over the top of the pipe at mid-October flow levels (Figure 6-36). This pipe should be redesigned to improve fish passage.

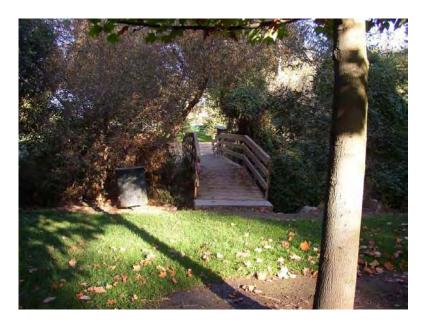
Figure 6-37 Bridge Over Secret Ravine in Loomis Regional Park

The park currently contains a concession stand, baseball fields, picnic areas with barbeques, porta-potties, unpaved trails and a bridge over the creek (Figure 6-37). A small sign adjacent to the bridge includes a calendar of events at the park. The parking lot has sufficient space for horse trailers, but is not currently striped for vehicles towing trailers.

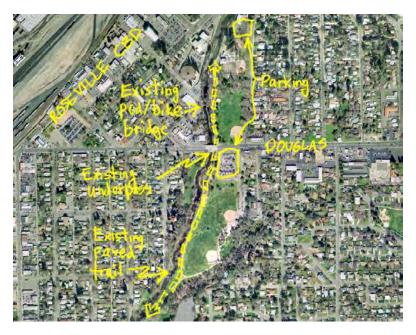
Figure 6-38 Dry Creek at Royer Park

Royer Park, in downtown Roseville, provides an excellent staging area for the Greenway (Figure 6-38). An existing trail follows the creek for the length of the park, providing access to sports fields, turf grass areas, tennis courts, basketball courts, restrooms, parking lots and other amenities.

The north end of this park is less than 500 feet from the new Roseville Civic Center and the revitalized downtown, providing easy access from this busy urban area via a pedestrian bridge over the creek.

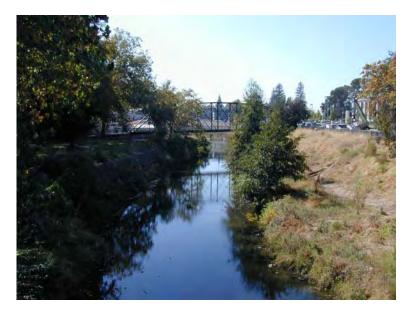
Figure 6-39 Royer Park Creek View

Riparian habitat in this area is marginal (Figure 6-39). The west creek bank is partially riprapped north of Douglas Boulevard, and parking lots are paved to the top of the bank in some cases (Figure 6-40). The riparian band throughout the park is narrow, often from 10 to 20 feet in width, especially in the area discussed above, and trees are relatively sparse. The most that can probably be accomplished in the west bank areas that are encroached upon by pavement is the application of biotechnical bank stabilization techniques that incorporate woody vegetation.

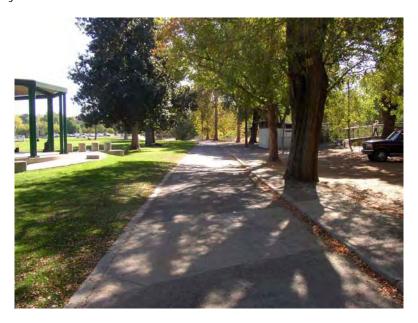
Figure 6-41 Paved Trail in Royer Park

The paved trail is moderately used. This trail is approximately 10 feet wide, and is striped south of Douglas Boulevard (Figure 6-41). In 40 minutes spent walking the trail in the early afternoon on a weekday, four cyclists, six pedestrians including a youth with a fishing rod, two dog walkers, and two people using electric mobility scooters were seen using the trail. This usage would certainly increase if the trail extended upstream and downstream through the Greenway. The paved path turns to a dirt track several hundred feet north of Darling Way.
