CORNER RECORD

County of Placer, California

Brief Legal Description 1/4 S28 | S27

T16N R16E M.D.M.

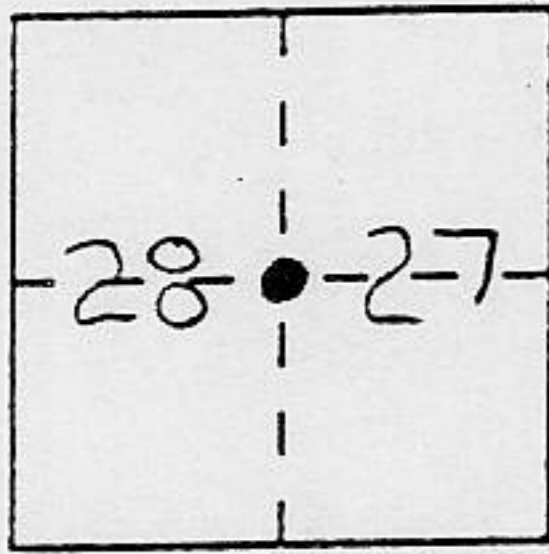
1/4
S28 | S27
1978

Found BLM Brass Cap in Stone Mound
with accessories per BLM Plat.

monument found disturbed by construction. Reset from
control ties to position prior to construction in 1992.
Rebuilt stone mound ± 3" dia by 1" high.
Hale-Tippin Consultants J/N 22.37A
