CORNER RECORD

Brief Legal Description LOTS 14 & 15, TAHOE VISTA SUBDIVISION NO. 1, B/MAPS/10 O.R.P.C.

PLAT OF SURVEY

LOTS 14 & 15, TAHOE VISTA SUBDIVISION NO. 1, AS FILED IN BOOK B OF MAPS AT PAGE 10, OFFICIAL RECORDS PLACER COUNTY, CALIFORNIA. A PORTION OF THE N.W. 1/4 OF SECTION 13, TOWNSHIP 16 N., RANGE 17 E., M.D.B. & M.

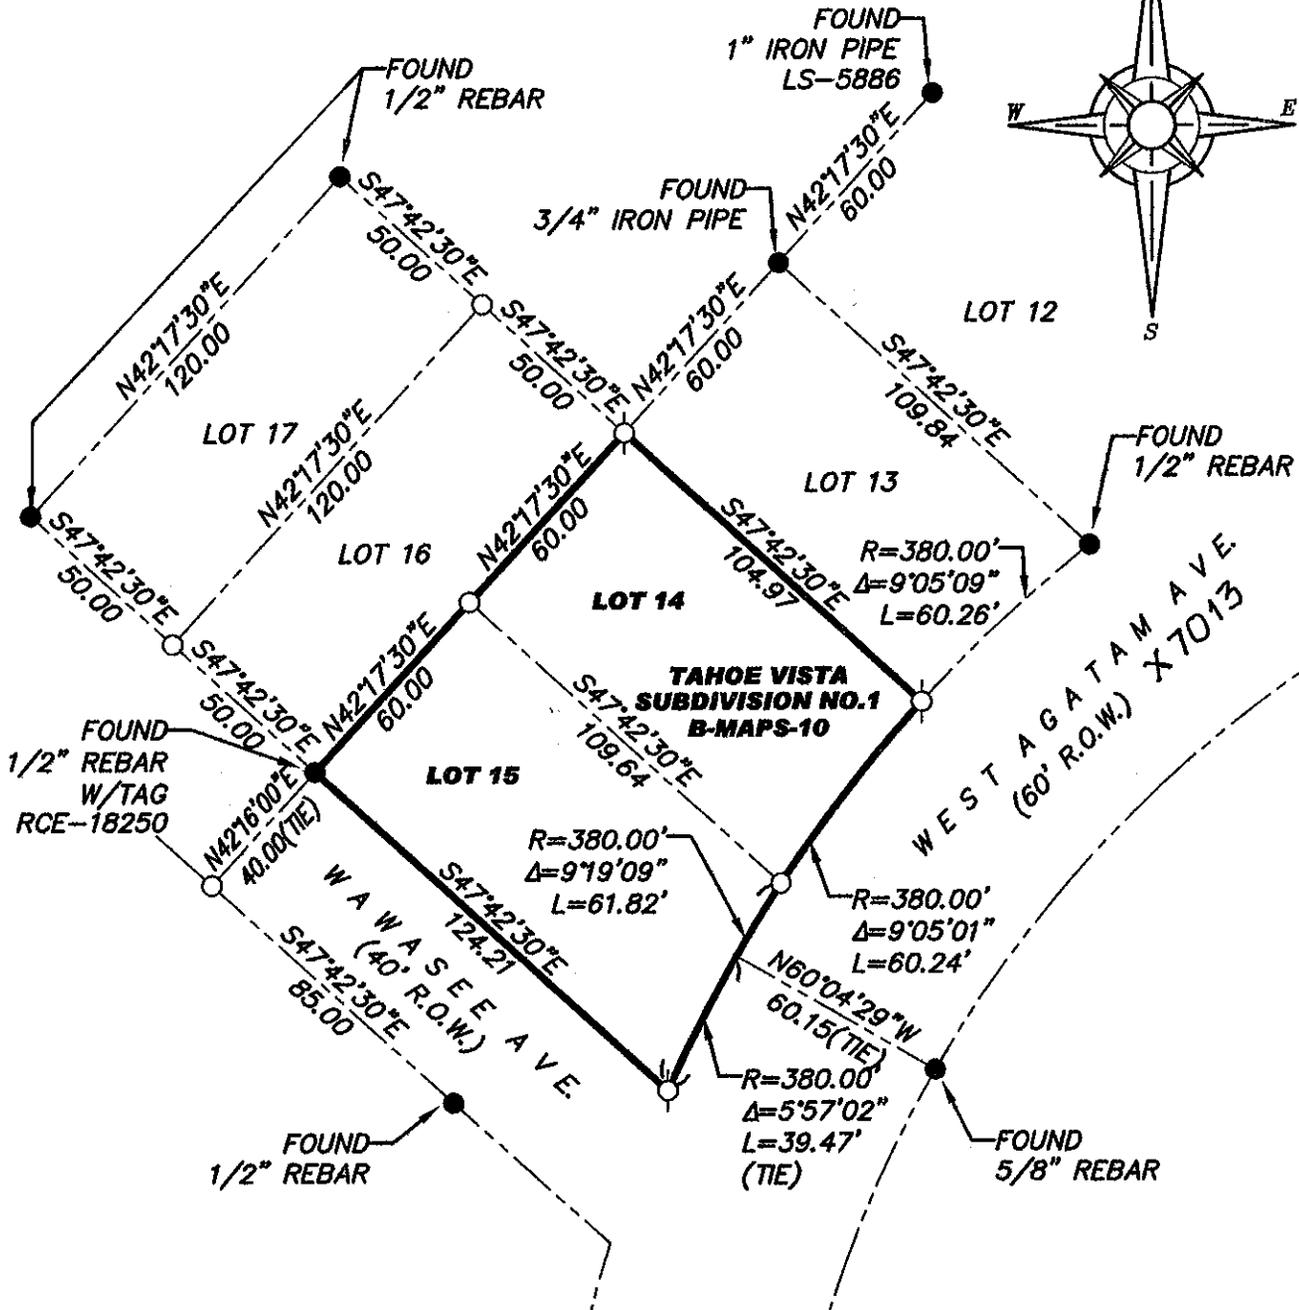
Identification and type of corner found: Evidence used to identify or procedure used to establish or reestablish the corner:
USED RECORD DIMENSIONS AND FOUND MONUMENTS PER B/MAPS/10 O.R.P.C. TO RE-ESTABLISH THE MISSING CORNERS OF LOTS 14 & 15, AS SHOWN ON ACCOMPANYING PLAT.

A description of the physical condition of the monument as found and as set or reset:
Ø SET 5/8" REBAR WITH YELLOW PLASTIC CAP LS-7429
• FOUND MONUMENT AS SHOWN ON PLAT

SCALE 1" = 50' DATE OF SURVEY 9/1/2010
