CORNER RECORD

Document Number 20120056

City of Homewood County of PLACER, California

Brief Legal Description Lot 5, Blackwood Cove/ Placer County, CA., Bk F/Maps/Pg.3

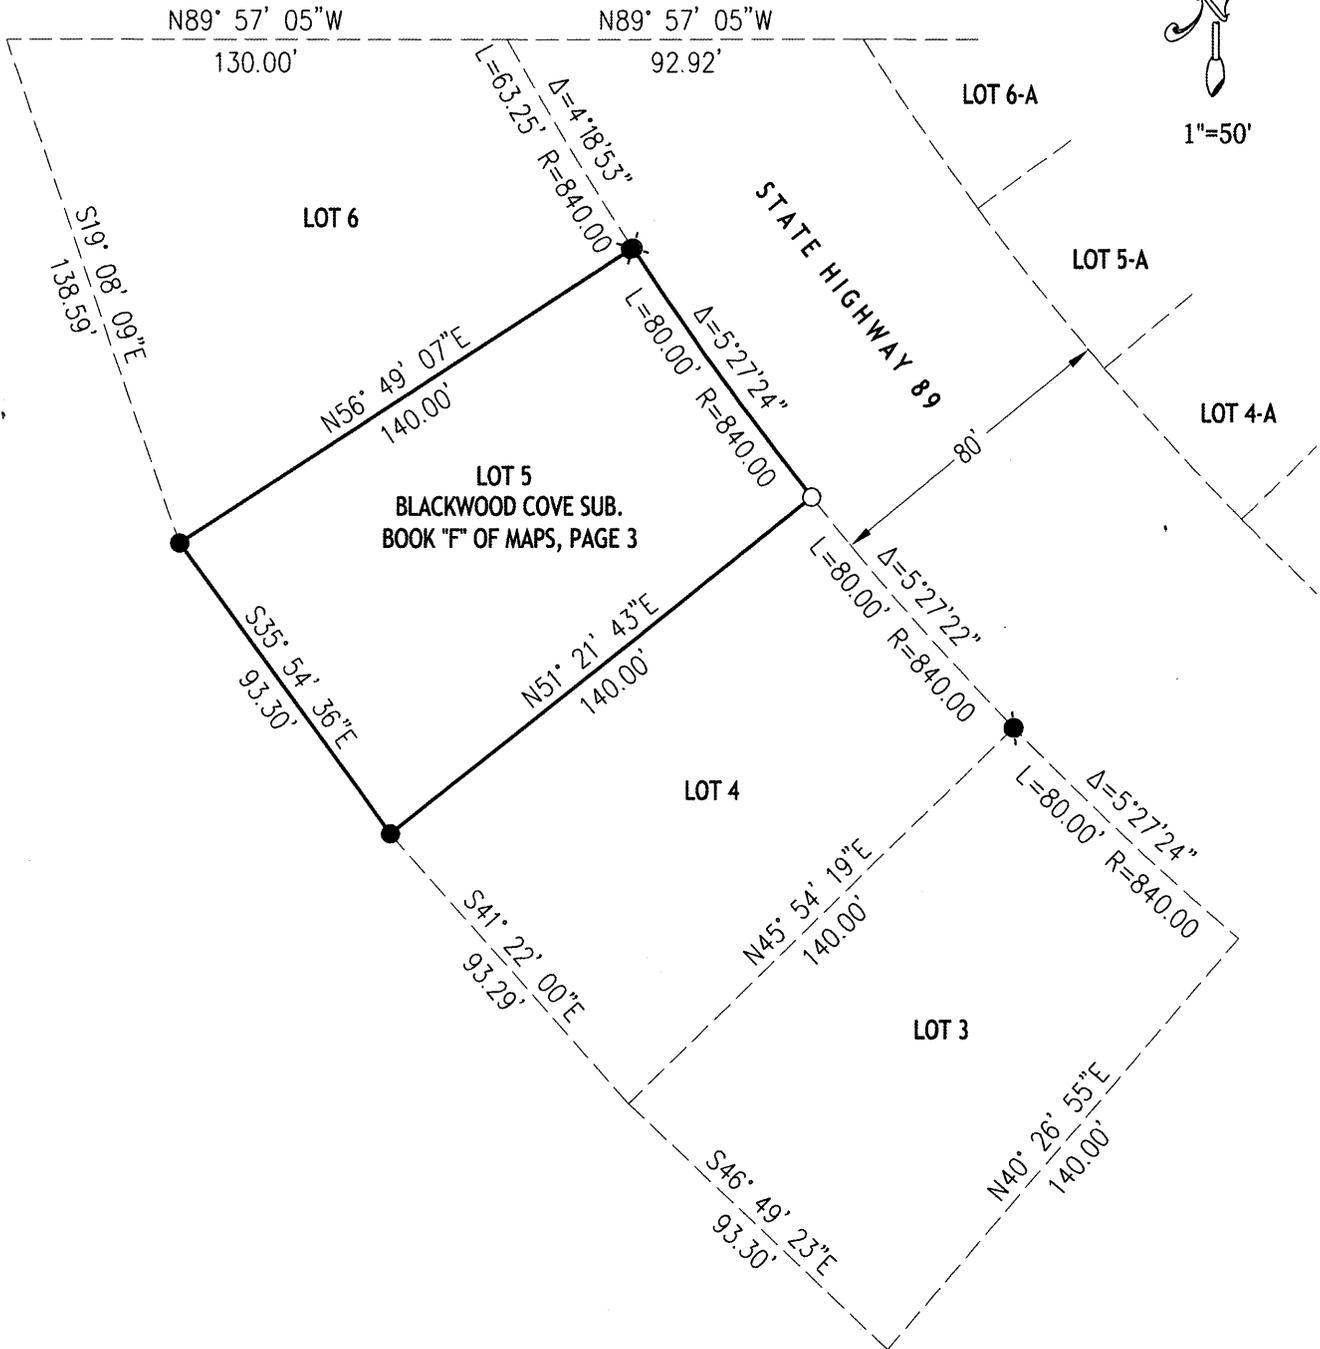
1"=50'

FOUND MONUMENTS AS SHOWN ON PAGE 2

USED NEAREST FOUND MONUMENTS WITHIN UNIT TO REESTABLISH PROPERTY

CORNERS AS SHOWN HEREON.

FOUND MONUMENTS IN GOOD CONDITION.

SET MONUMENT AS SHOWN ON PAGE 2

PLACED LATH AT SET MONUMENT.
